READING BOROUGH COUNCIL

Record of Condition Survey Report
Arthur Clark Care Home and Albert Road Day
Centre
June 2013

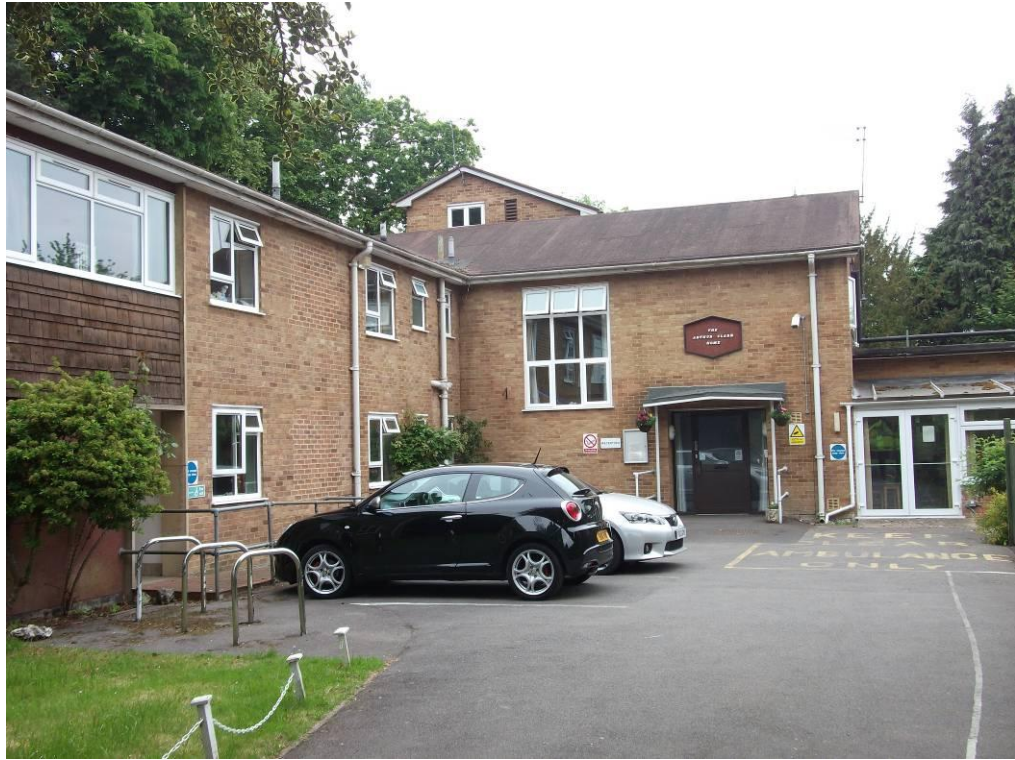
Photograph 01 (Main entrance)

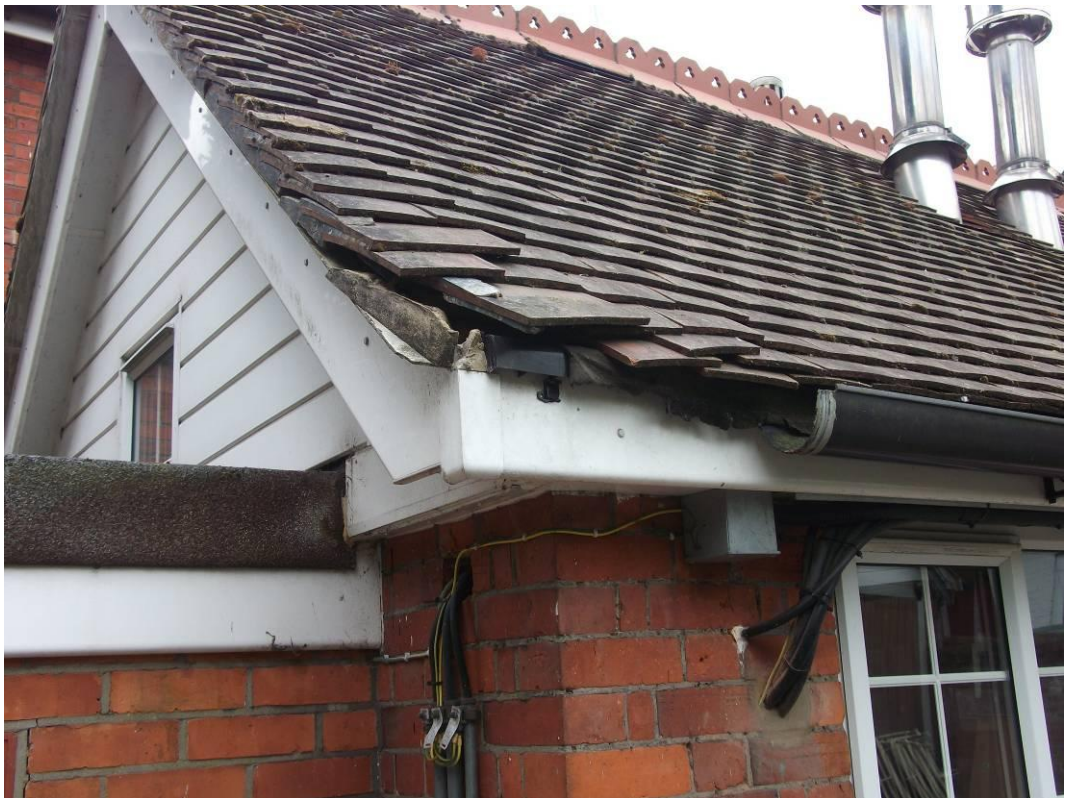
Photograph 12 (Impact damage electrical intake room)

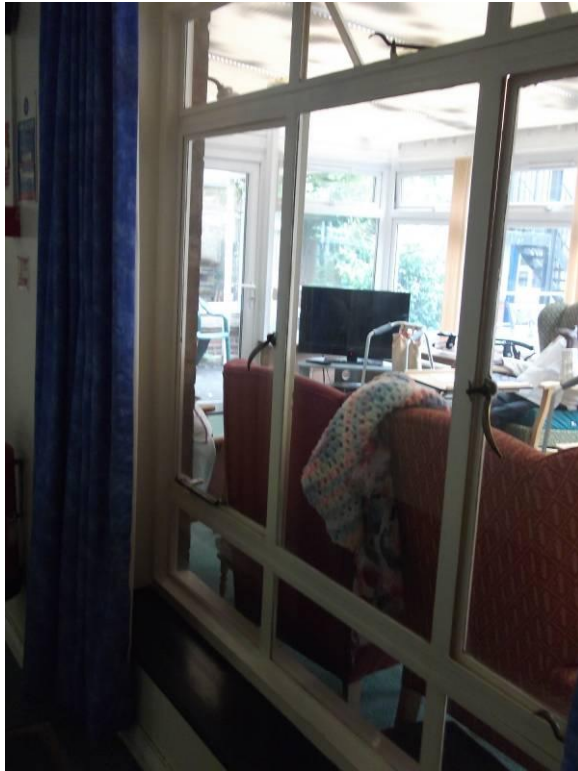
Photograph 13 (Internal window with low level panels)

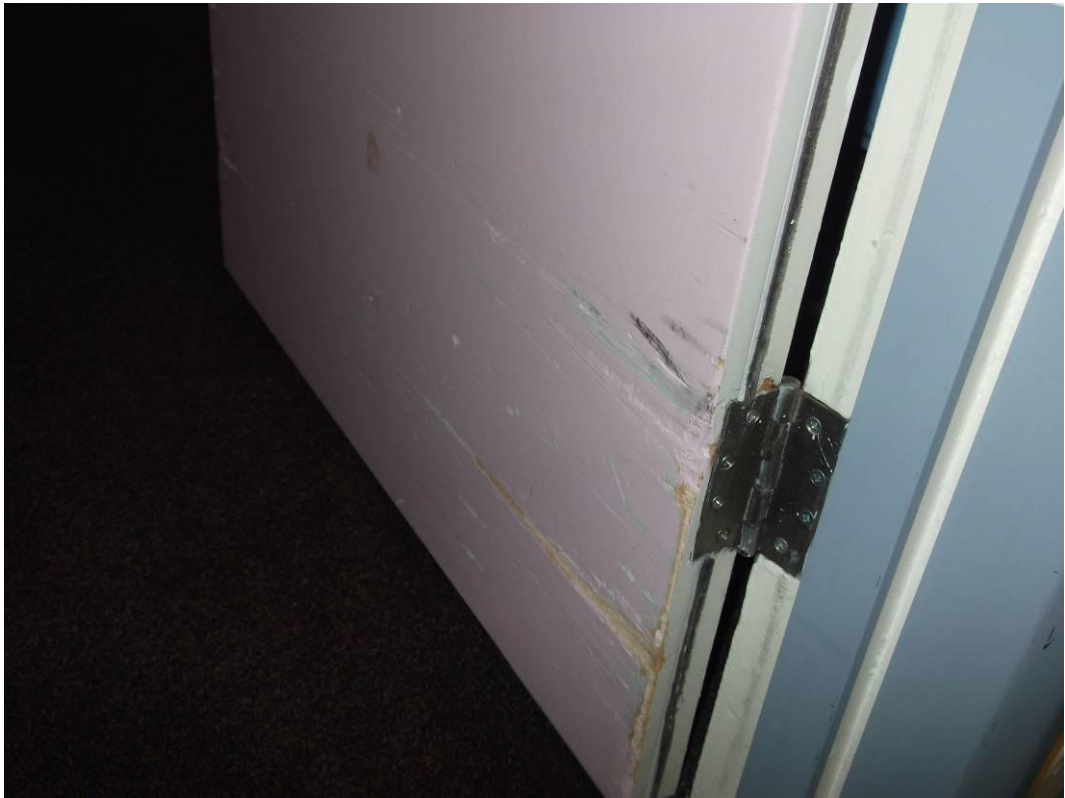
Photograph 16 (Typical damage to bedroom door)

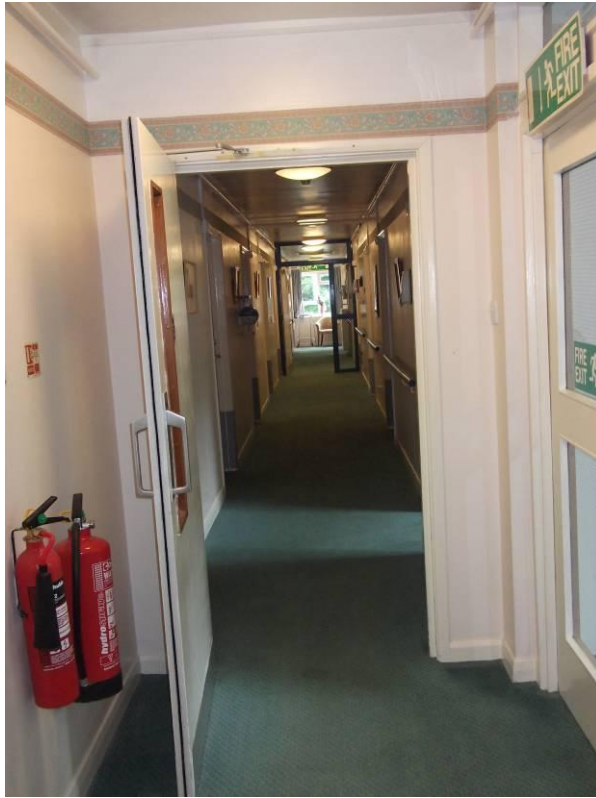
Photograph 17 (Typical corridor)

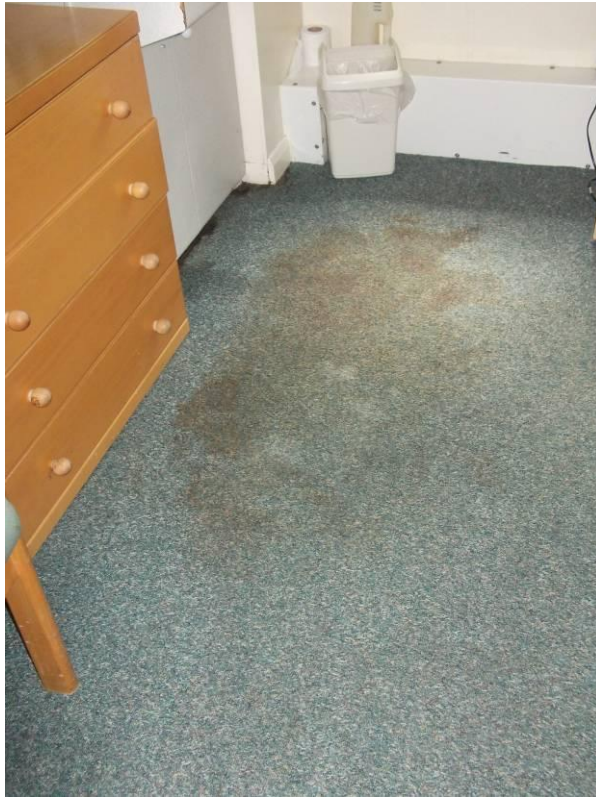
Photograph 19 (Staining to carpet)

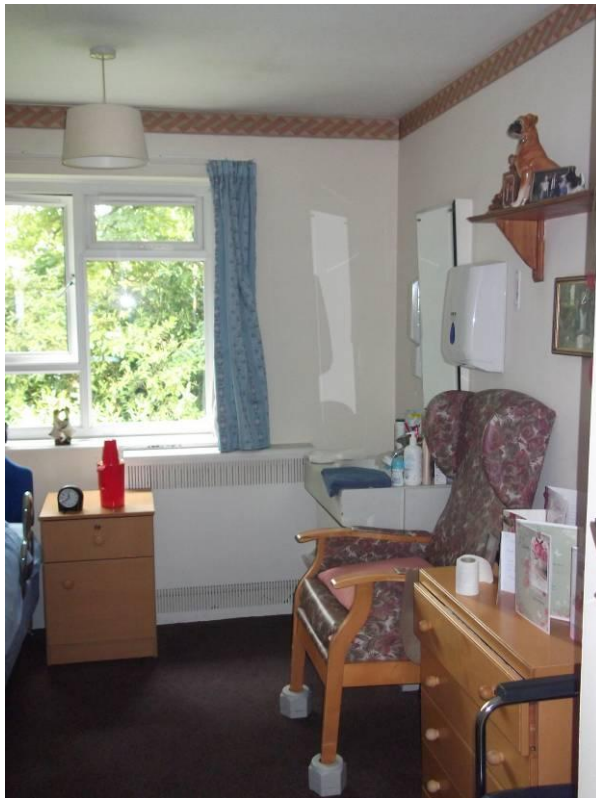
Photograph 20 (Typical bedroom)

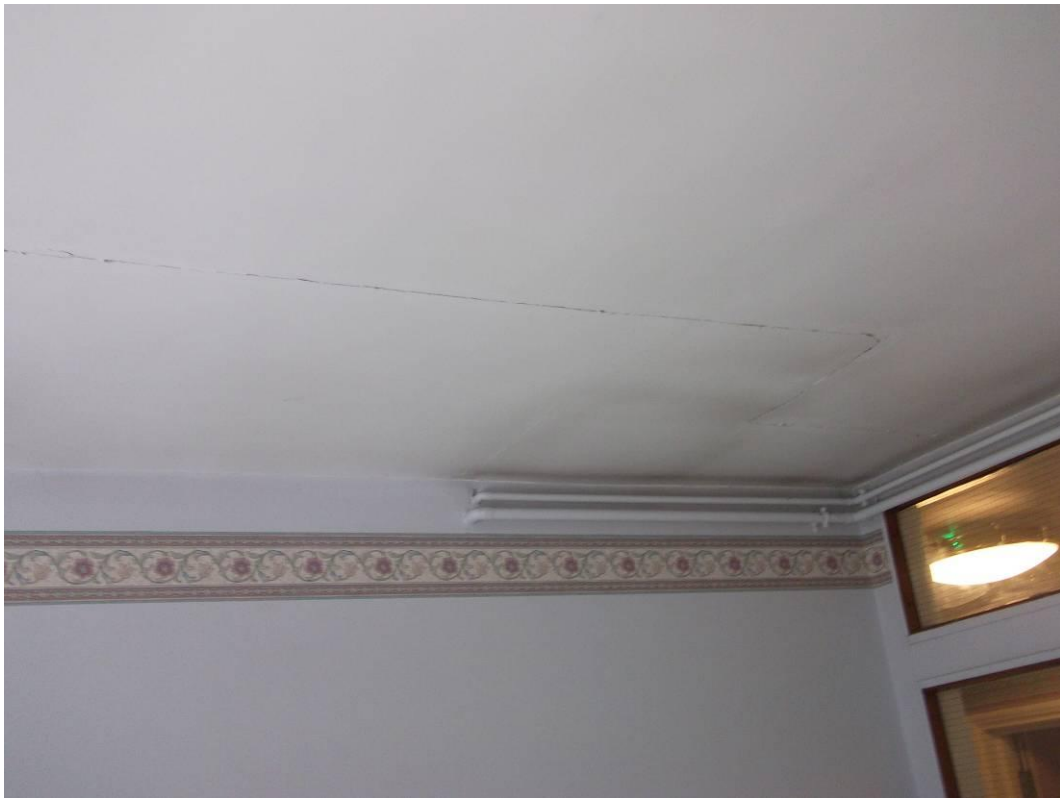
Photograph 21 (Typical plasterboard junction cracking)

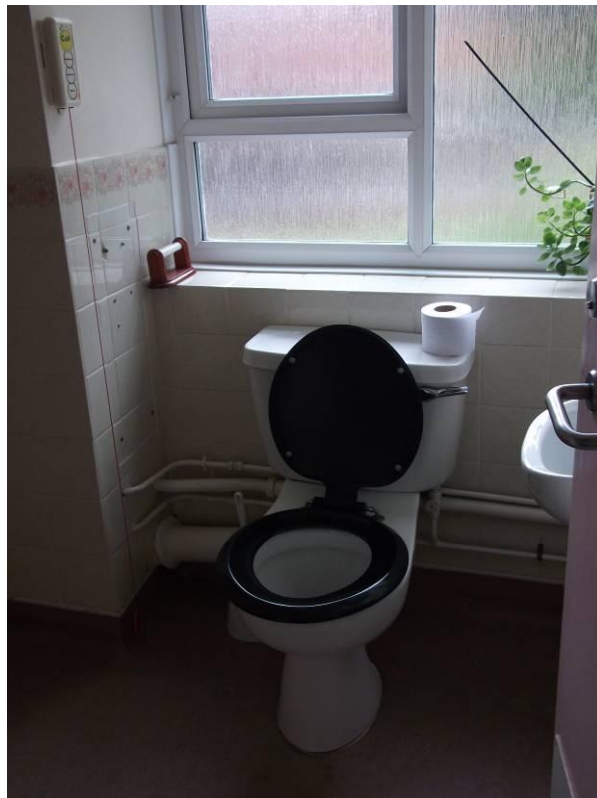
Photograph 22 (Typical WC adjacent bedrooms)

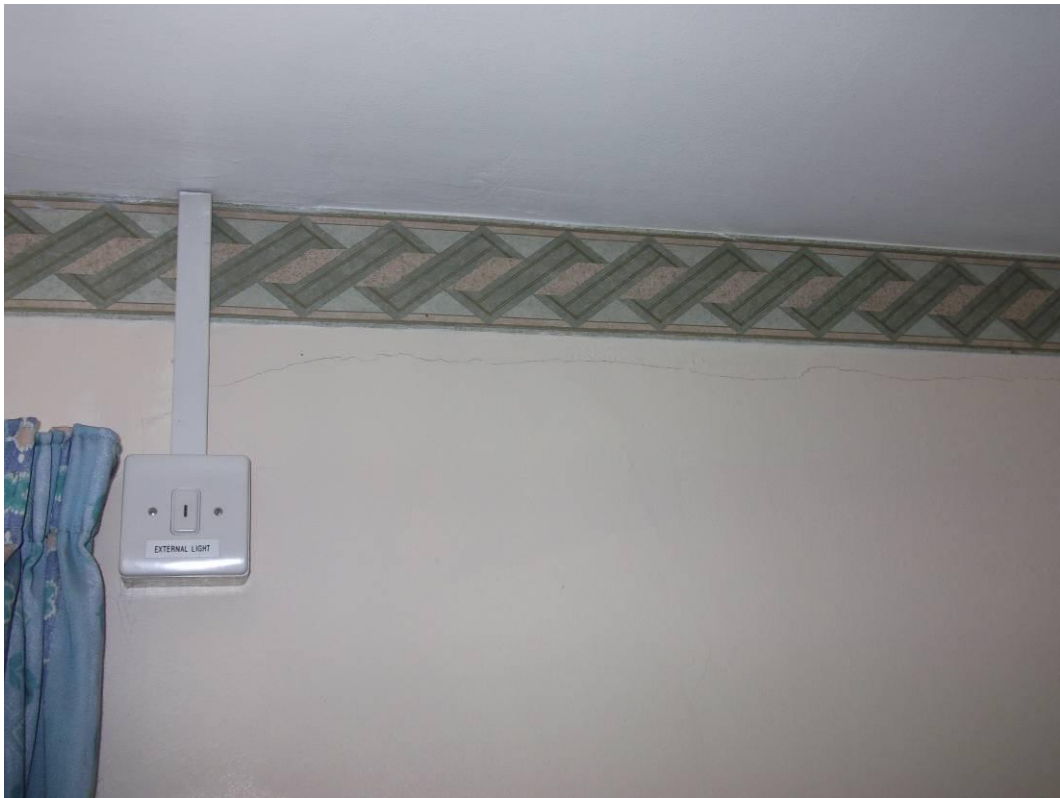
Photograph 23 (Typical cracking to plaster finish)

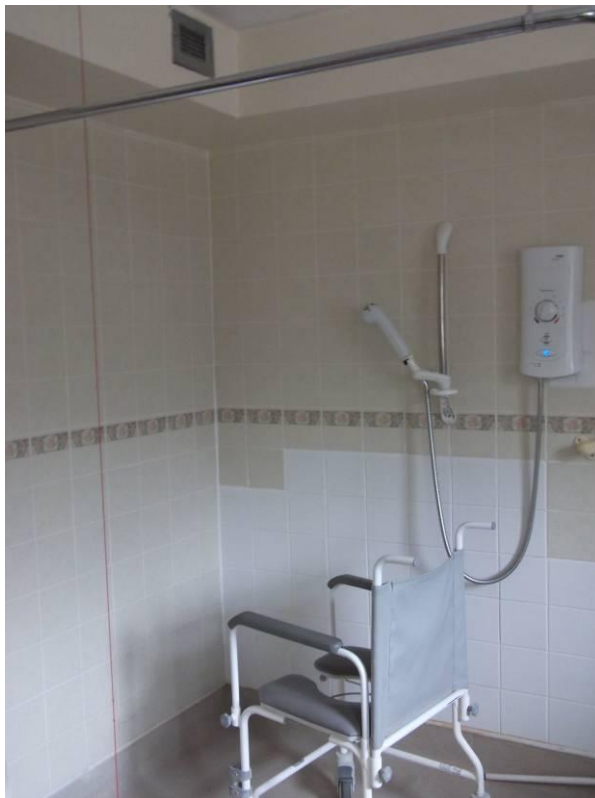
Photograph 24 (Accessible shower)

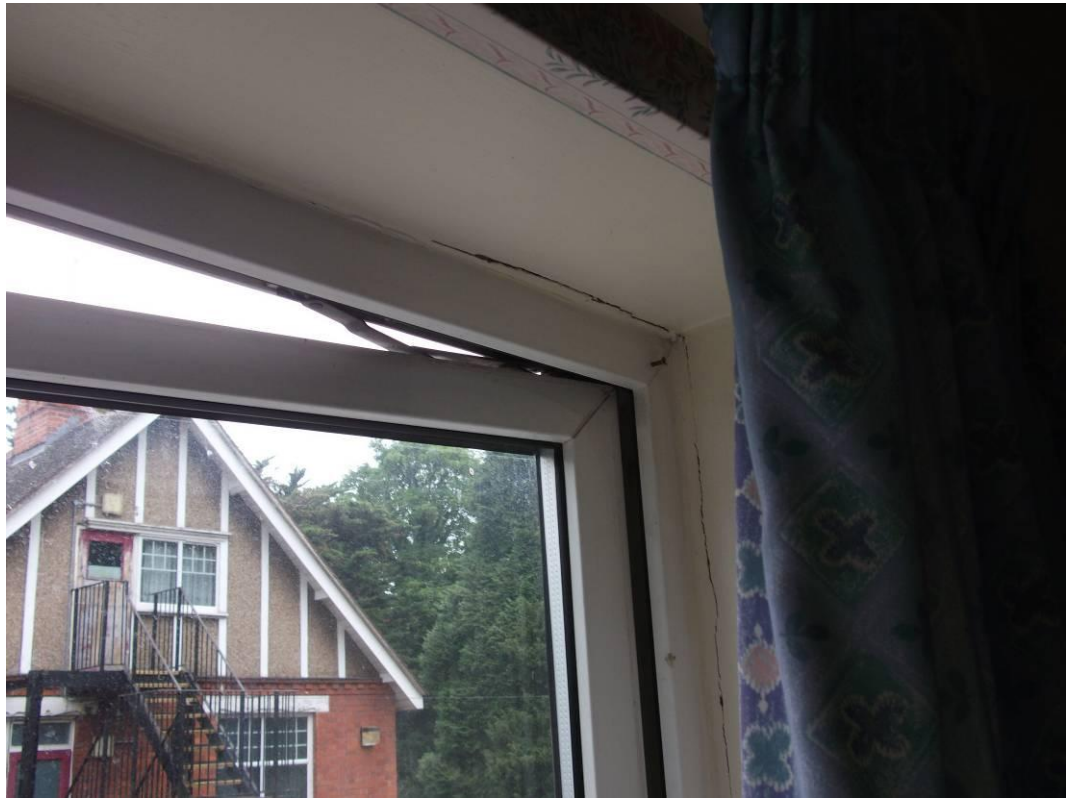
Photograph 26 (Plaster damage first floor bedroom)

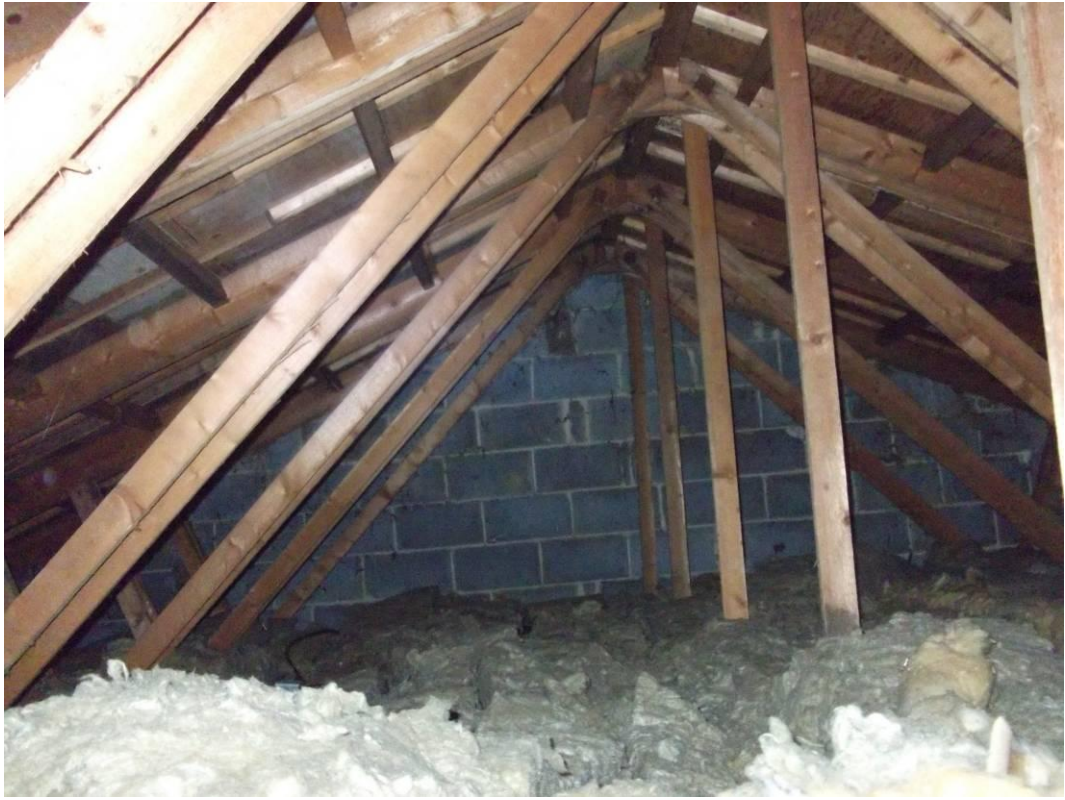
Photograph 27 (roof void West wing)

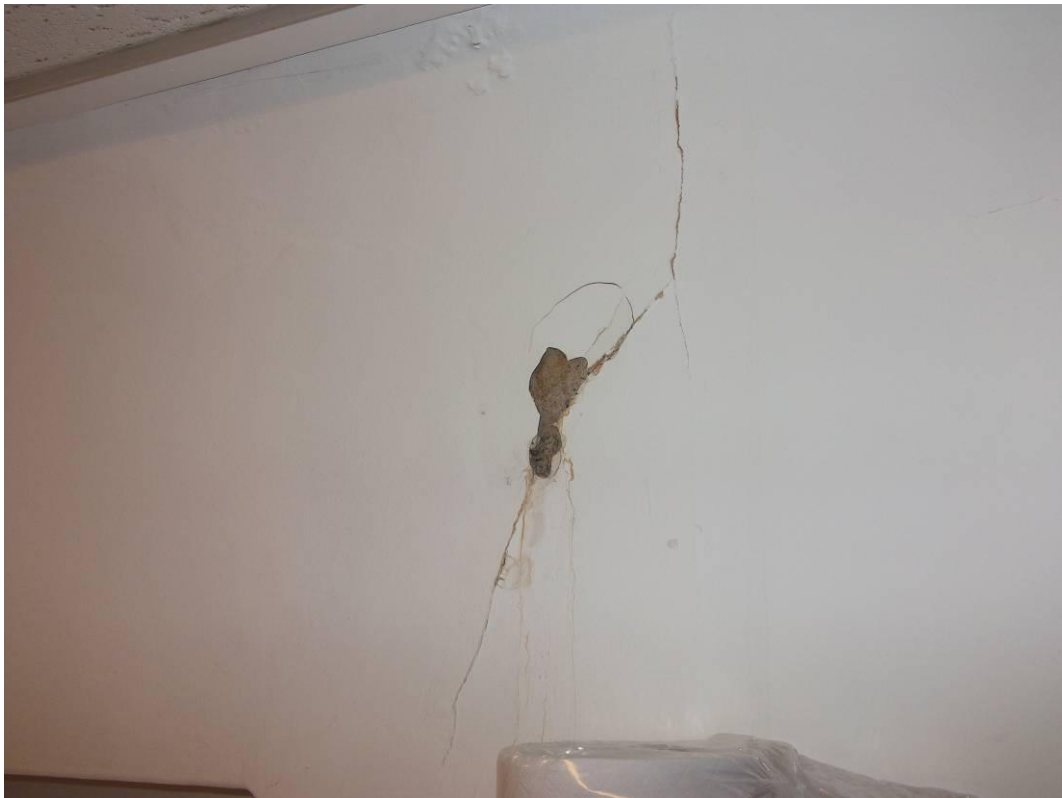
Photograph 32 (Plaster damage to main toilets ground floor)

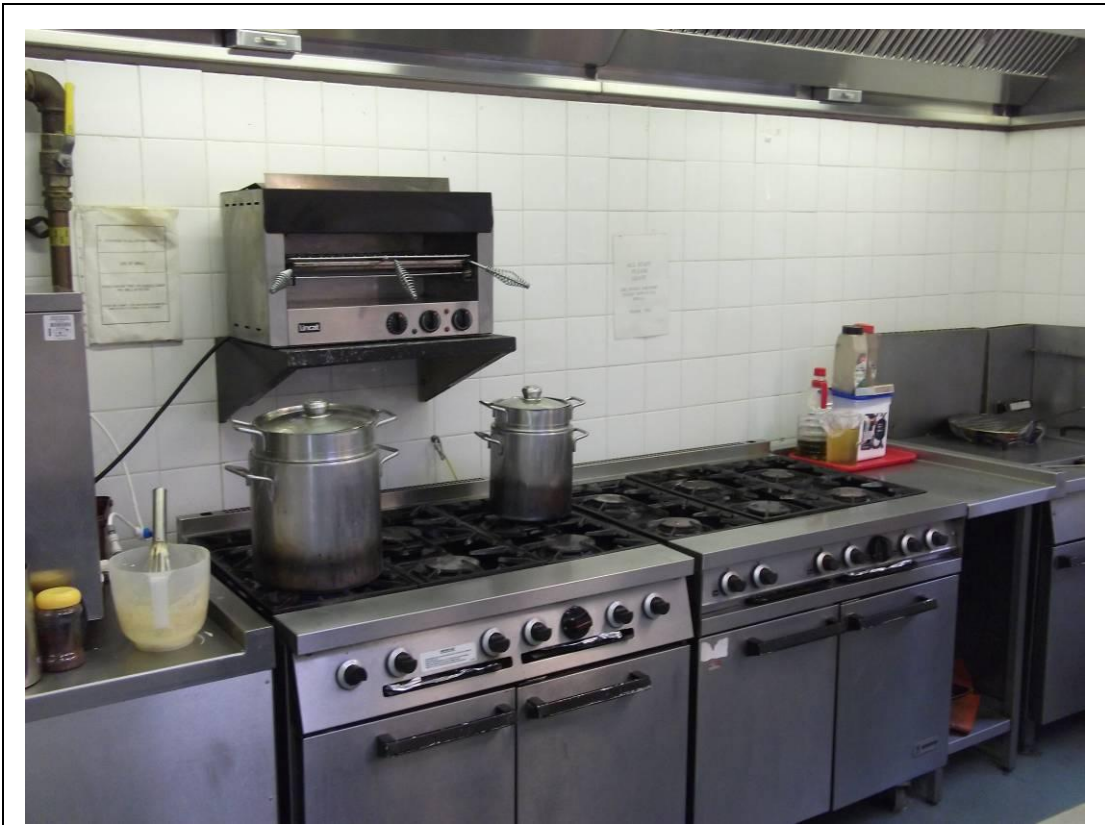
Photograph 33 (Kitchen equipment)

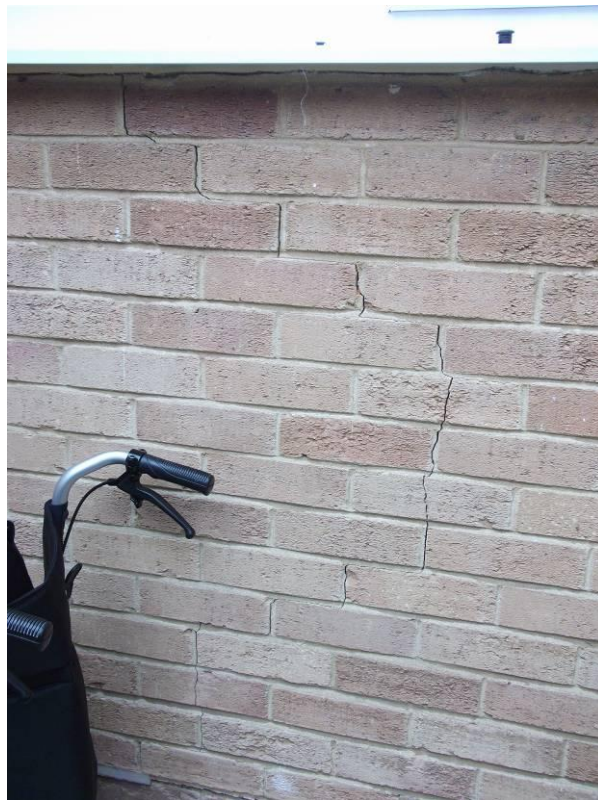
Photograph 36 (Cracking to masonry wheel chair storage)

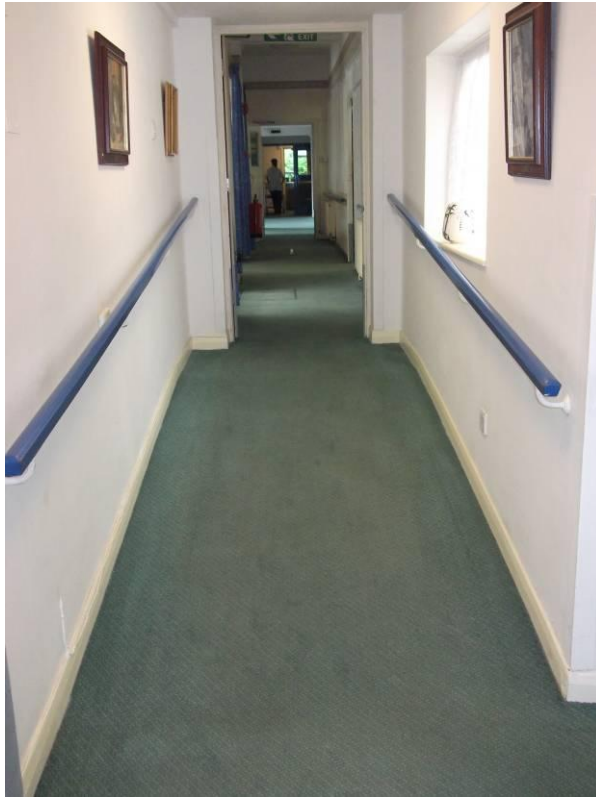
Photograph 37 (Internal ramp)
