Appendix B
Photographs – Albert Road Day Centre

Arthur Clark Care Home and Day Centre**Appendix E - CJR Midlands Mechanical and Electrical Report - Current Condition Ratings****Room: 4**

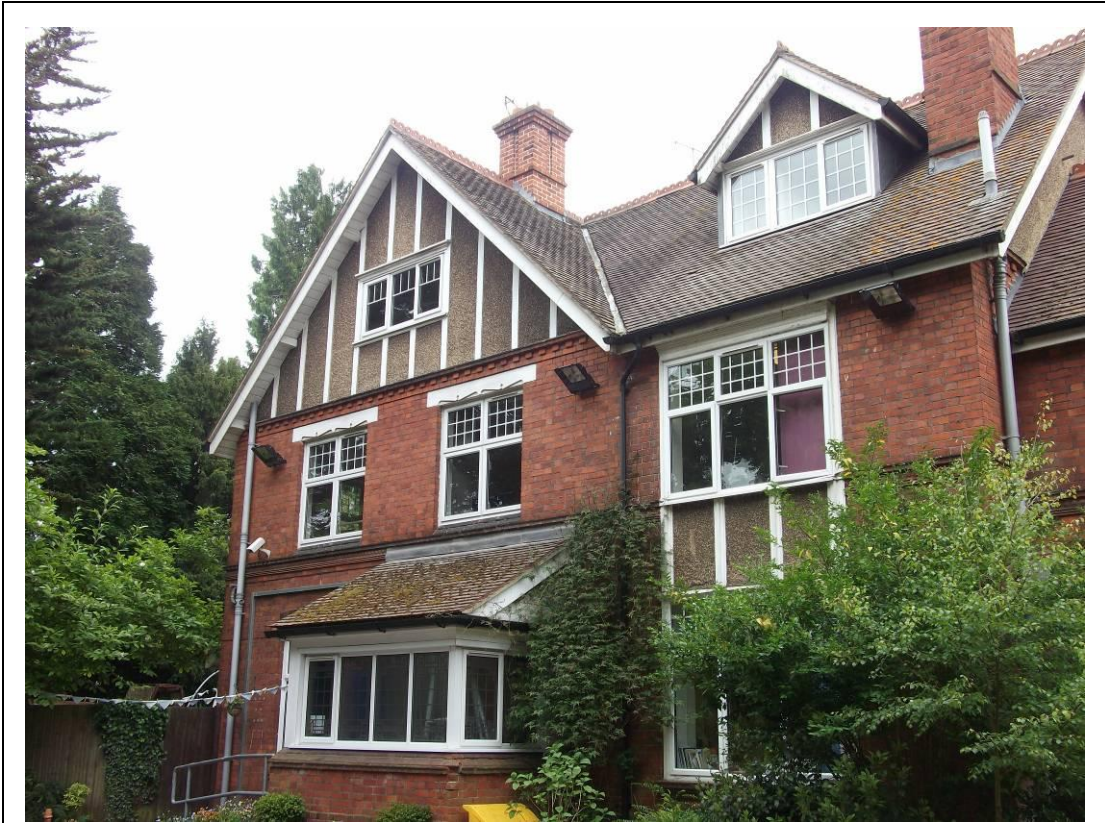
Photograph 01 (East elevation)

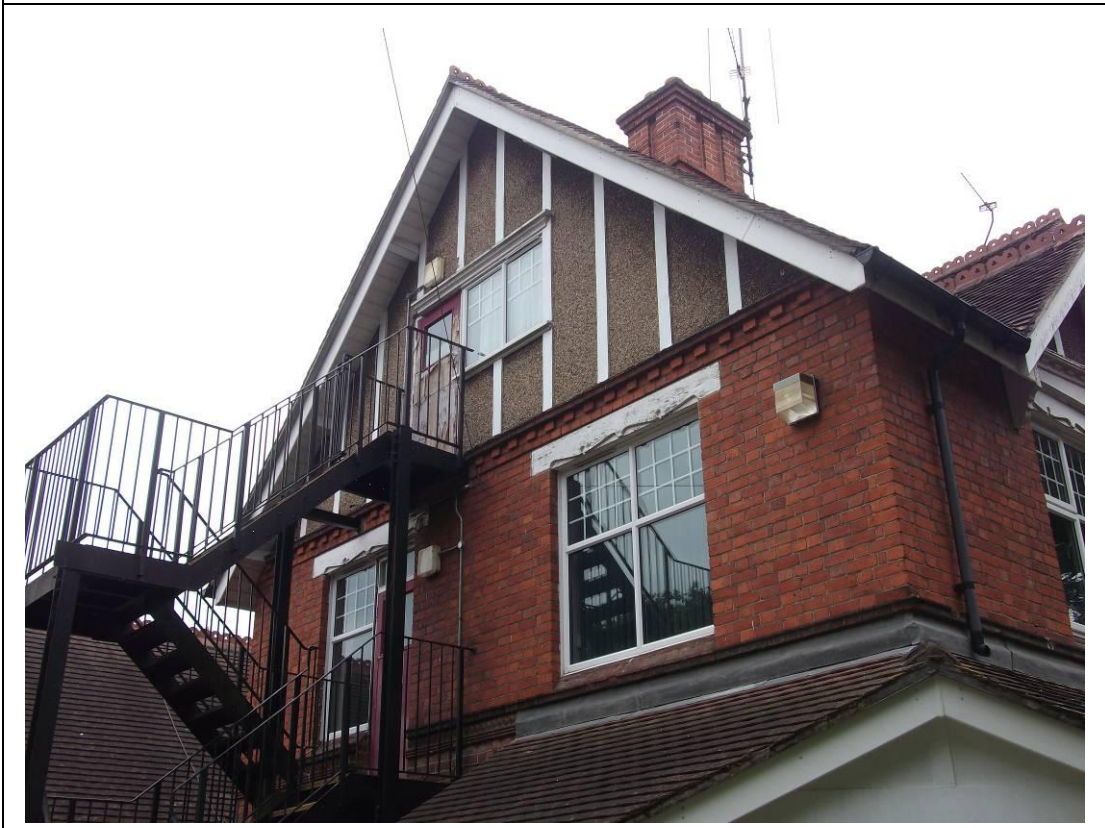
Photograph 02 (South elevation 1st & 2nd floors)

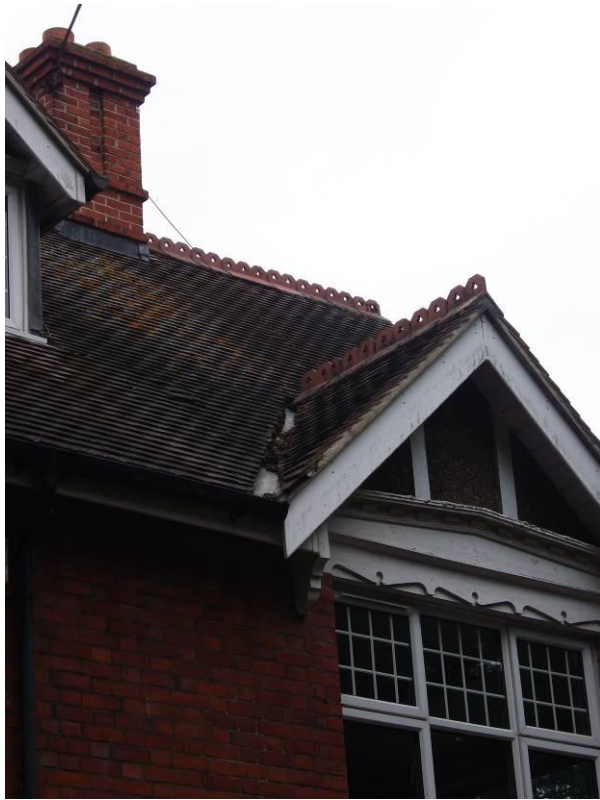
Photograph 03 (East elevation roof)

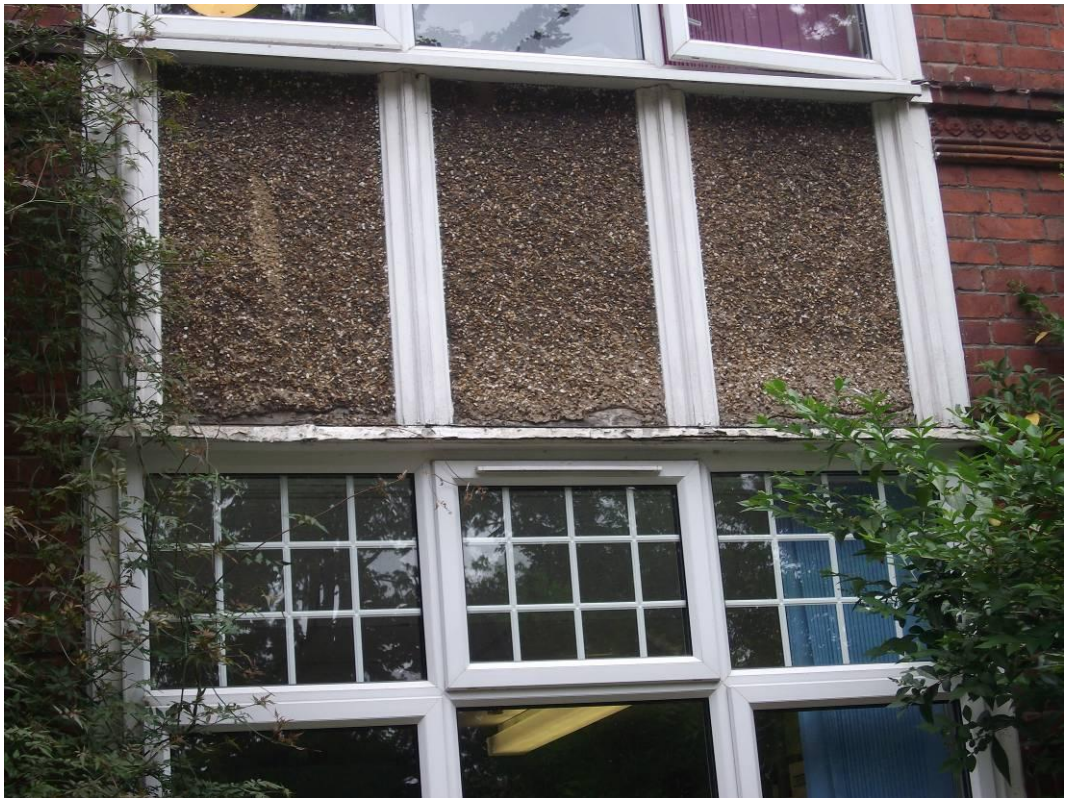
Photograph 04 (East elevation render infill)

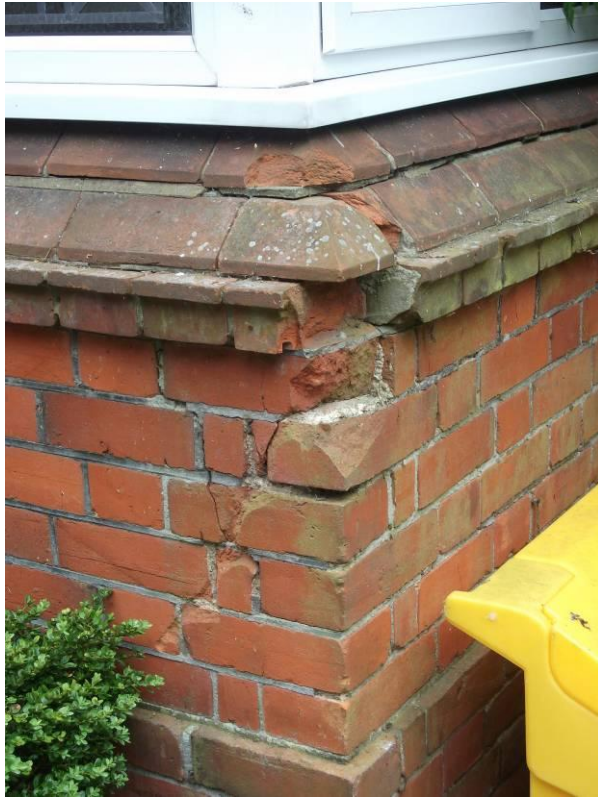
Photograph 05 (Entrance porch brickwork damage)

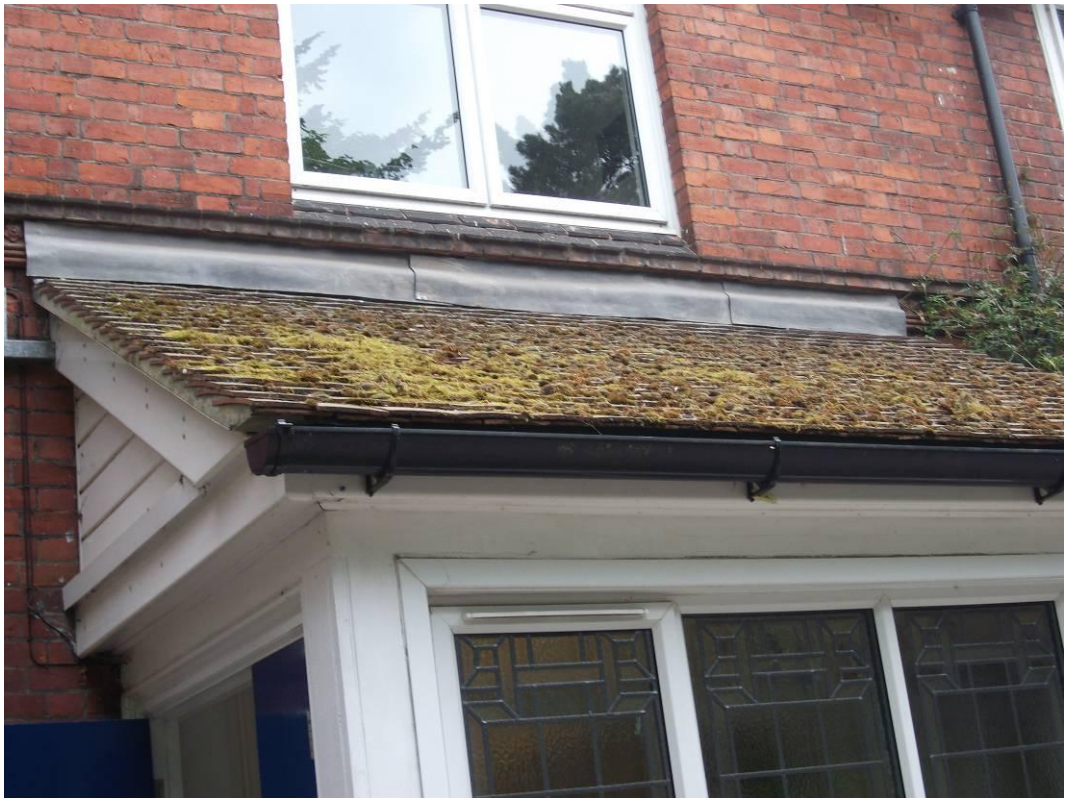
Photograph 06 (Porch roof)

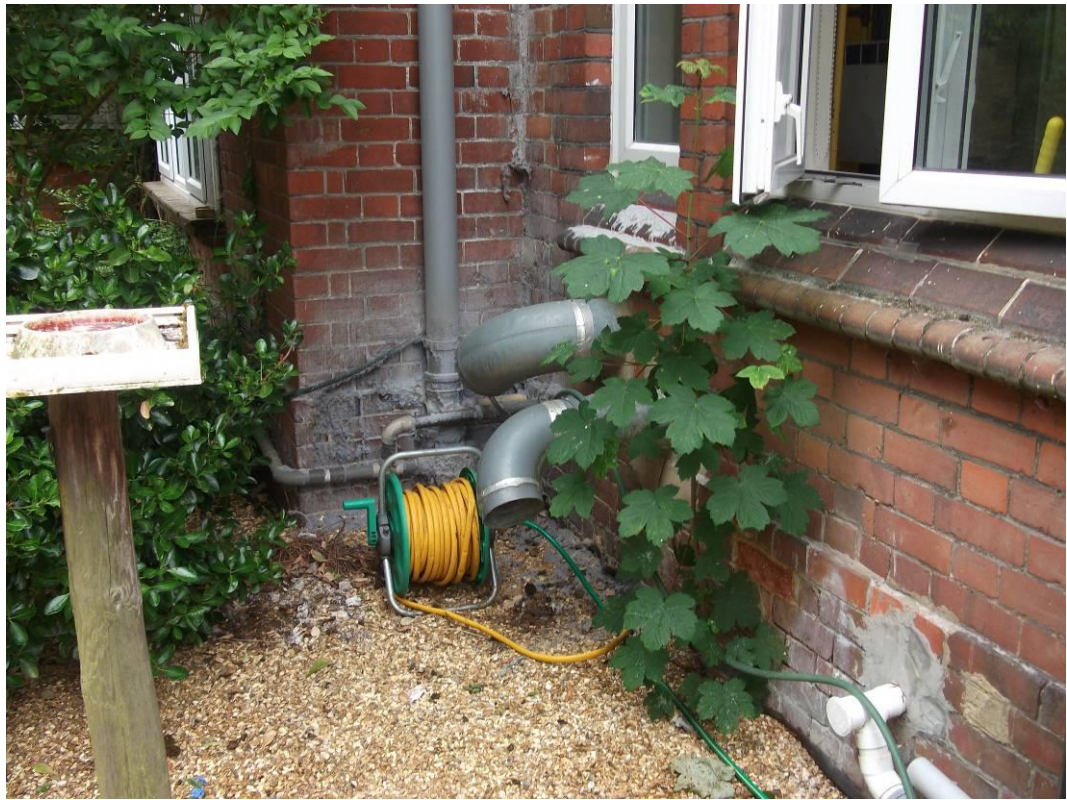
Photograph 07 (Tumble extracts)

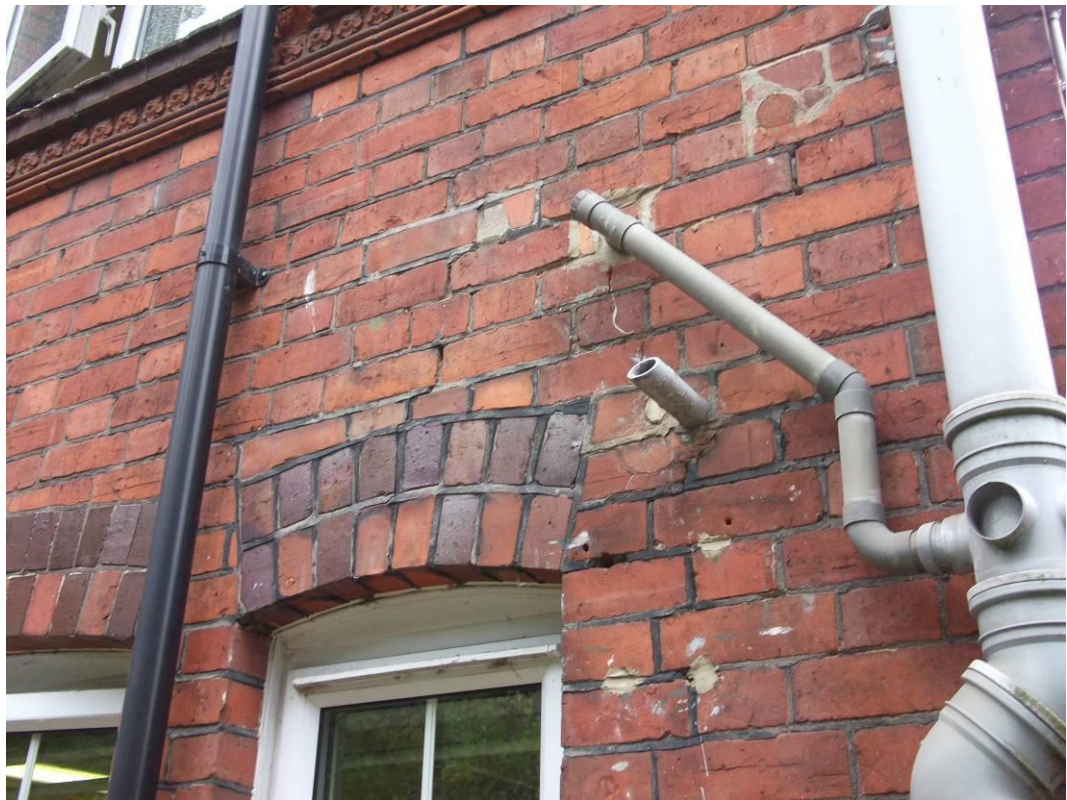
Photograph 08 (SVP pipe work)

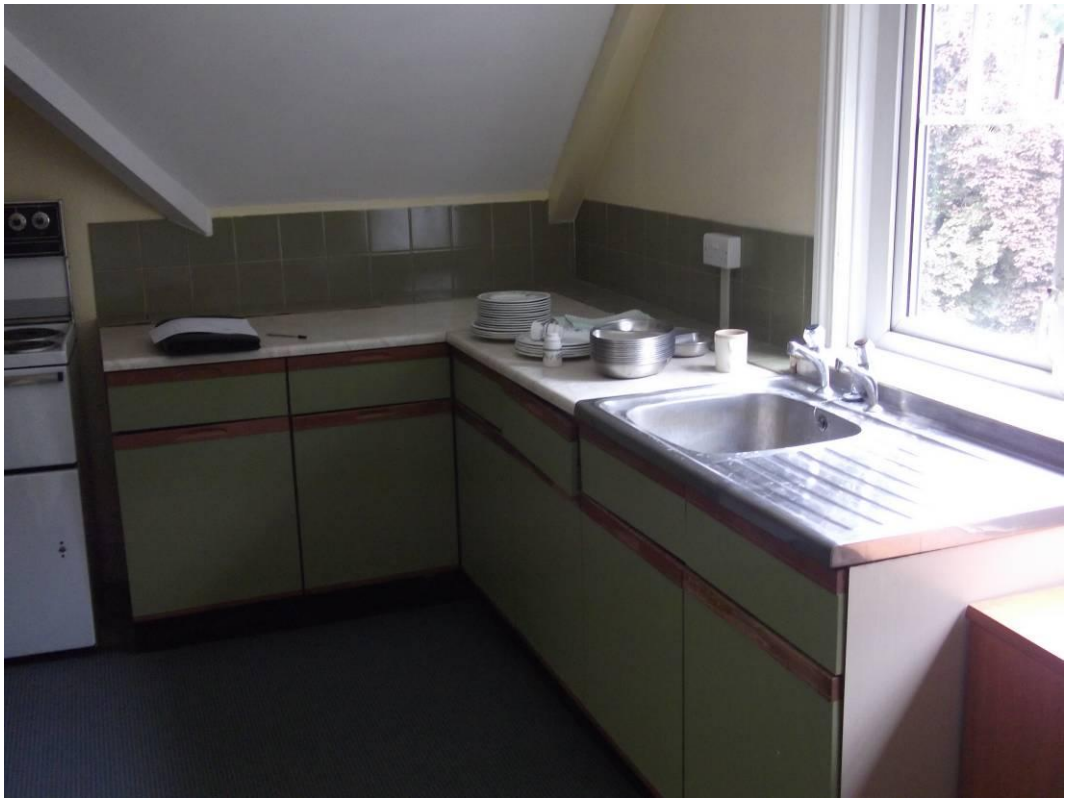
Photograph 09 (Kitchen second floor)

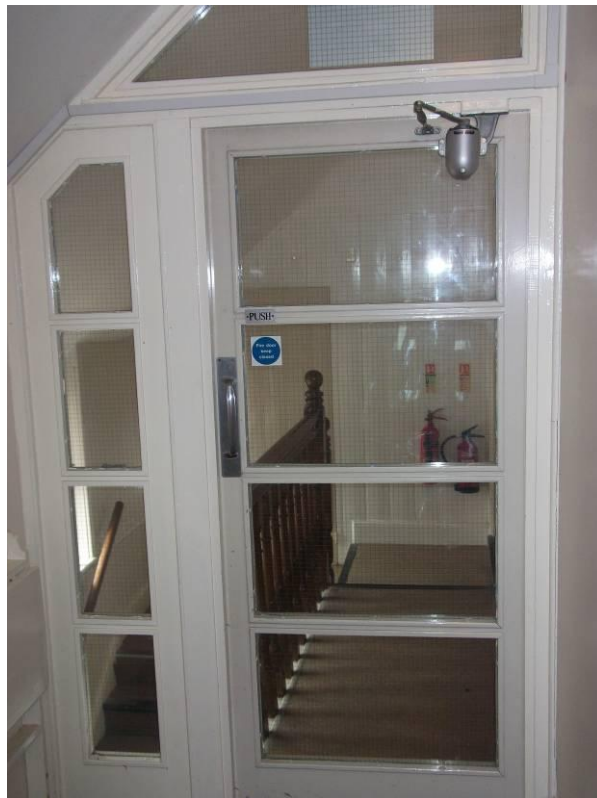
Photograph 10 (Fire door second floor)

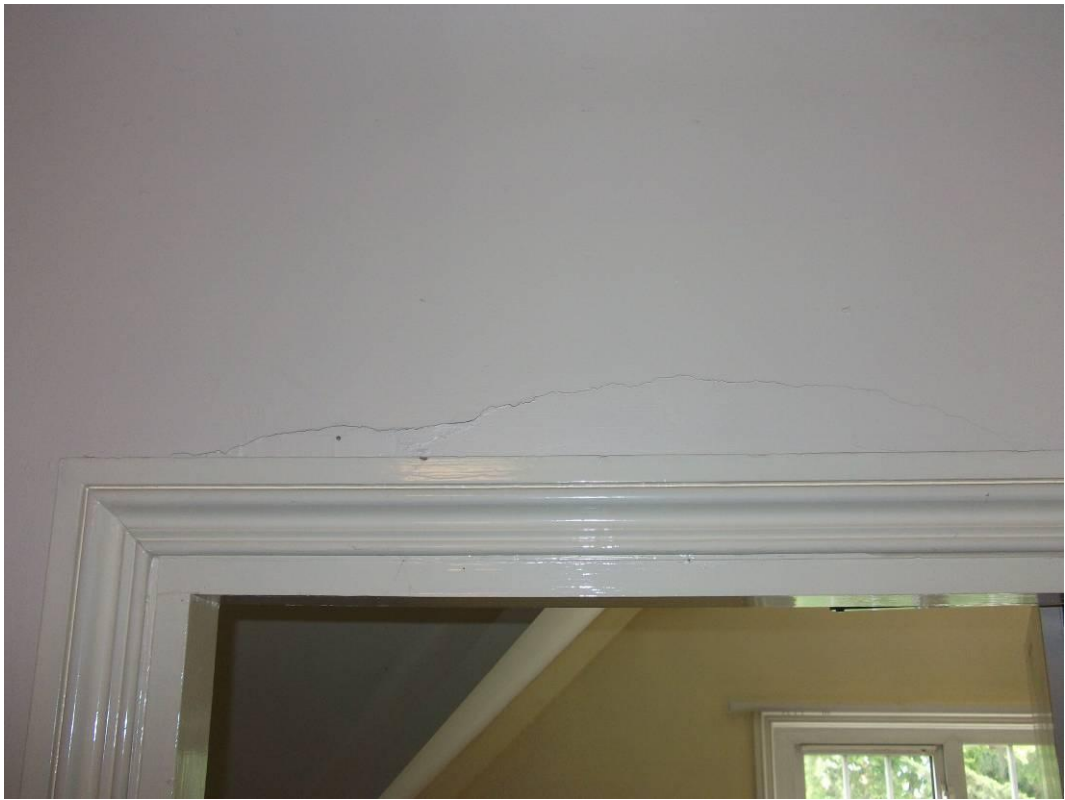
Photograph 11 (Crack above door second floor)

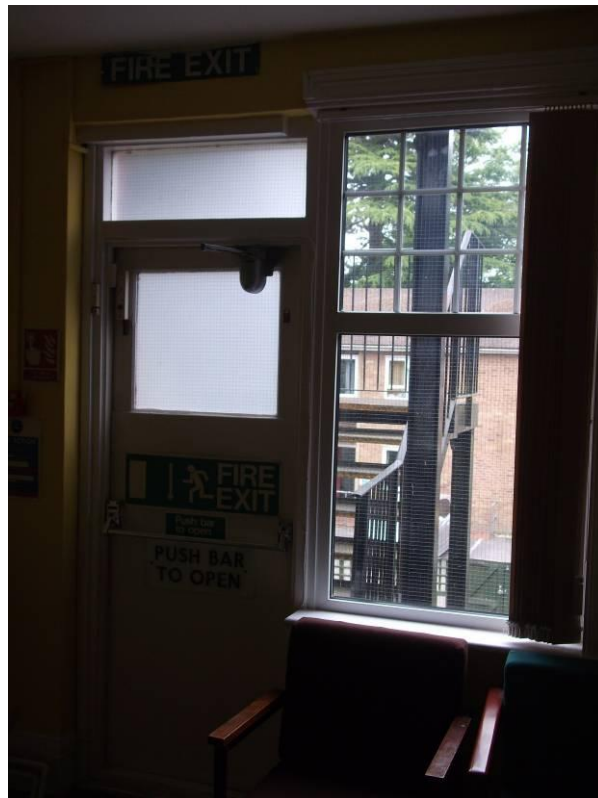
Photograph 12 (fire exit first floor)

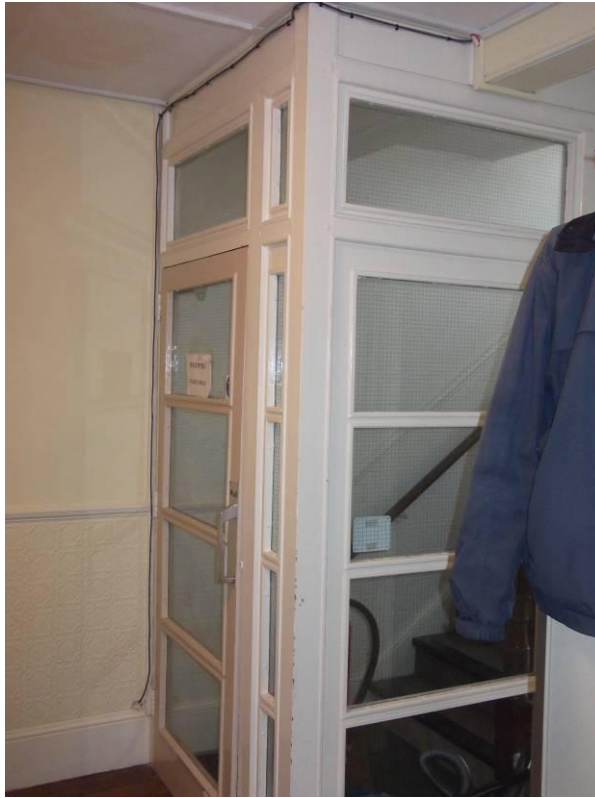
Photograph 13 (Fire door to stairs first floor)

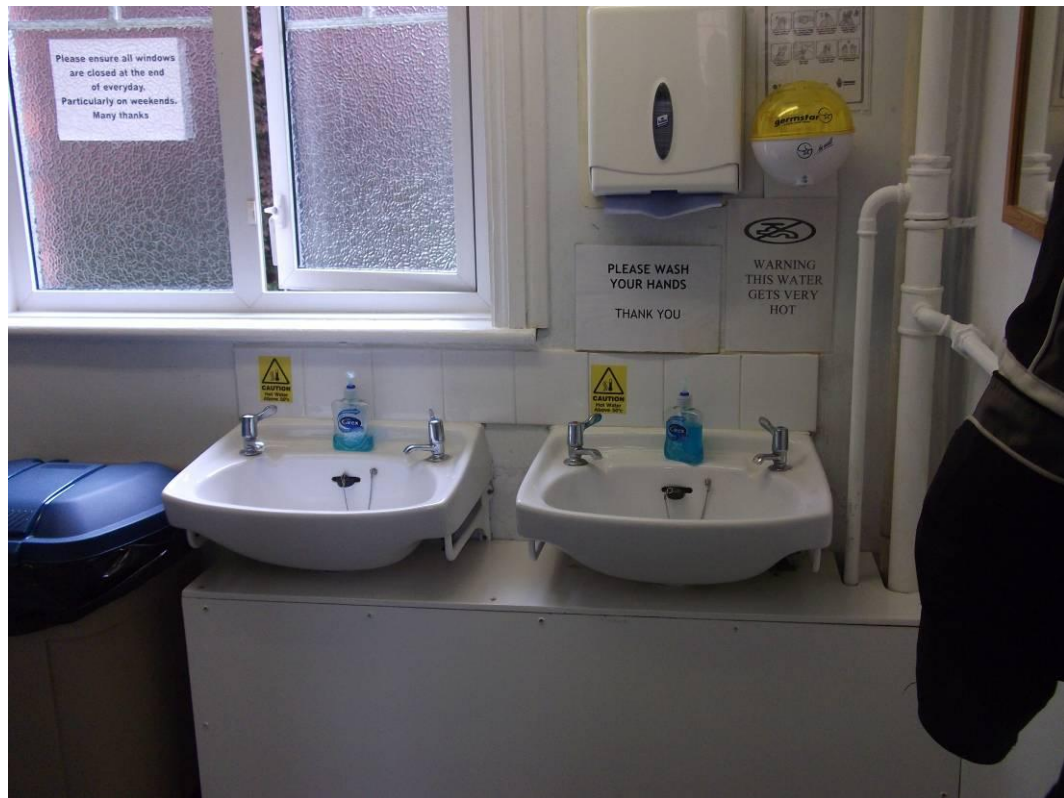
Photograph 14 (first floor toilets)

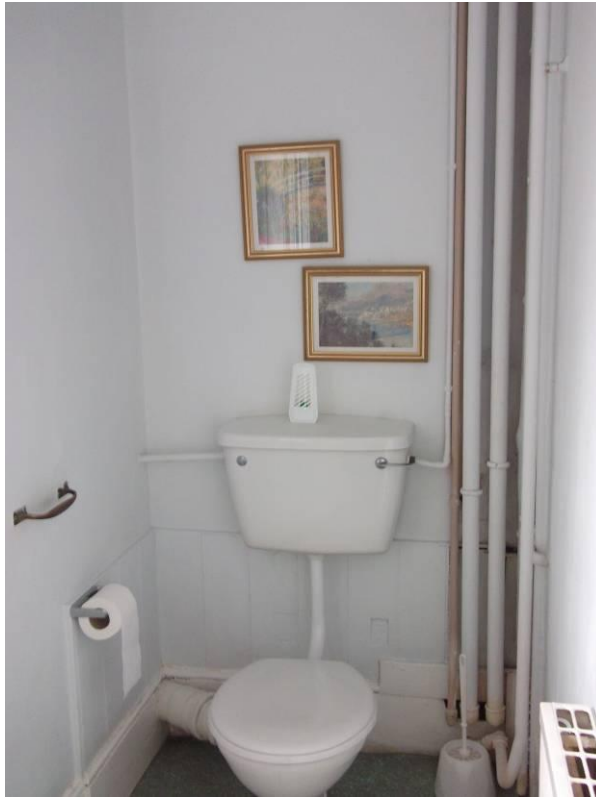
Photograph 15 (Typical WC)

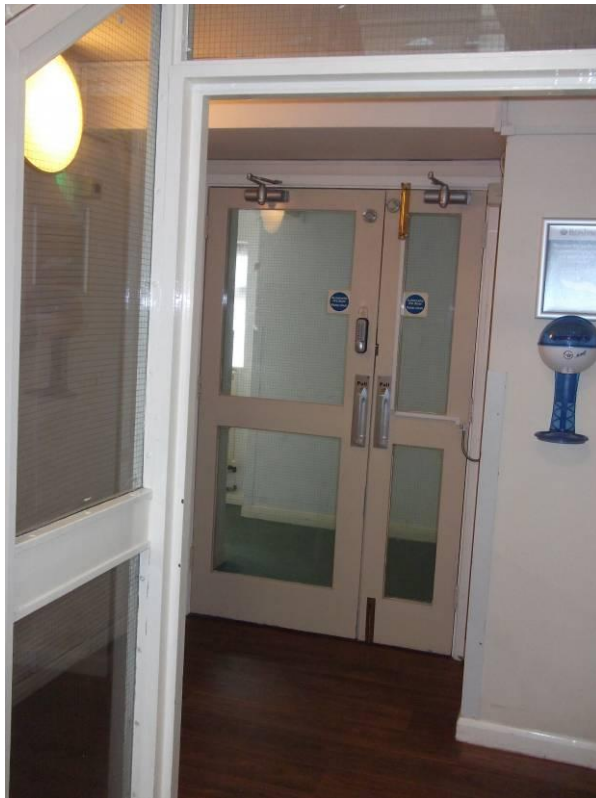
Photograph 16 (Door to Arthur Clark)

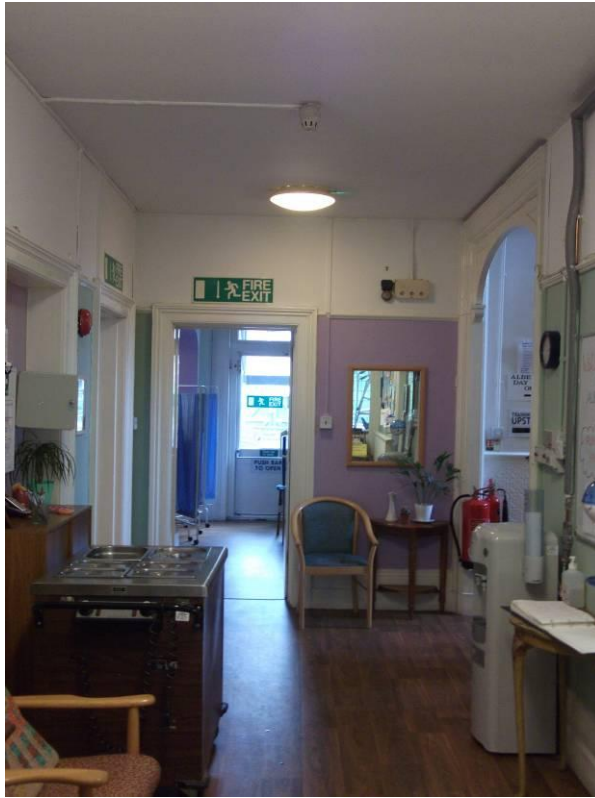
Photograph 17 (Entrance lobby)

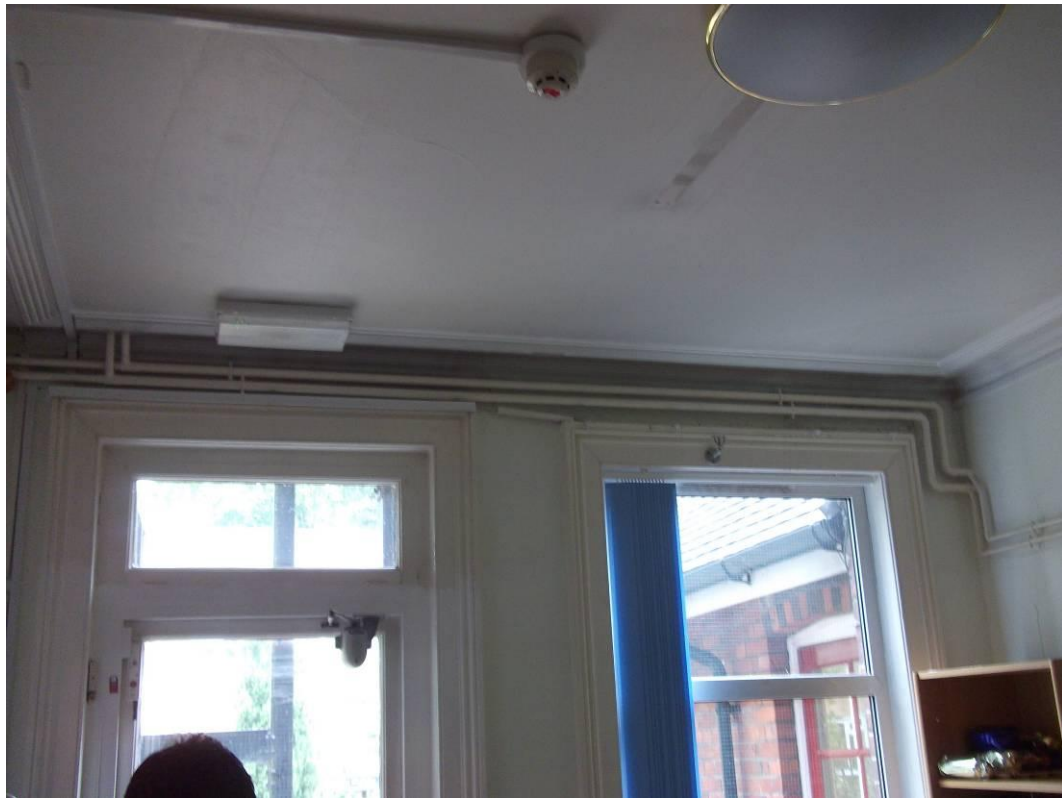
Photograph 18 (Typical ceiling)

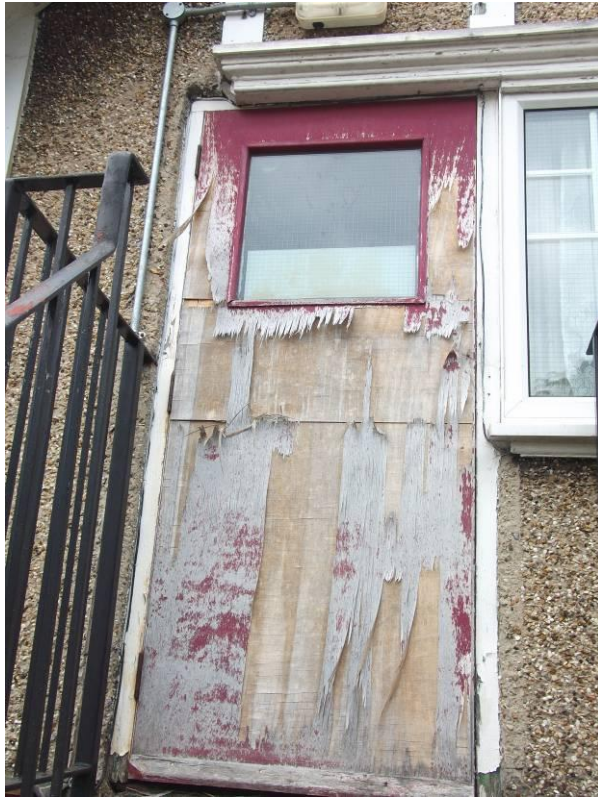
Photograph 19 (Second floor fire exit door)

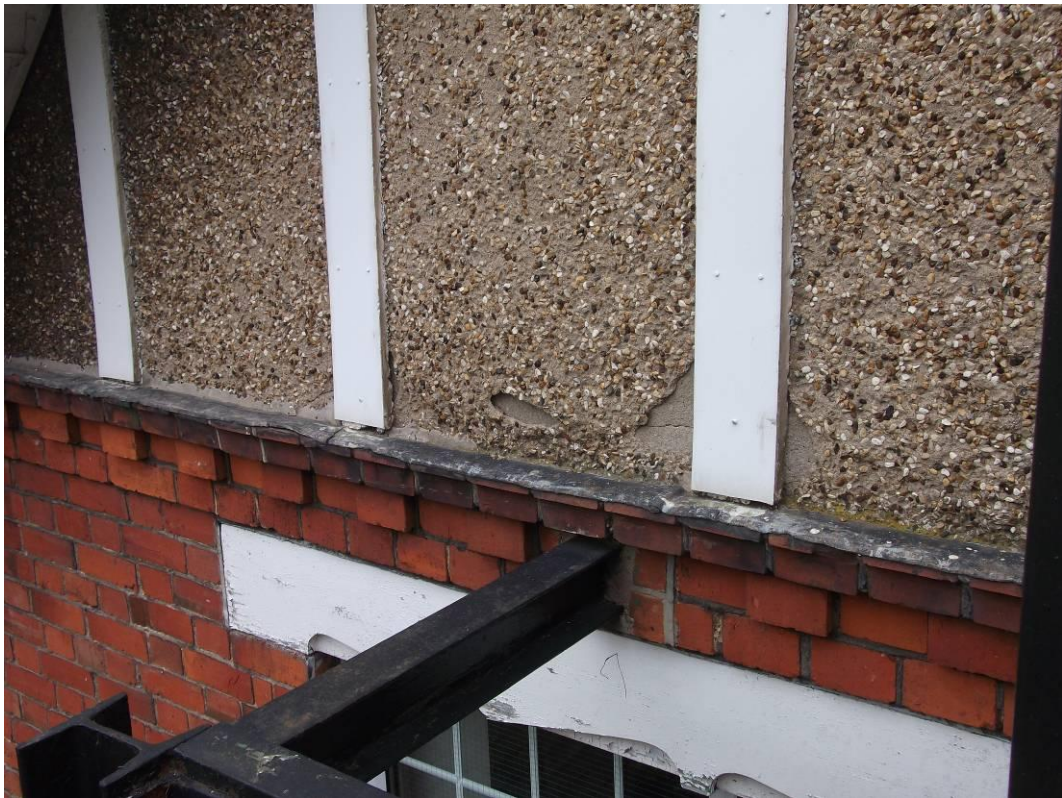
Photograph 20 (Render South elevation second floor)

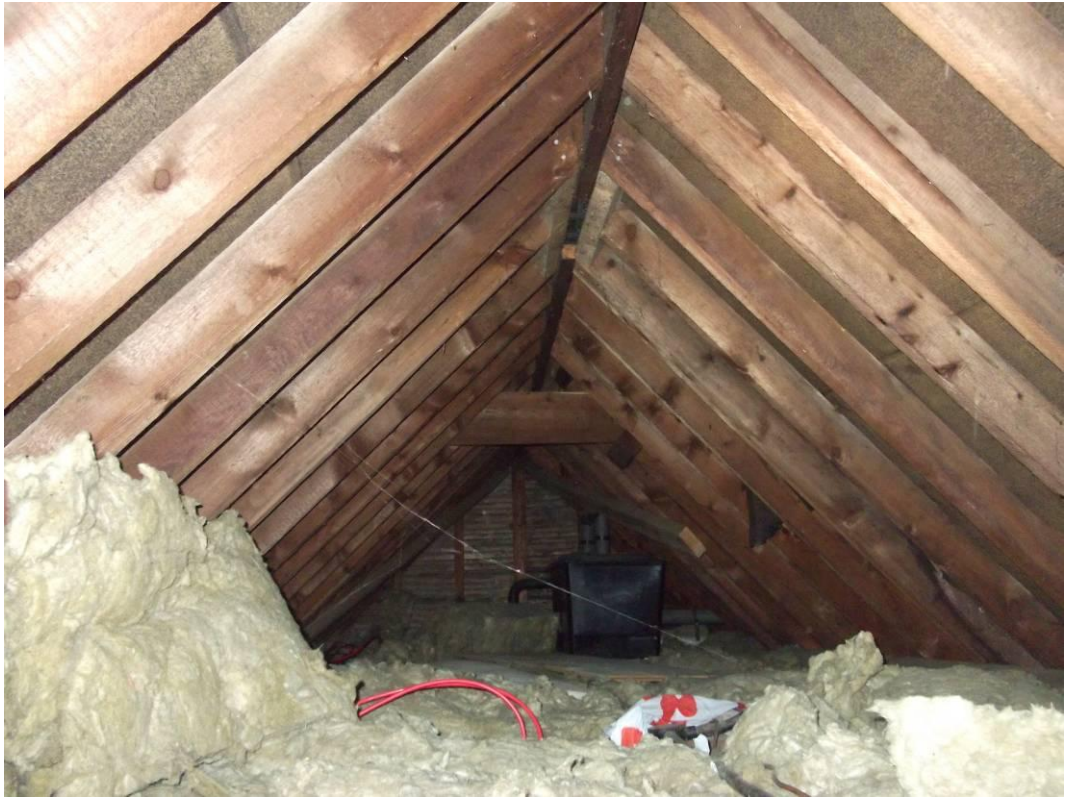
Photograph 21 (roof void)

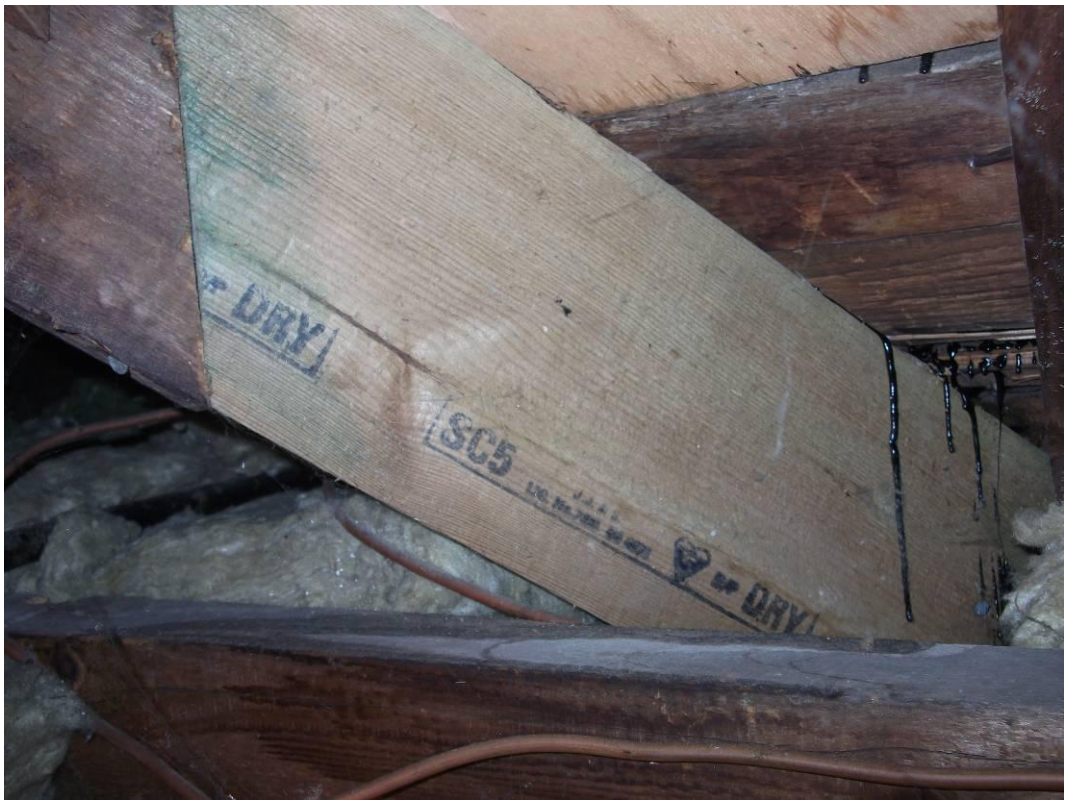
Photograph 22 (Timber repairs)

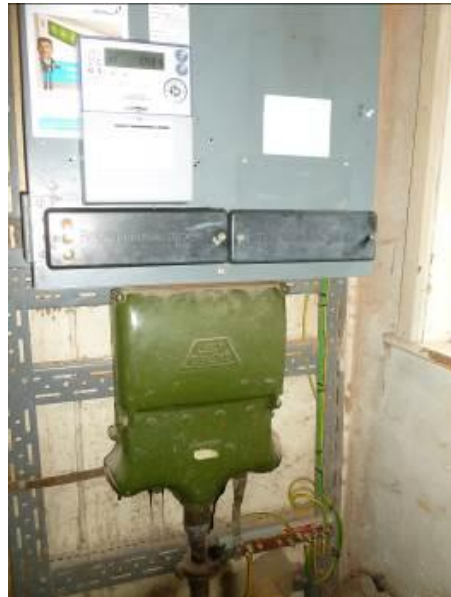
Photograph 4 – Care home main electrical incoming supply for both buildings.

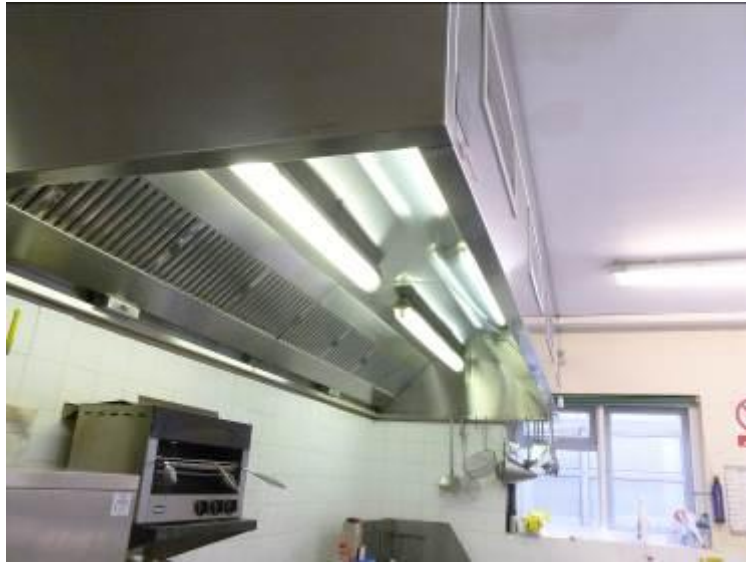
Photograph 5 – Care home new kitchen ventilation system.

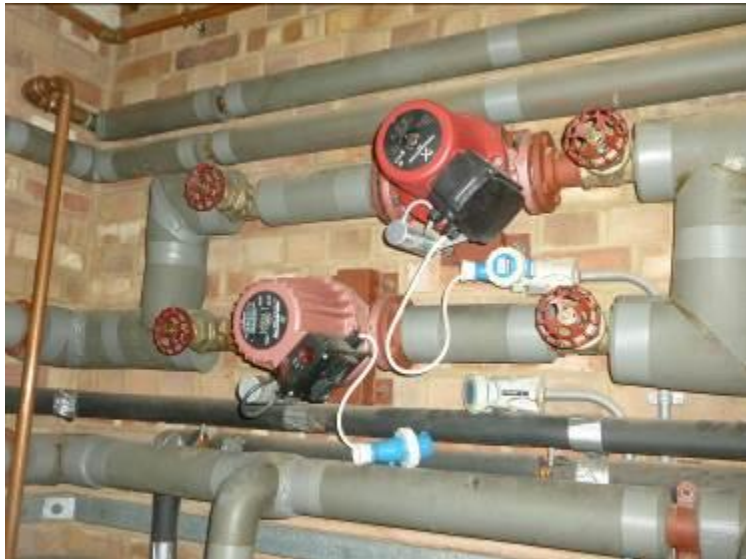
Photograph 6 – Care Home plant room heating circulating pumps and distribution pipework.

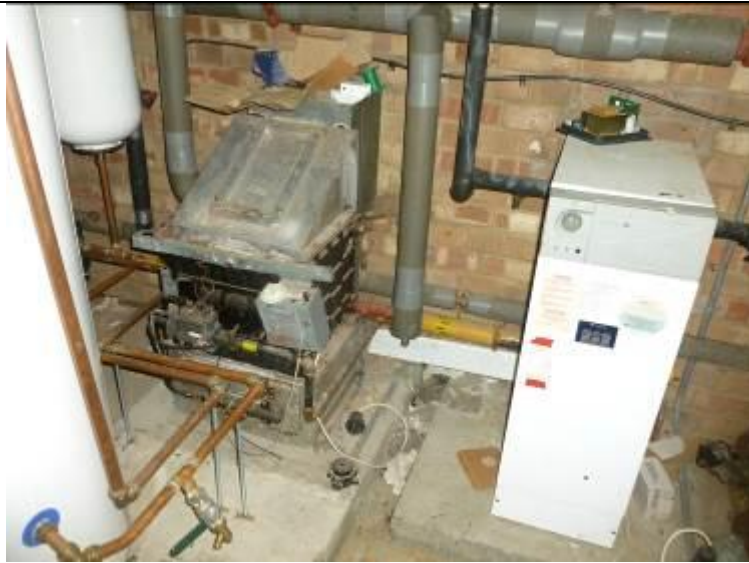
Photograph 7 – Care Home Potterton boilers life expired and de-commissioned.

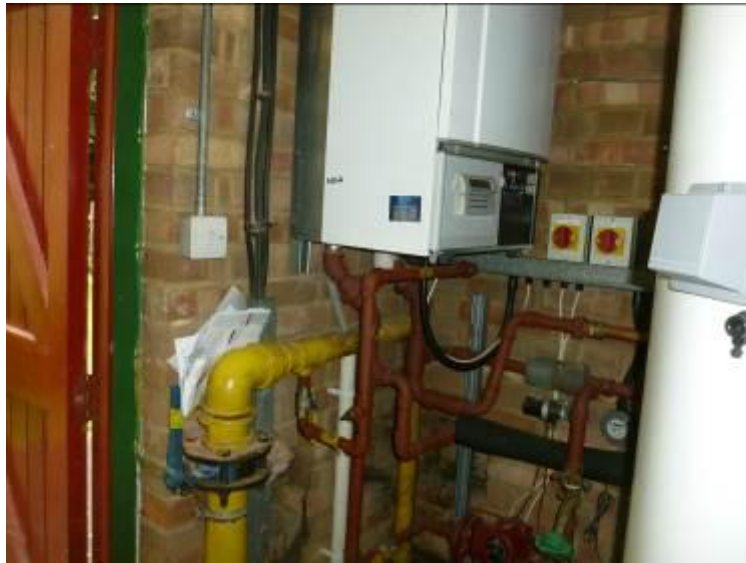
Photograph 9 – Care home more recently installed Broag gas fired boiler

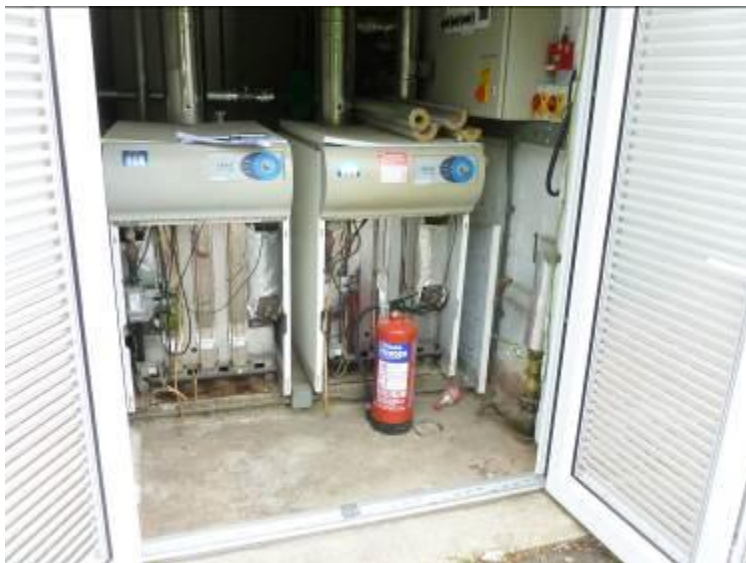
Photograph 10 – Day Centre Ideal gas fired boiler.

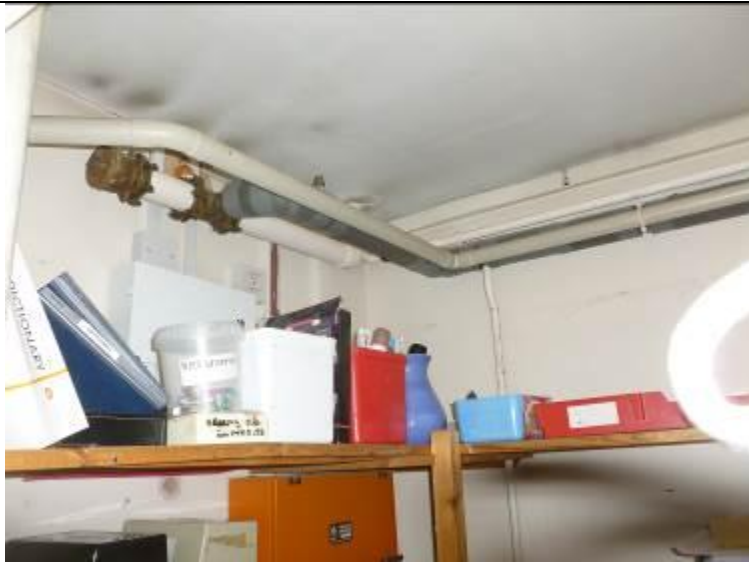
Photograph 11 – Example of distribution pipework.

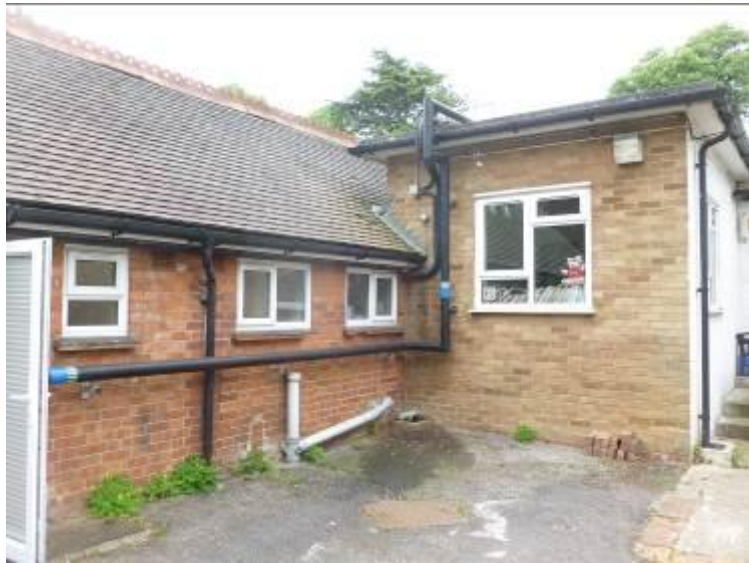
Photograph 12 – External distribution pipework extending to tank room.

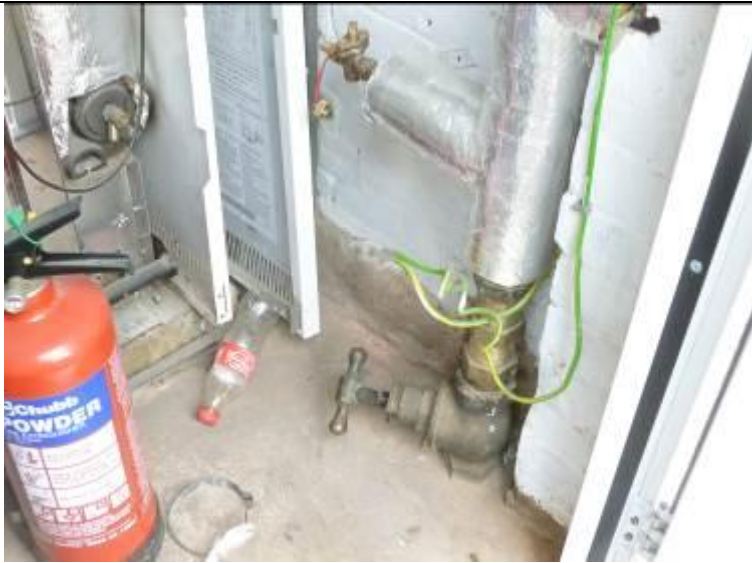
Photograph 13 – Main incoming water supply, note possible dead leg and earth bonding issue.

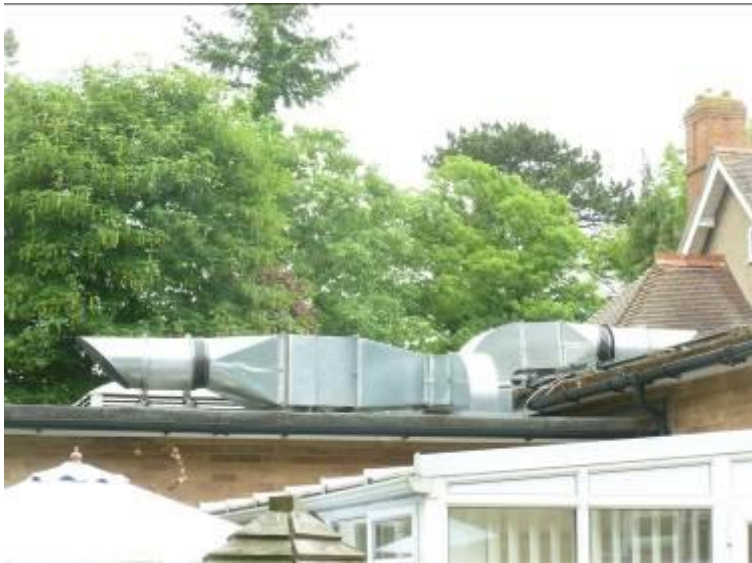
Photograph 14 – Roof mounted kitchen ventilation plant.
