POST CLEAN INSPECTION REPORT

Kitchen Extract System Audit

| Client | | |
|---|---|--|
| Location: S& | S group Limited | |
| Pepes | s Reading | |

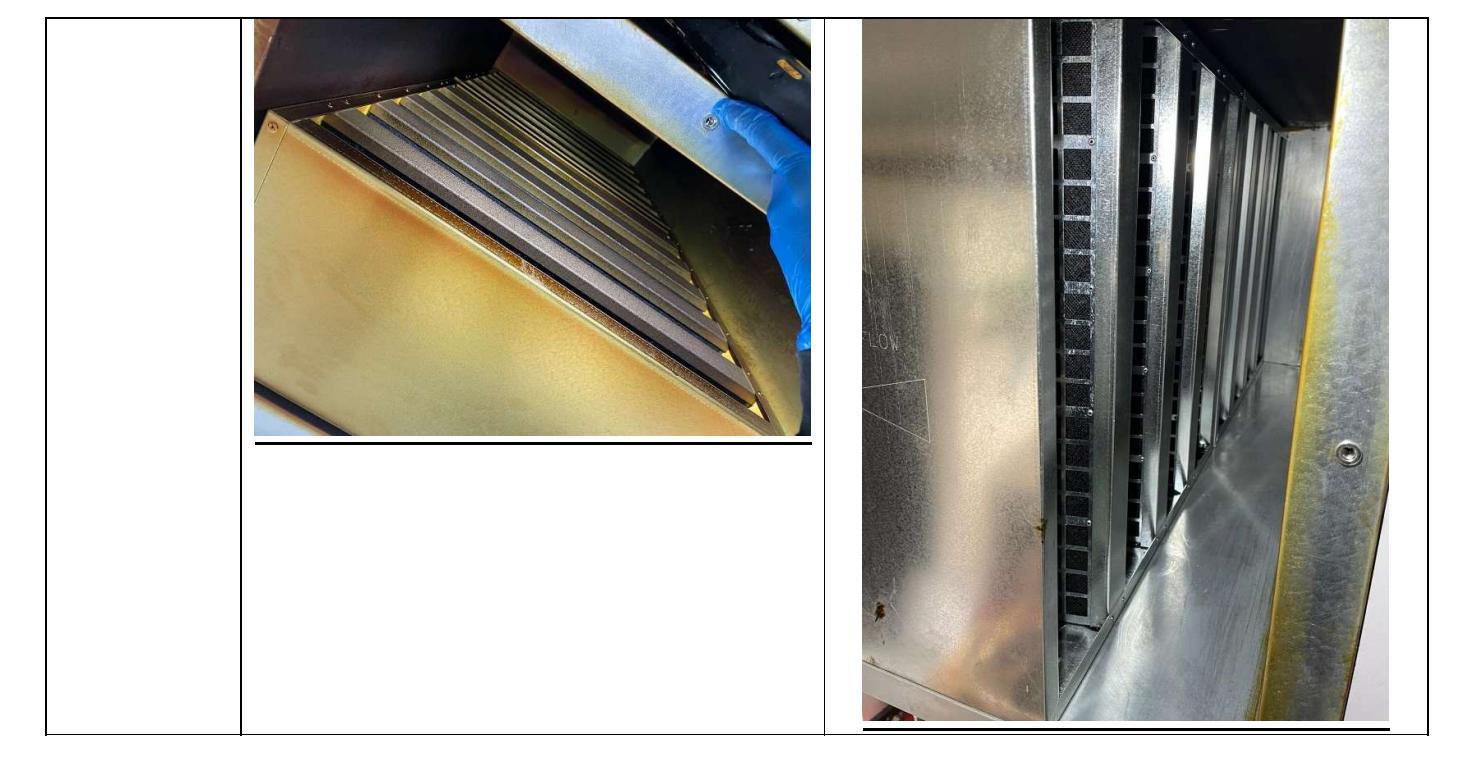
| I | Micron Reading Locations | Readings Prior | To System Clean | Readings After System Clean | Additional Information | | |
|---|---|---|---|---|---|---|--|
| 7 | Fan Unit | >1mm | | | | | |

| Fan | |
| Further Pictures | |
