St Peters Conservation Area – Appraisal of Issues

Following the development of the document by interested Community Groups 'Protecting and Enhancing Reading's Conservation areas' submitted to RBC on 31st August 2015, representatives of the Caversham and District Residents' Association (CADRA) with the Friends of Caversham Court Gardens (FCCG) set out below some issues and potential pressure points in respect of the St Peters Conservation Area. St Peters is a small Conservation Area and whilst it may not have some of the extreme issues of some central Conservation Areas, there are increasing causes for concern.

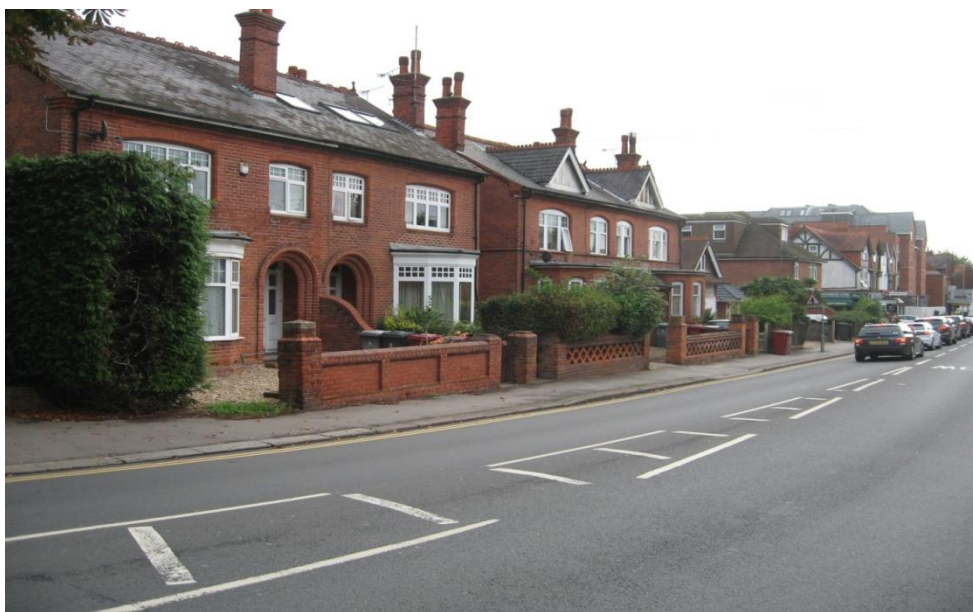
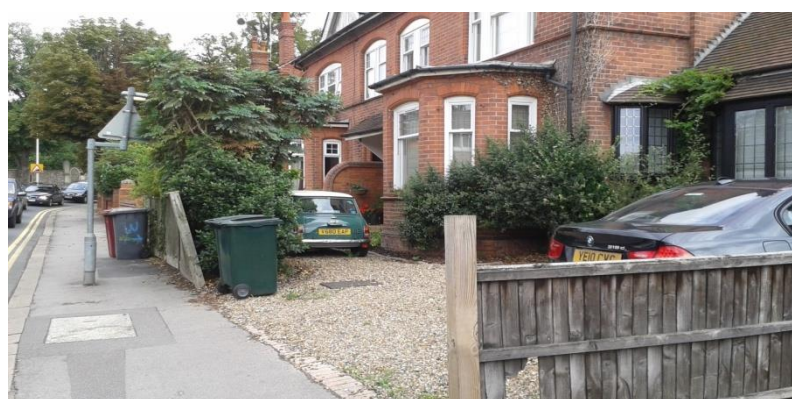
1. Flats or HMOs have resulted in deterioration on the north side of Church Road. (No 37 & 33 garden replaced by gravel/ paving, bins in front garden, no greenery; No 31 multiple cars, bins left out) In contrast, the corner of St Anne's Rd is well managed, with a garden, parking & bins at the rear.

The front gardens and garden walls of these 4 substantial semi-detached houses are under pressure. There is a potential risk to the remaining garden walls which are characteristic of the period in Reading.

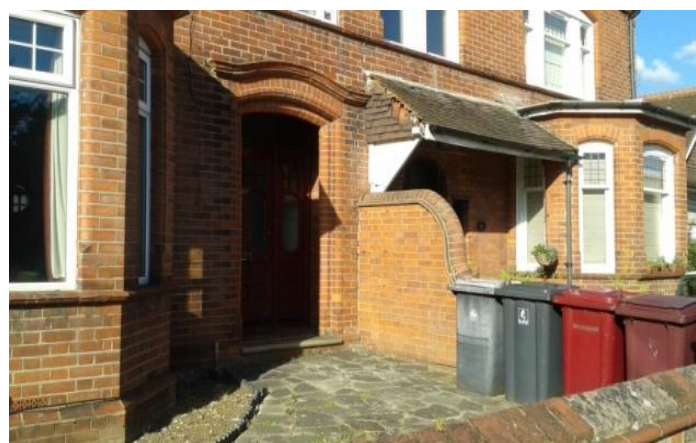
Gravel/paving frontage, removal of greenery, bins in front

Velux roof lights would be preferable on rear roof slopes

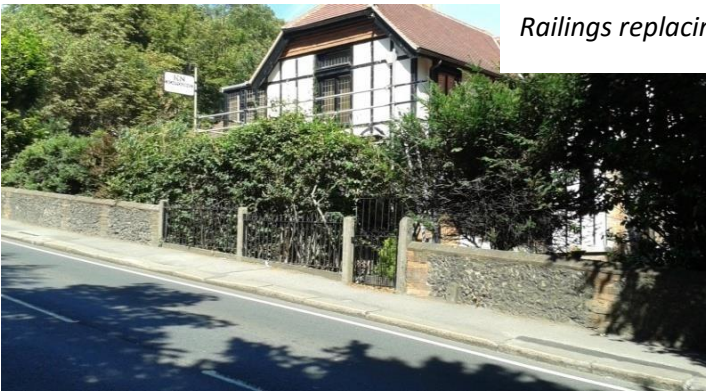
Railings replacing flint walls, St Peters Hill

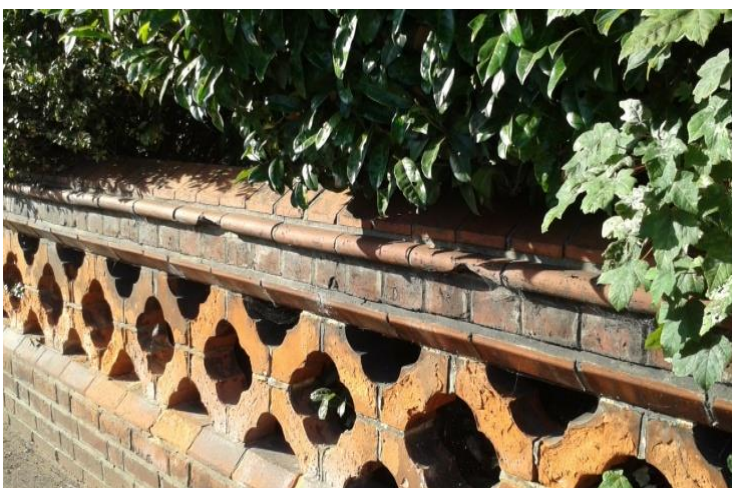
Traditional walls at risk

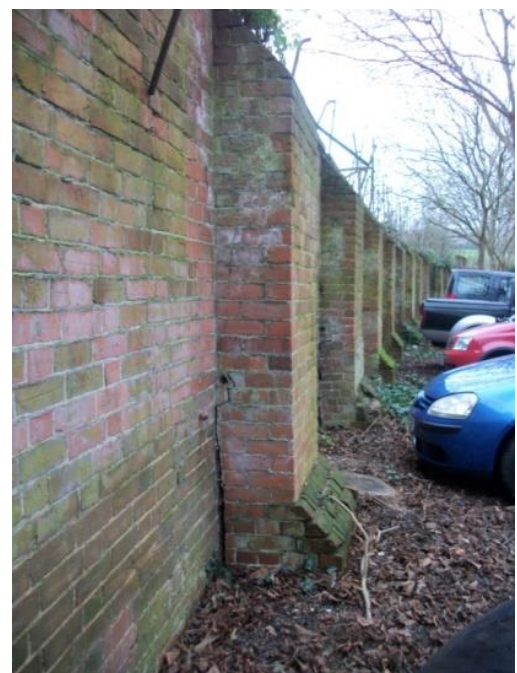
Brick boundary wall to Caversham Court Allotments on The Warren in disrepair

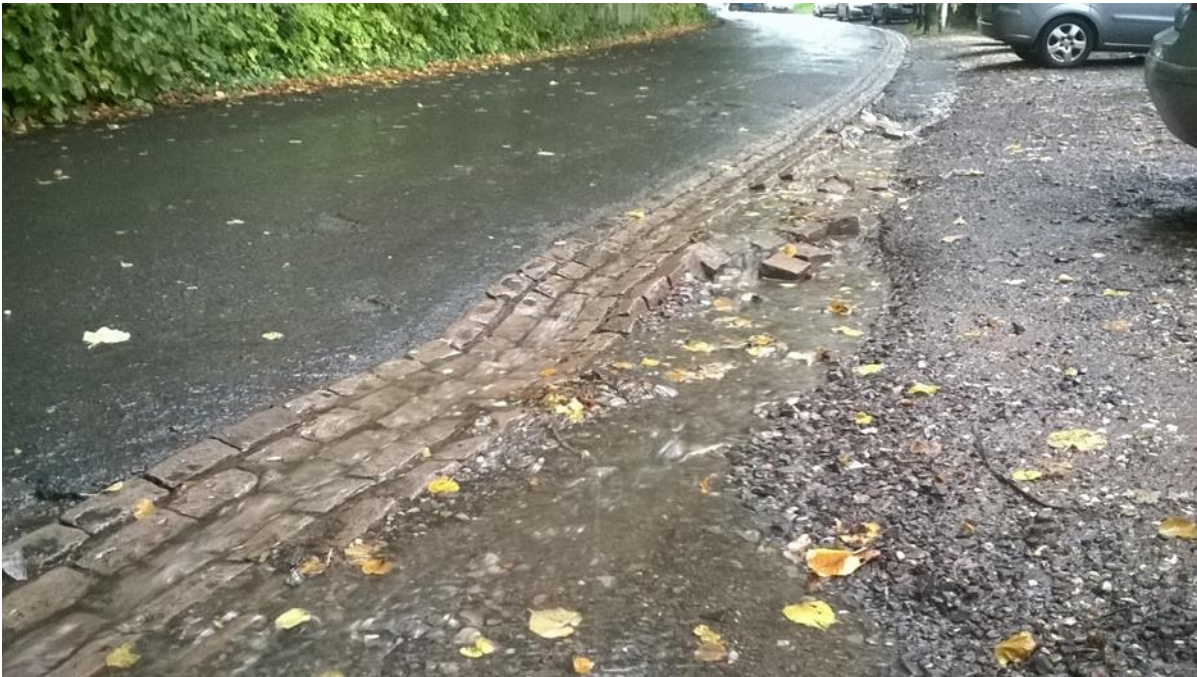
The Warren. The road gutter nearest to the wall is being increasingly eroded by heavy rain creating a river effect. This, in turn is eroding the ground between the wall and the road.

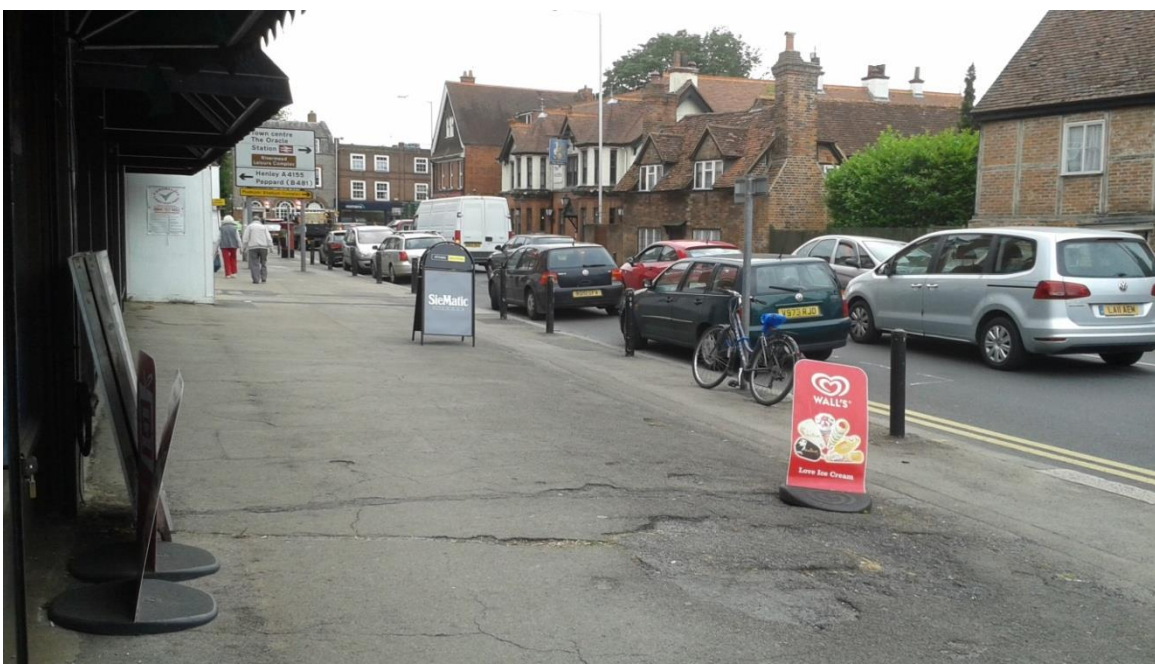
Trip hazards – poorly maintained pavement surface on north side of Church Street (technically outside CA)

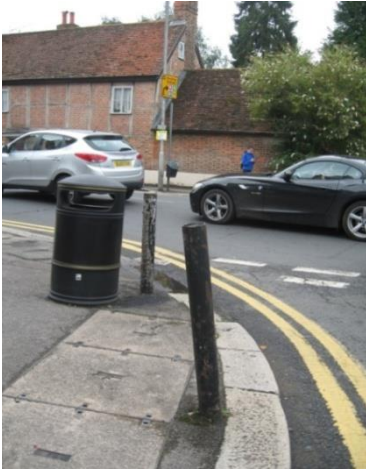
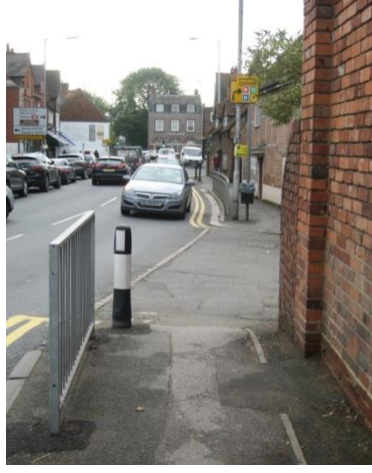
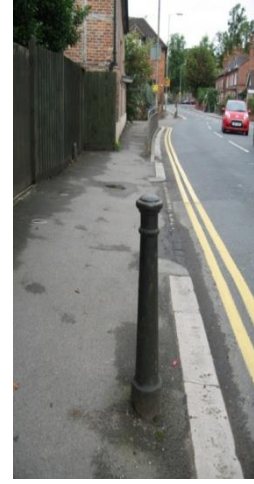
Three different bollard types within a few metres of each other. Rationalisation to suitable cast iron bollards shown to the right could take place as and when maintenance/ replacement is required. Advantage should be taken when development occurs. E.g. 13 – 17 Church St where unsightly concrete filled steel pipe bollards remain in front of the new development.

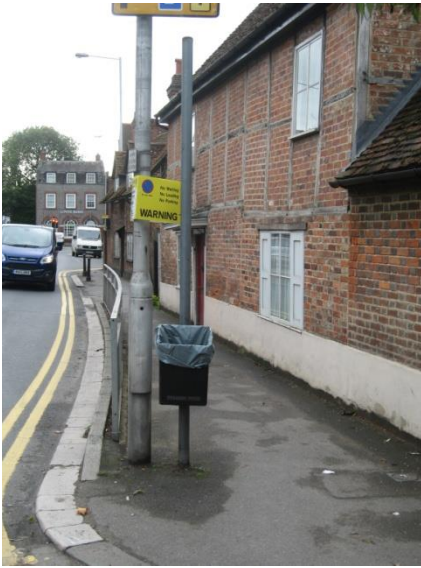
There is scope for the rationalization of street furniture. The lamp post next to a bin attached to a redundant pole crowd the narrow pavement and detract from the listed building behind.

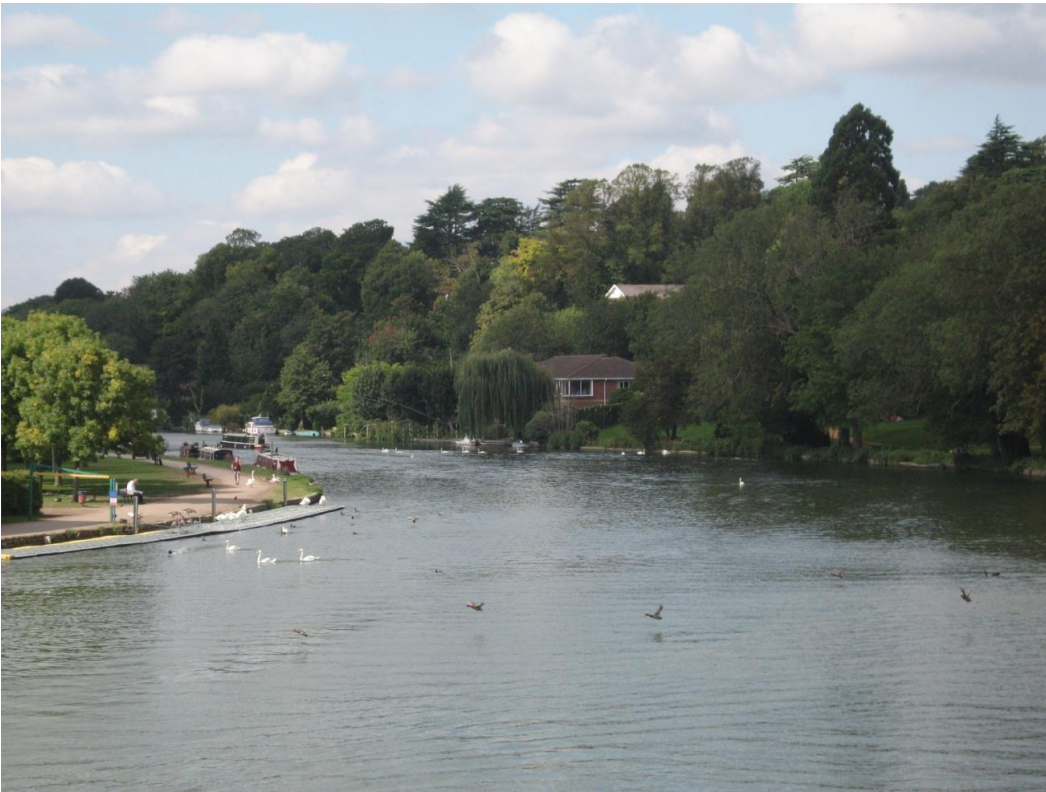
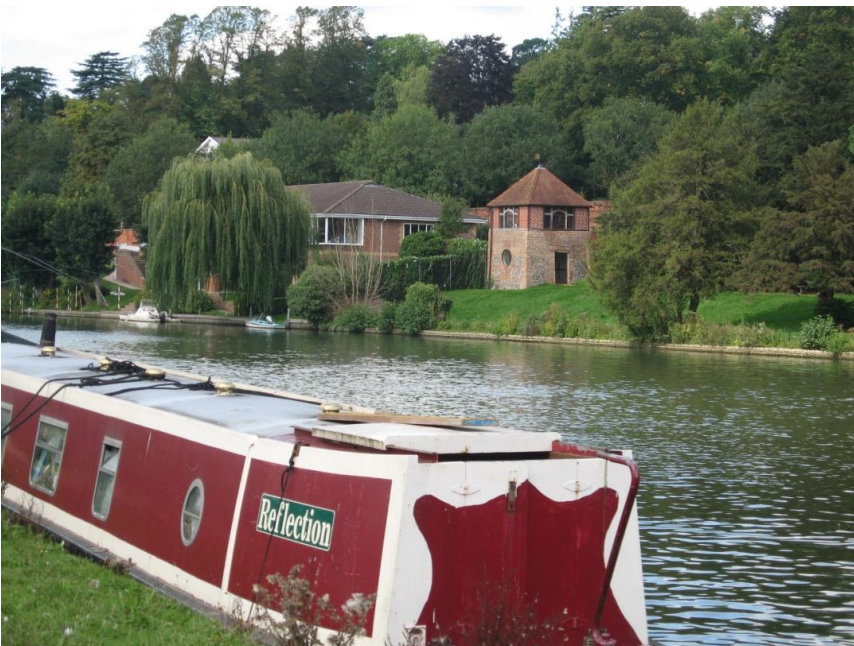
4. Vistas towards the Conservation Area. The RBC appraisal plan reproduced at the end of this document highlights several important vistas (yellow arrows) which look towards the Conservation Area from Caversham Bridge and the Thames Promenade on the South Bank of the river. These views give the impression of a green escarpment rising from the river and are important. Recent developments have started to impinge on these views. The new canoe club, at its eastern end detracts from the setting of the restored gazebo in Caversham Court Gardens. This particular problem could be simply ameliorated by the planting of small trees or large shrubs when an opportunity arises. Further back, a recent house in the area of the Warren breaches the tree line and the white gable emphasizes the intrusion. The effect of development on these important views should be considered by RBC when proposals for development are brought forward in the Warren and Upper Warren Avenue (although those areas themselves may be outside the Conservation Area)

Views towards the Conservation Area from Caversham Bridge and the Promenade

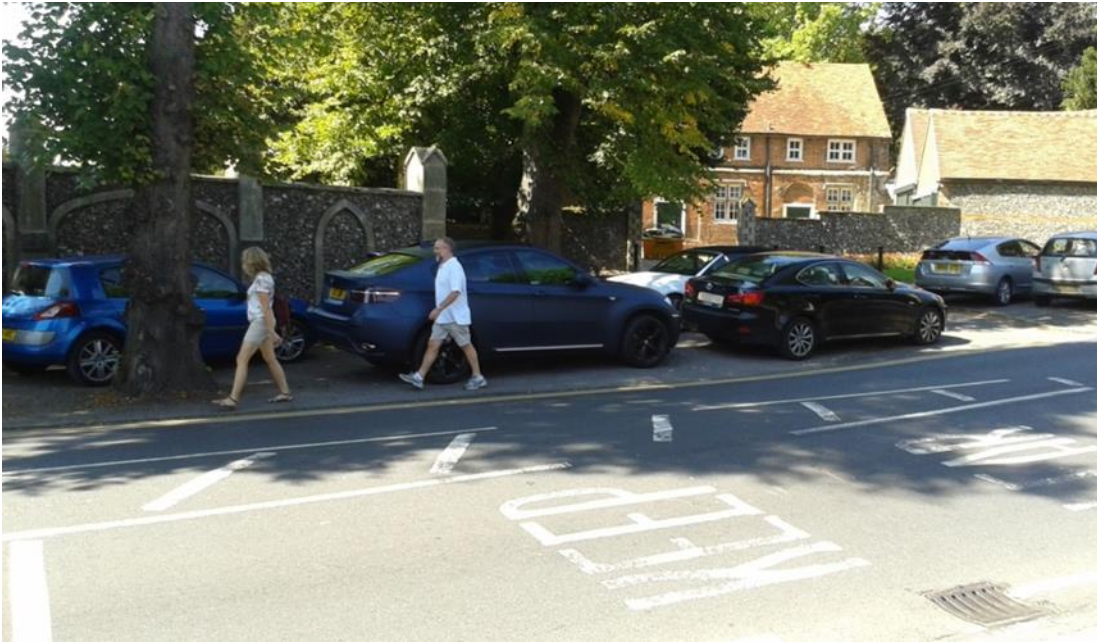
5. Heritage sites. St Peter's Conservation Area is the site of Caversham's oldest church, dating from 12th century or earlier. Caversham Court is a tourist and entertainment venue. Visitors arrive from the nearest hub: railway station, Thames Prom car park, Caversham centre car parks. They then walk along a very narrow and obstructed pavement with heavy traffic passing. Parking on the pavement frequently obstructs the footway outside Caversham Court. Those with wheelchairs, walking aids or pushchairs experience real difficulty and are often forced into the very busy road.

Parking on pavement outside Caversham Court, obstructing footpath

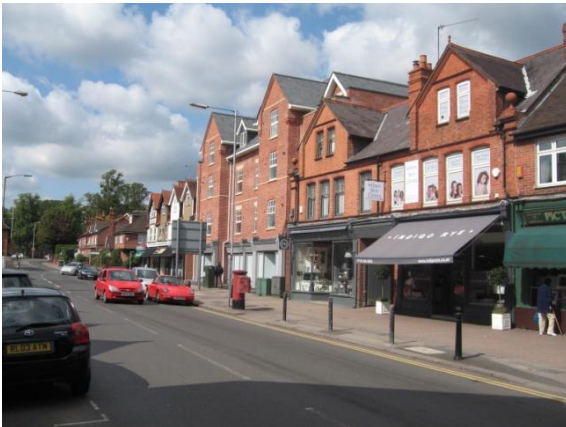
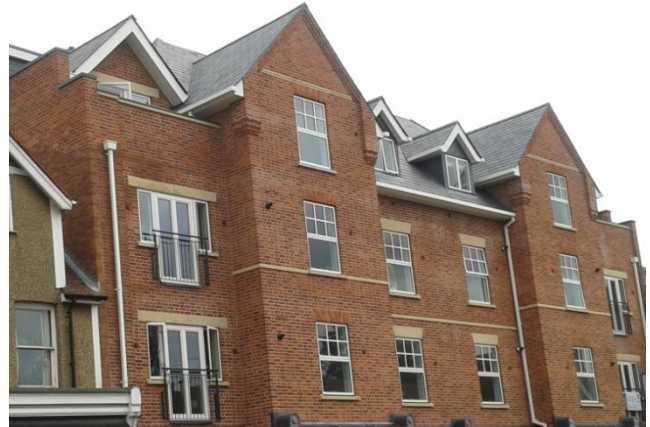
Reference was made in item 4 to the importance of considering the effect of potential development outside the Conservation Area or close to it, on the perceived quality of the Conservation area. The recent development in Church St. attempts to relate to the gables of adjoining buildings. However the extra height of this new building and the quality of architectural detailing on the upper floors do not enhance the Conservation Area and the listed buildings on the other side of the road.
