STRATEGIC ENVIRONMENT, PLANNING AND TRANSPORT COMMITTEE 16 MARCH 2020

<u>WARDS AFFECTED</u>	<u>Page No</u>
10. ADOPTION OF THE CASTLE HILL/RUSSELL STREET/OXFORD ROAD CONSERVATION AREA APPRAISAL - APPENDICES 2 TO 4	ABBEY; BATTLE; MINSTER	3 - 160

APPENDIX 2: STATEMENT OF CONSULTATION ON CONSERVATION AREA APPRAISAL FOR THE RUSSELL STREET/CASTLE HILL CONSERVATION AREA

Initial Statement

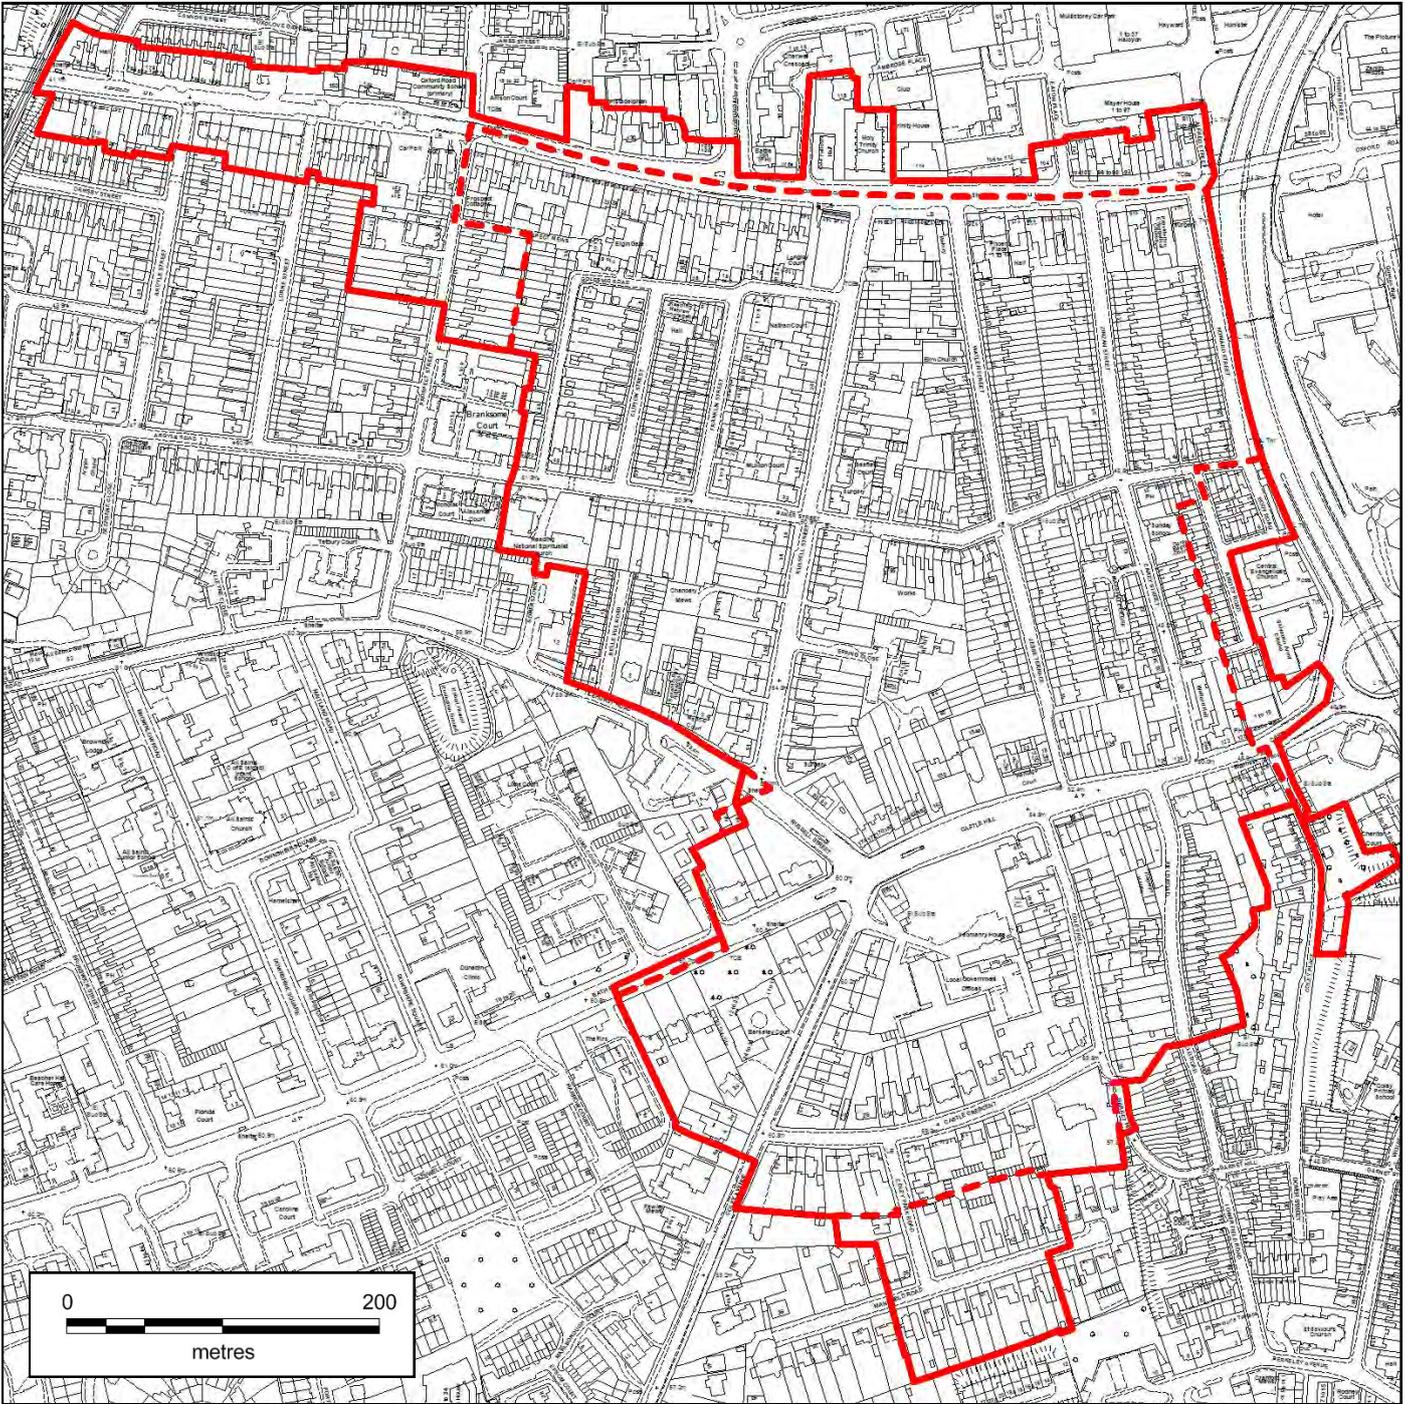
Proposed Conservation Area boundary 2019

After careful review of the existing boundary of the Conservation Area, taking into account feedback from the public consultation process and a detailed study of each of the character areas within the Conservation Area, the following extensions to the Conservation Area boundary are proposed as shown on Figure SS5.1.

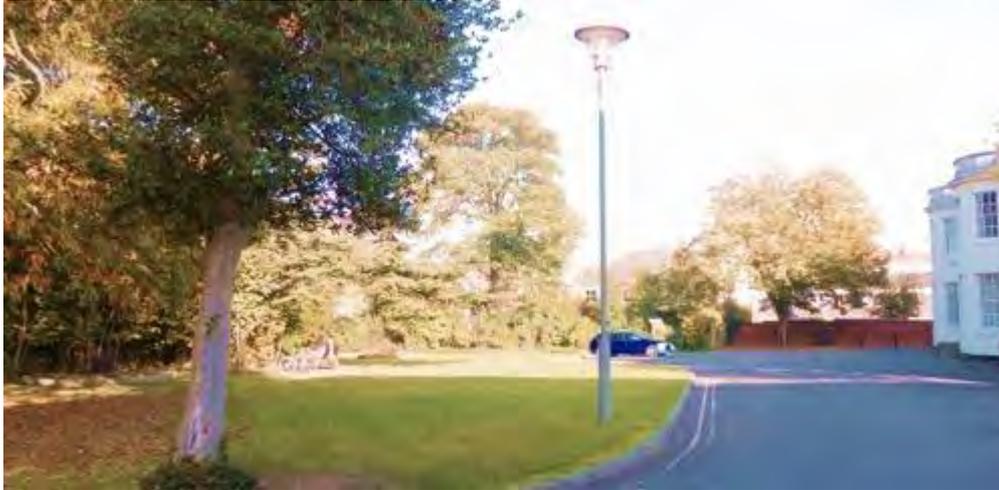
Figure 4.3.5 The historical, open front garden space in front of Yeomanry House (Karen Rowland)

The front garden of Yeomanry House is part of the site recently sold and being changed into a nursery. It was noted in the 2004 appraisal as a much-needed green space for the area which at the time was publically accessible, although never an official "public open space." The garden is important to retain in terms of its historical relationship to Yeomanry House's original layout.

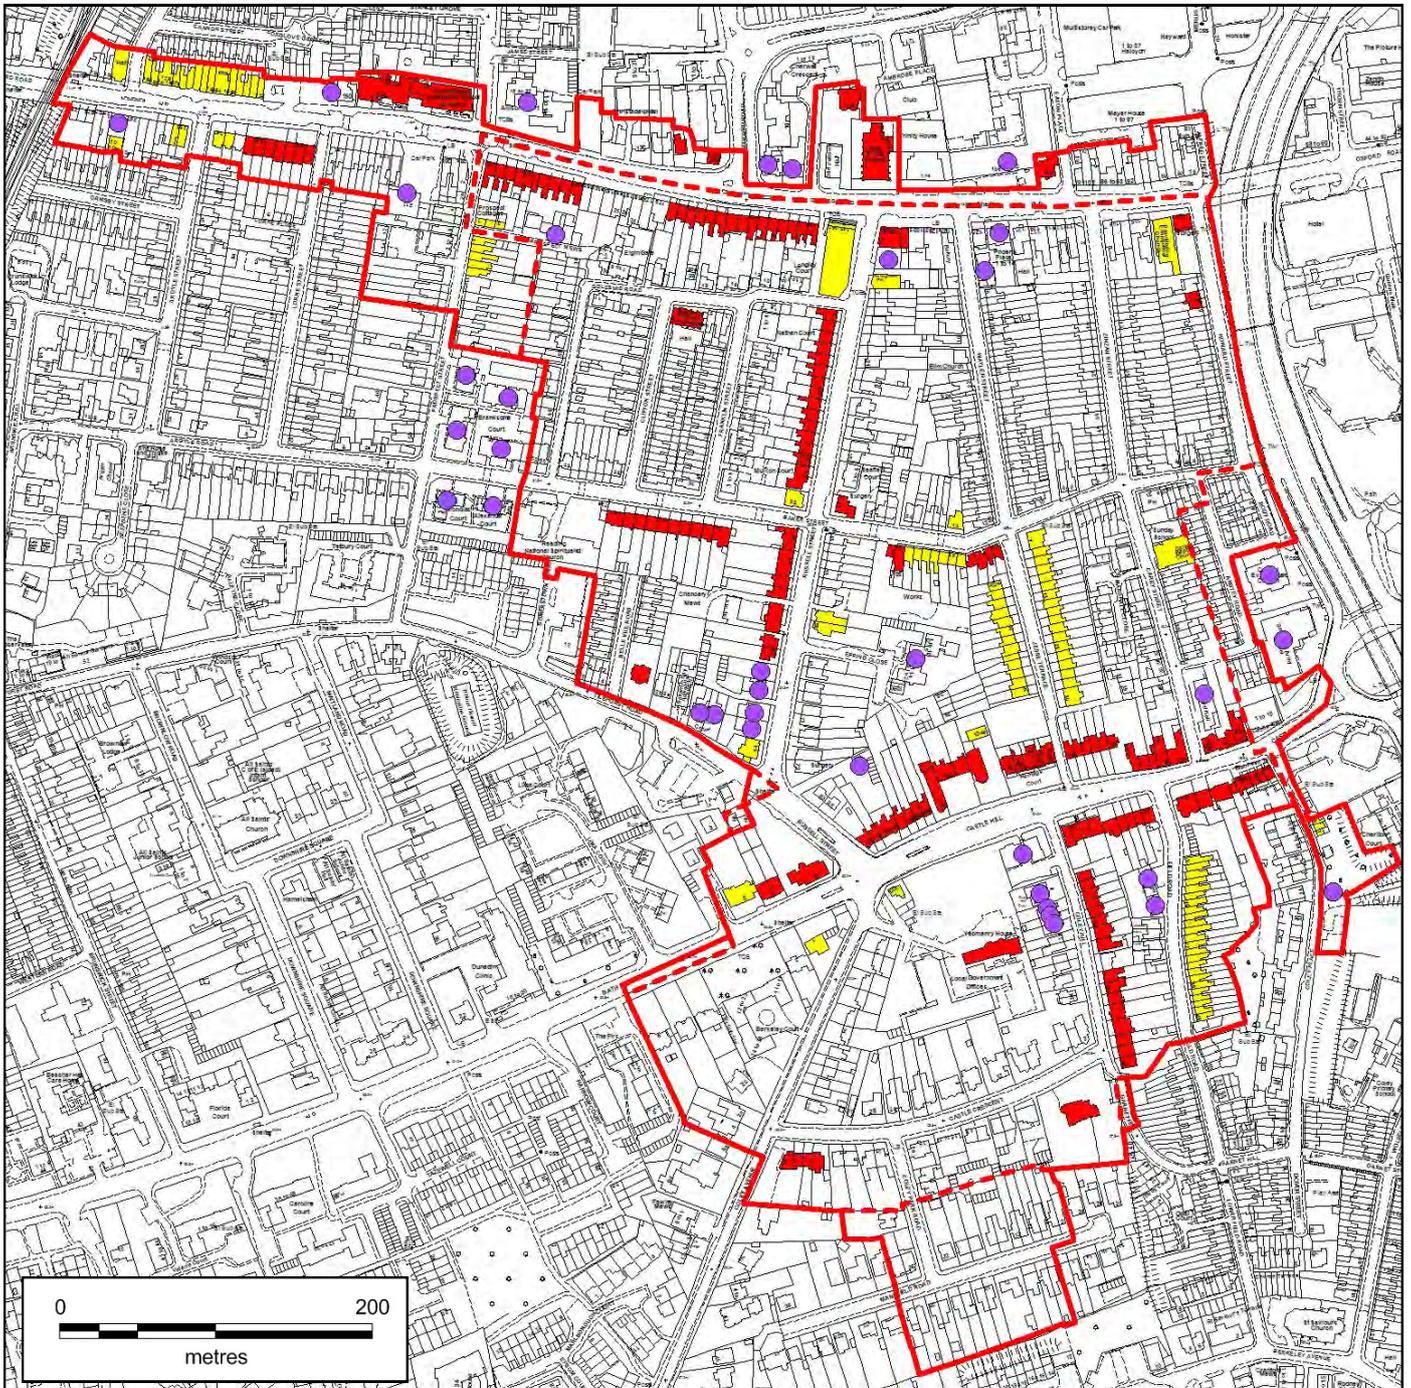
Russell Street/Castle Hill Conservation Area
 Figure 5.1.1: Buildings and site classification
 November 2019

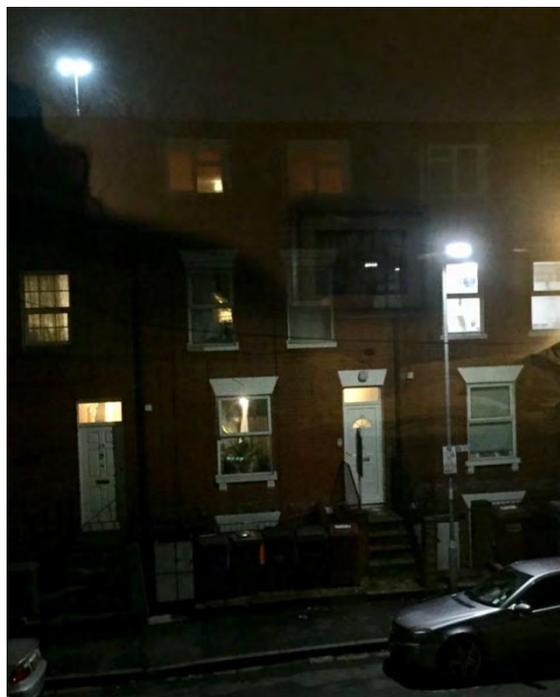
Most of the area's lighting is provided by slim silver modern steel columns with simple glass lanterns. Though not particularly dominant, they are not in keeping with their conservation area setting and are detrimental as a whole to the area. Their bright lights, at first-floor level for many of the terraced houses, cause a harsh shine into bedrooms and living areas.

The Council's recent replacement lighting scheme has replaced lights in lampposts throughout the town with halogen. This has meant the loss of many old cast iron gas lampposts throughout the town and regrettably, the Conservation Area lost all but one on Franklin Street as a result.

The main thoroughfares have the tallest lamps with shorter ones in residential streets. Light pollution due to the proximity to the town centre and the IDR has a detrimental effect, especially in Howard Street, Body Road, Anstey Road, Carey Street and Zinzan Street.

Figure 5.5.1 *Lights from the IDR (above left) and halogen street lights glaring into terraced housing at night along Zinzan Street (Karen Rowland)*

Improving street lighting has wide potential for improvement to the local streetscape.

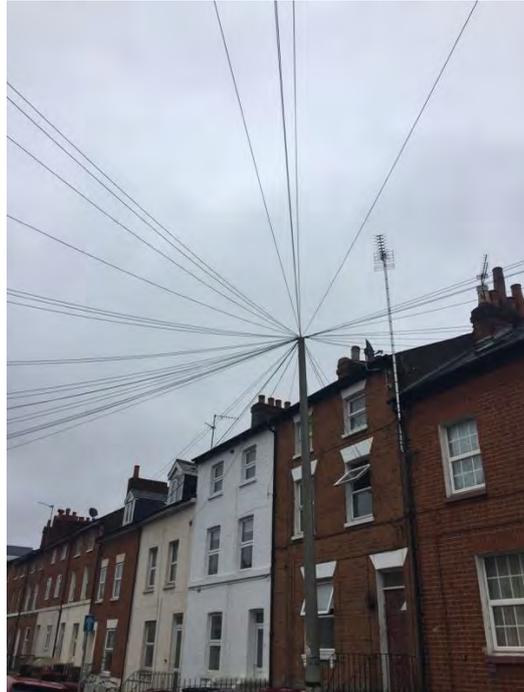
The proliferation of wires from telegraph poles particularly in streets with a high proliferation of HMOs blights the streetscape and sky views. A programme of work with service suppliers to reduce redundant wires would be welcome.

Figure 5.5.2 Overhead wires on a street with numerous HMOs (Karen Rowland)

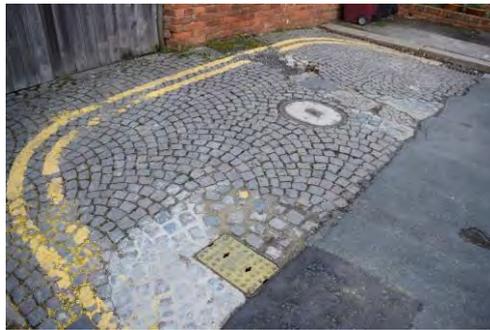
Belle Vue Road: at the end of the road near the fencing to the back of the properties, remains a large area of setts (appx 12 sq. m) uncovered by tarmac and with the fan pattern visible, which once may have covered much of the area.

Figure 5.5.3 *Sett stone pavement at the end of Belle Vue Road, still displaying the fan pattern of road that was common in the area (Karen Rowland)*

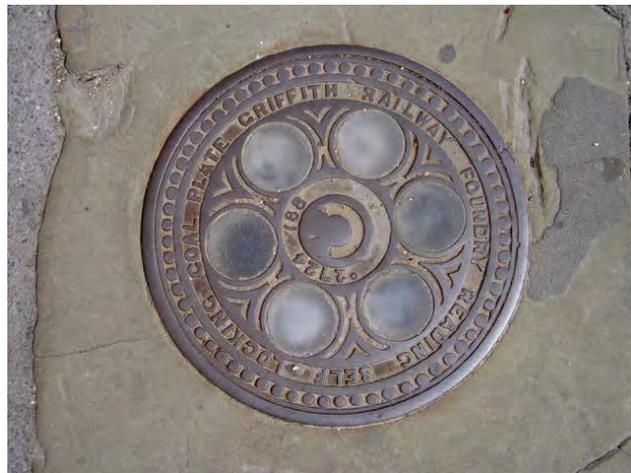
Cast iron coal hole covers made originally in Reading's foundries are particularly in evidence on Castle Hill and Prospect Street.

Figure 5.5.4 *Coal hole cover, Castle Hill (Evelyn Williams)*

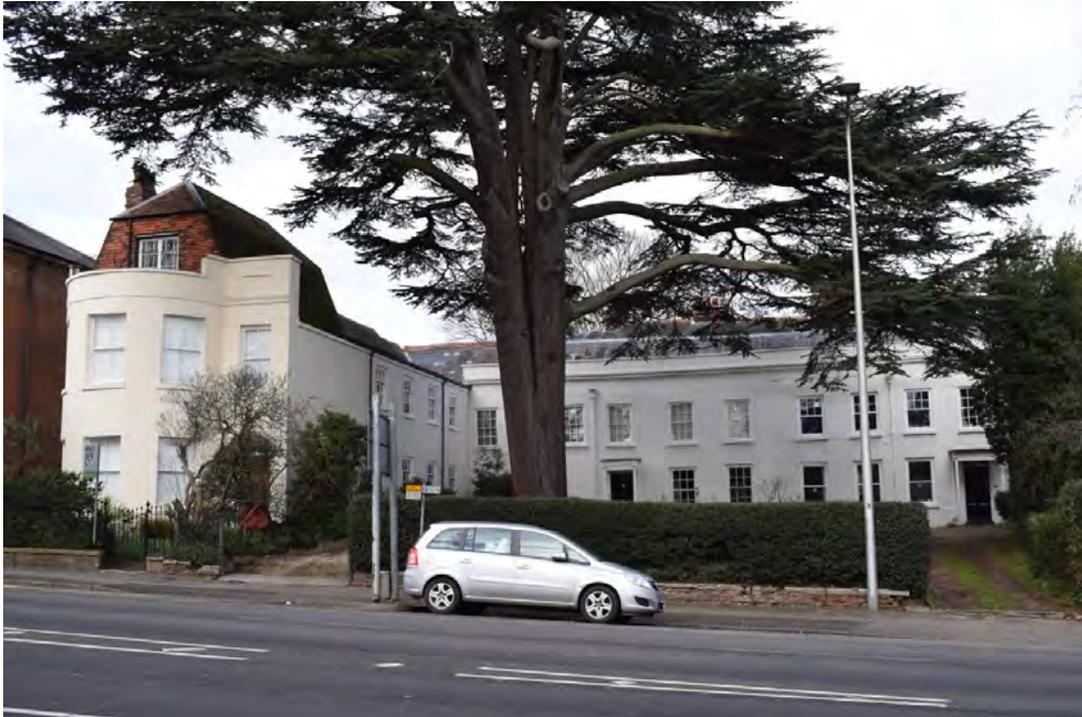
The Grade II* 154-160 Castle Hill, originally the Kings Arms Inn, with its striking Cedar of Lebanon tree in its forecourt, is the street's most notable and impressive building (see figure 6.1.4). Dating from the late 17th century, its long history is detailed in Appendix I. The 18C railings to the street are hidden within holly bushes,

Figure 6.1.4 154- 160 Castle Hill, the former Kings Arms Inn, and Jesse family home (Karen Rowland)

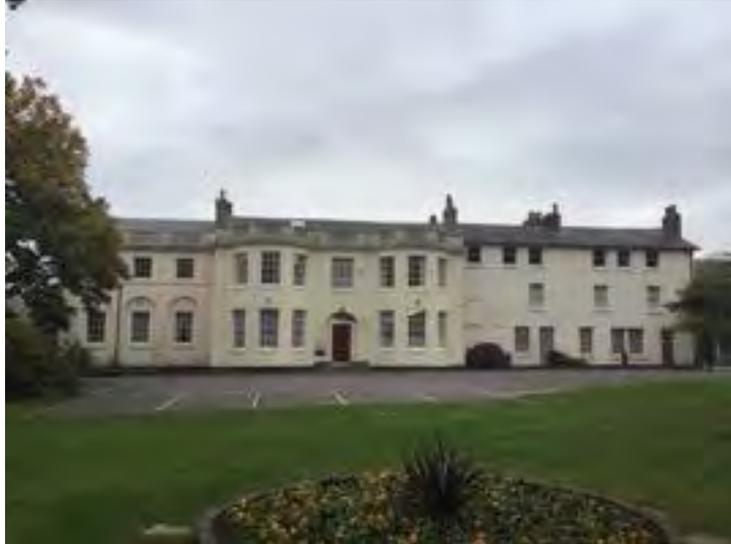
Yeomanry House, Grade II, and its associated gatehouse, at 131 and 133 Castle Hill, comprise the most significant remaining example of the grand houses built at the junction of Castle Hill, Russell St and Coley Avenue for the wealthy and prominent businessmen of Reading. It exemplifies the layout of these properties with its c.1840 gatehouse and large front garden facing directly onto Castle Hill. The footprint of its original drive is still in situ. The gatehouse is notable for its early and extensive use of salmon-coloured brick.

Figure 6.1.6 Yeomanry House at 131 Castle Hill - house, front drive and garden, (Karen Rowland)

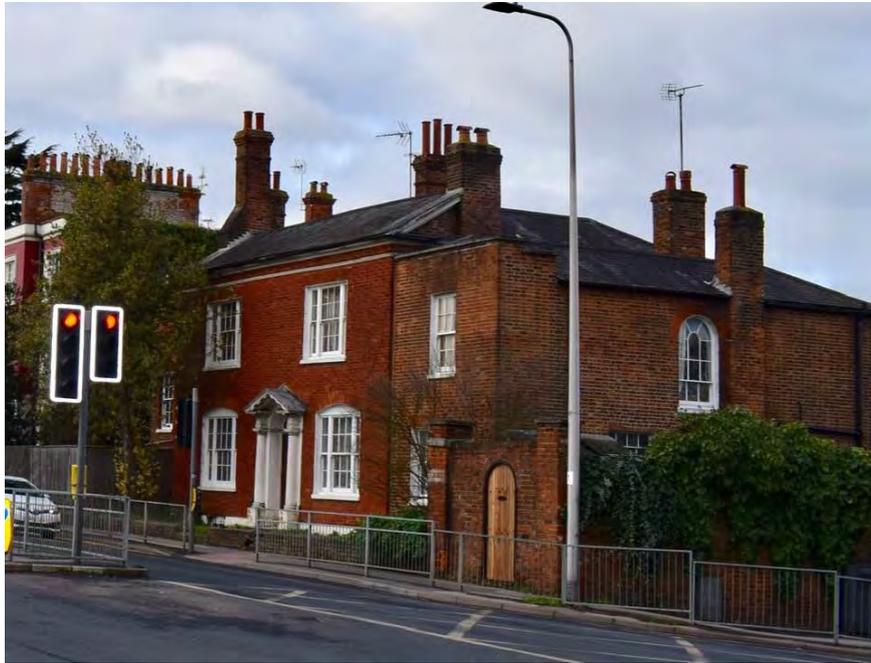
The Grade II 2 Bath Road, the former home of local market gardener, William Pratt Swallow has a fine Georgian frontage and an attractive chimneyscape (also see figure 4.2.3). The busy intersection that it sits directly upon, with frequently backed-up cars and street furniture compromises its originally important setting.

Figure 6.1.9 **William Pratt Swallow's house, 2 Bath Road** with busy junction in front of it (David Neale)

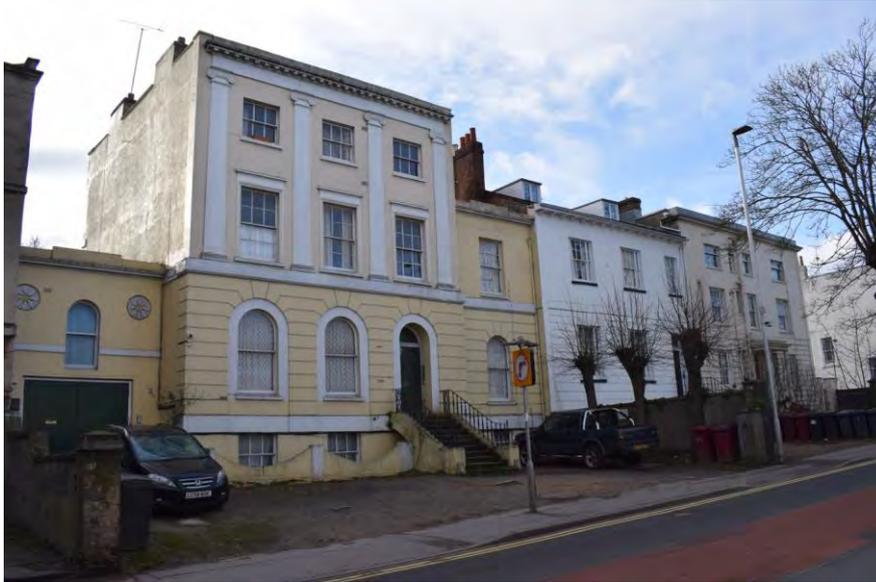
The houses at nos.107-111 and nos.122-132 (all Grade II), define the early building at the east end of the street. These houses are large, often rusticated and stuccoed; many with original arched windows and fanlights. The house at no.107 still retains its stable building and the footprint of its large, original garden to the rear.

Figure 6.1.10 Large rusticated Georgian houses on the south side of Castle Street at 107-111 (David Neale)

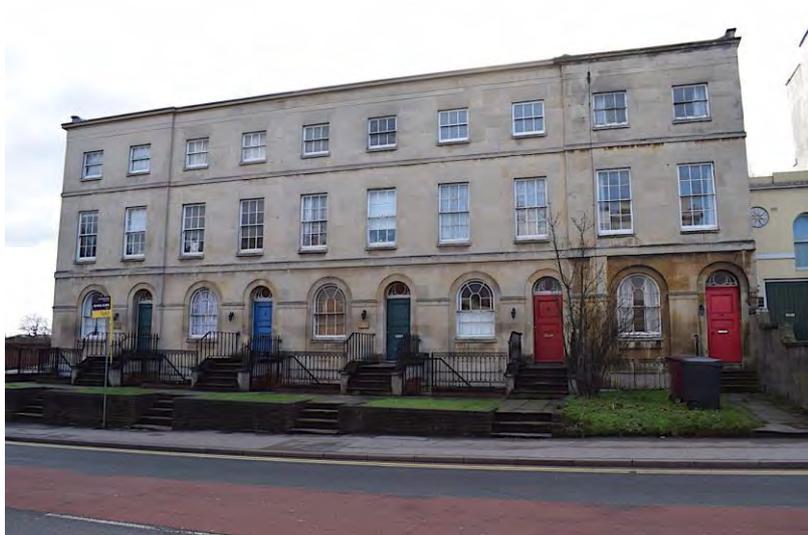
The Grade II early 19th century Bath stone Blenheim Terrace, at nos. 97-105 Castle Street, is impressive in scale and its classic detailing. It is one of only two extant Bath stone properties remaining within the conservation area. No.105 is regrettably in a poor state of repair.

Figure 6.1.12 Blenheim Terrace, Bath stone terrace, 97-105 Castle Street (David Neale)

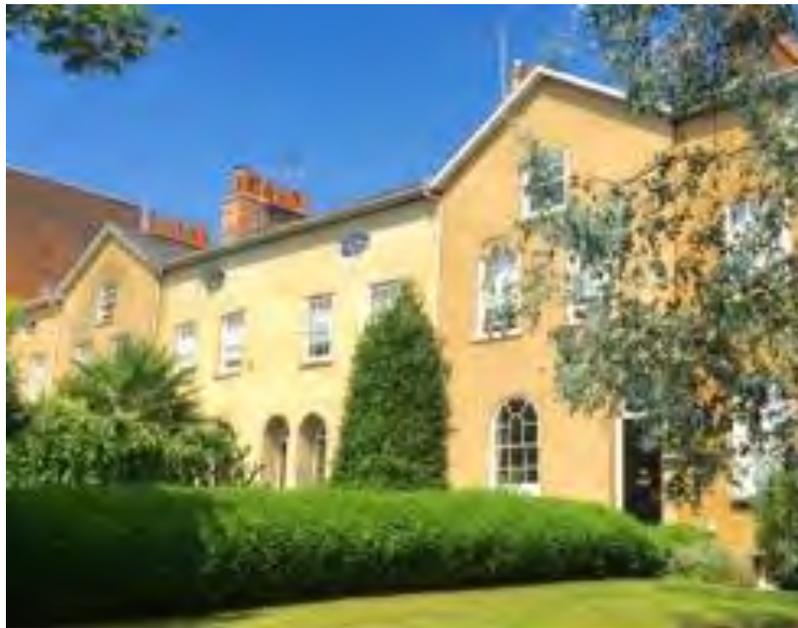
The attractive Grade II Regency detailed terrace at 134-144 Castle Hill is set back from the road in well-tended deep gardens. Its Bath stone coloured stucco façade is a replacement of its original Bath stone façade which was removed in the 1960s.

Figure 6.1.13 Bath stone coloured stuccoed Regency style terrace, 134-144 Castle Hill (Karen Rowland)

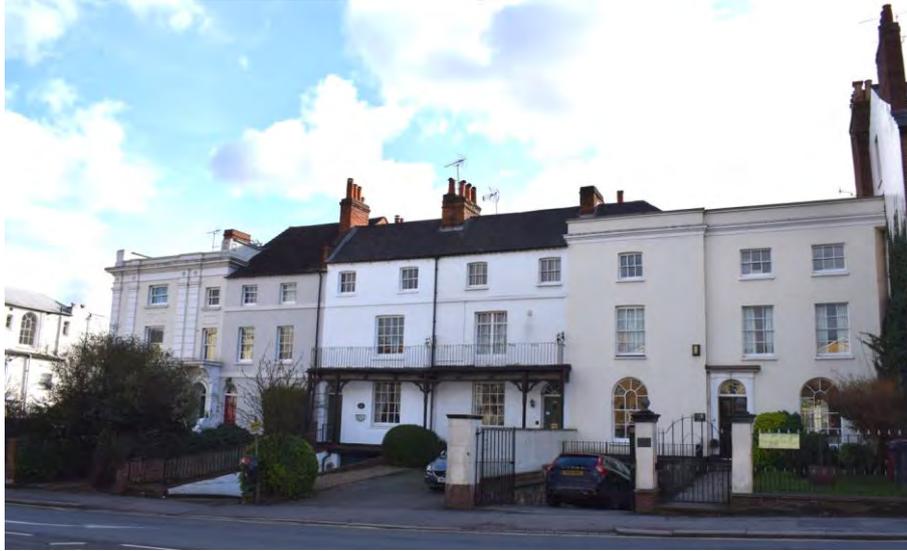
The fine grouping of houses at nos. 113-121 (all Grade II) create a pleasing collection on the south side of the street. The terrace is attractive because of the houses' Georgian architectural variety, despite dropped kerbs for parking along most of the fronts. No. 113 forms a particularly striking end with its rusticated paired pilasters, topped with wreaths.

Figure 6.1.14 Attractive diverse terrace of Georgian properties at 113-121 Castle Street (David Neale)

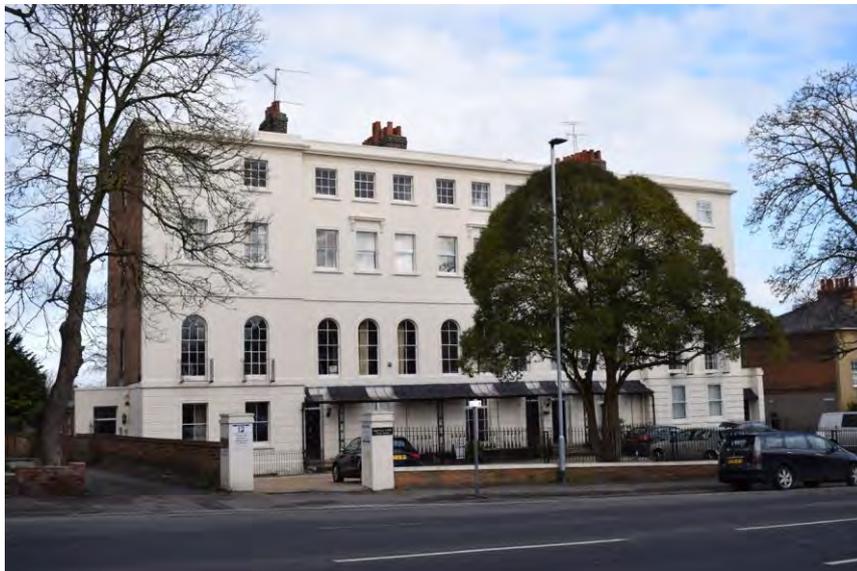
Heritage Court (nos. 144A – 152) and the terrace at nos.162A- 166 (all Grade II) are the legacy of the local Jesse family of developers. The attractive verandas with concave metal roofs and Regency style metal work distinguish the families' developments along Castle Hill.

Figure 6.1.15 Heritage Court, 144A- 152 Castle Hill, a Jesse family development (David Neale)

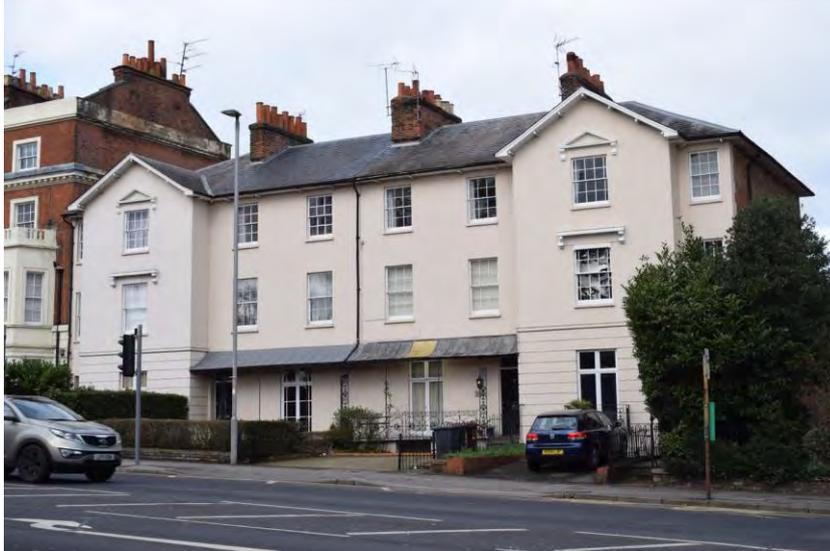
Figure 6.1.16 Nos. 162A-168, with Regency iron detailing, an early Jesse family development (David Neale)

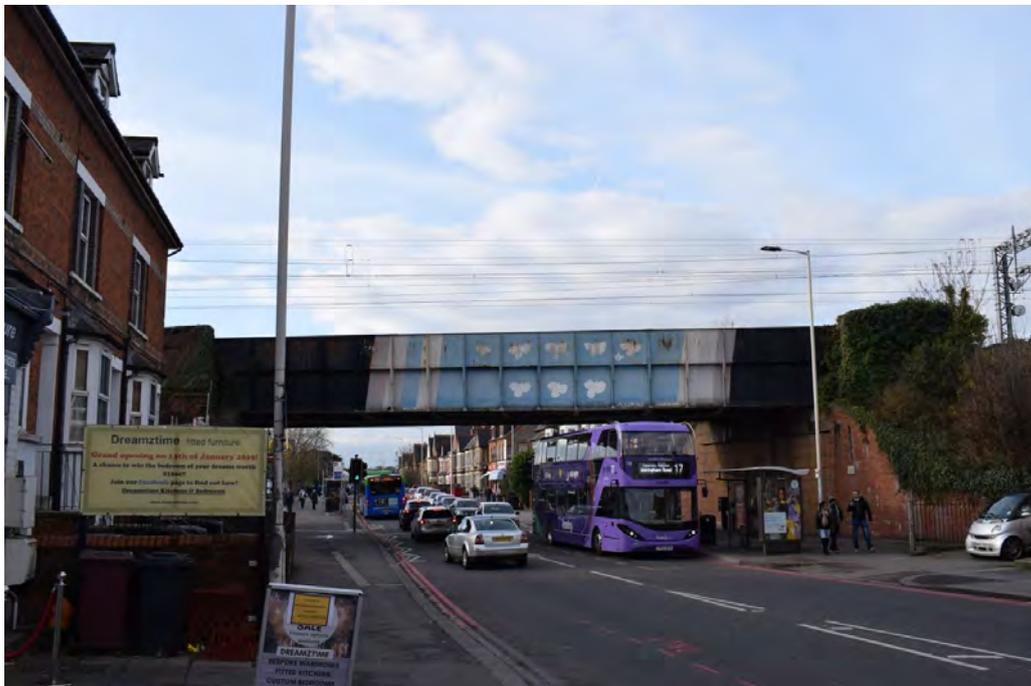
Figure 6.2.2 Reading West railway bridge, facing west along the Oxford Road, the iron bridge replaced an original brick design (David Neale)

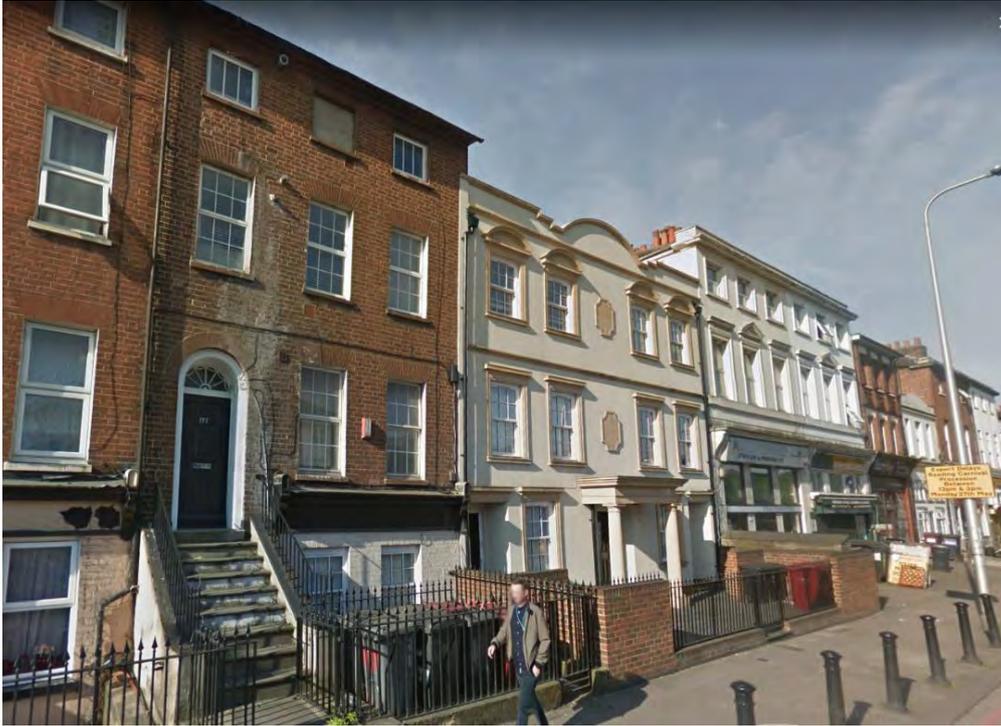
Figure 6.2.3 Oxford Road between Russell Street and Prospect Street - poor condition Georgian terraces, acceptable modern pastiche of pre-existing elements, varied shop façades and poor public realm (Google Maps)

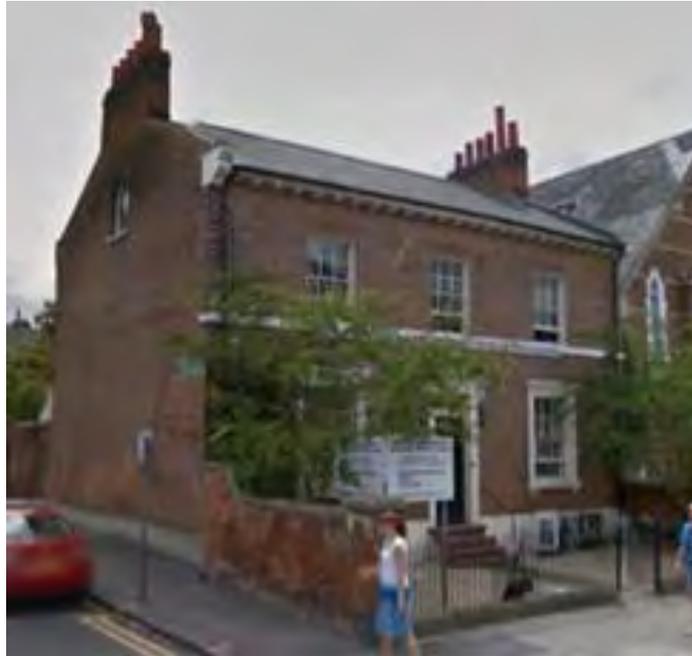
Additionally, two detached Georgian houses at 101 and 104 Oxford Road remain from the earlier villas that dotted the route. Both buildings house businesses and 104 Oxford is particularly well maintained.

Figure 6.2.5 101 Oxford Road-a detached Georgian family home with original high back garden walls (David Neale)

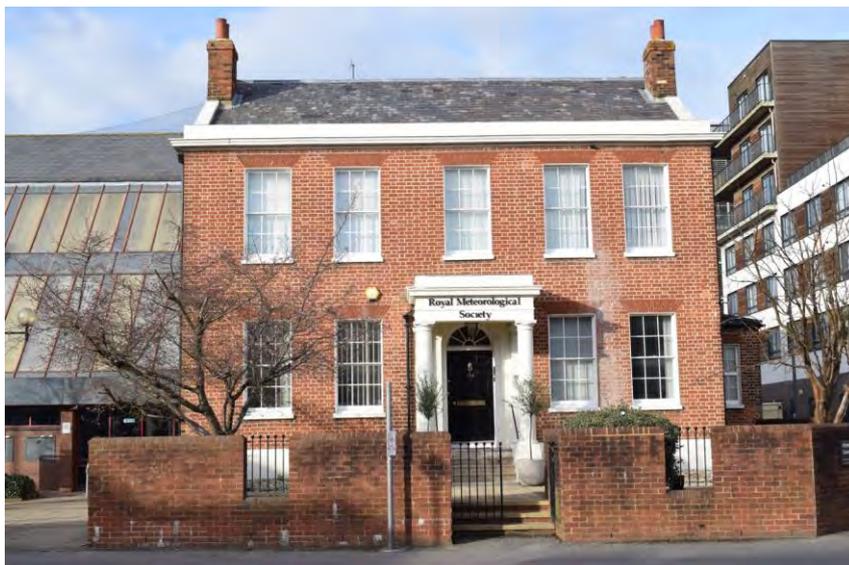
Figure 6.2.6 National Meteorological Society at 104 Oxford Road, a detached Georgian house with porticoed front porch surrounded by unsympathetic modern build (David Neale)

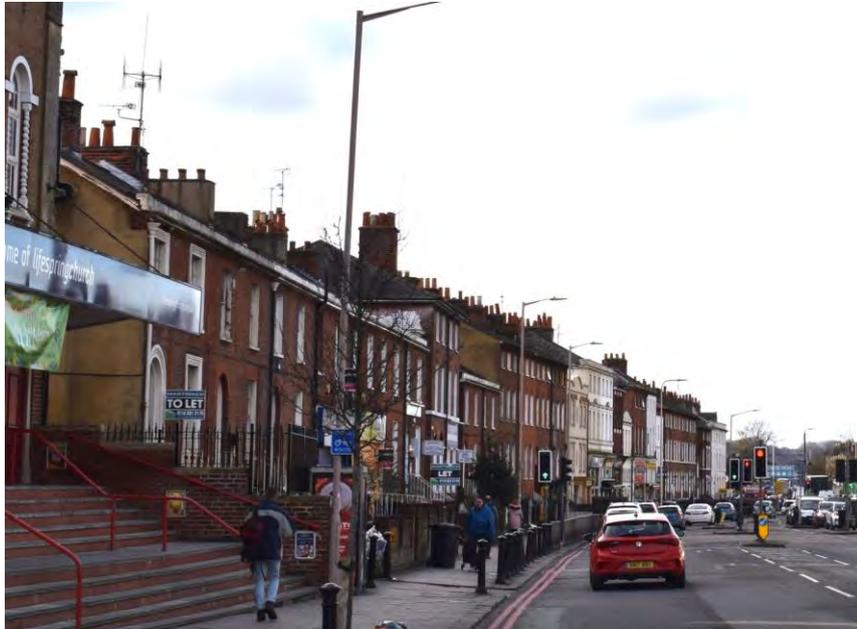
Figure 6.2.7 Listed Georgian terraces along Oxford Road, in poor repair, lost behind cluttered street furniture and busy road traffic (David Neale)

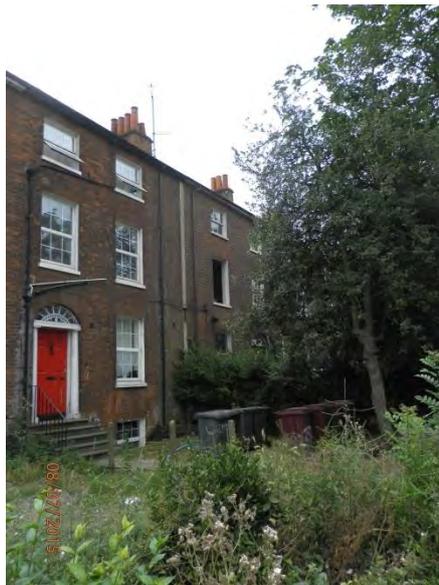
Prospect Terrace is a fine, Grade II Georgian terrace set back from the Oxford Road largely in poor condition and negatively impacted by the petrol station opposite and the busy road.

Figure 6.2.8 237 and 239 Oxford Road, part of Prospect Terrace, 237-247 Oxford Road/2 Lorne Street (Reading Borough Council)

- The listed Georgian terraces of 149-177, 187-193, 195-197, 197-203 and Prospect Terrace at 2 Lorne Street/237-247 Oxford Road, though many of these properties are in poor condition.

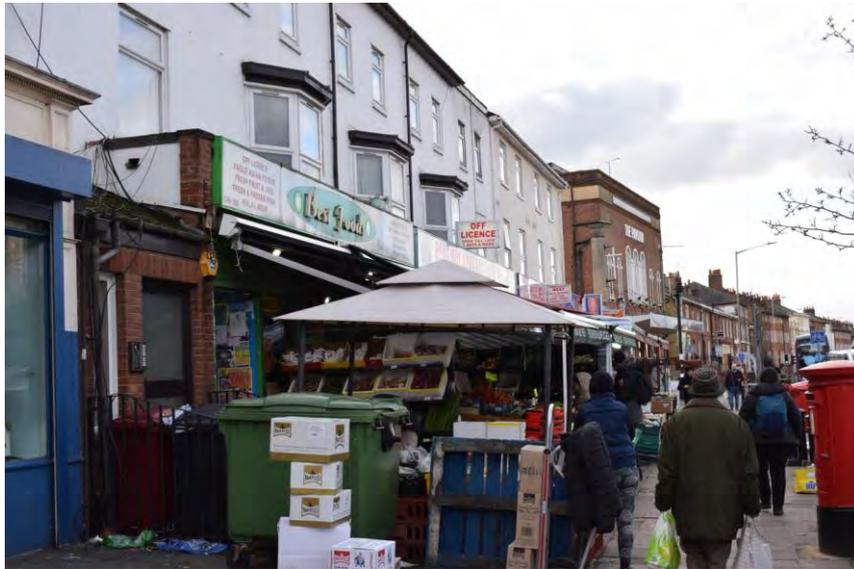
Figure 6.2.9 Proudly diverse grocers and shops do business amid clutter and poor signage which mask the original early 19th century structures on Oxford Road between Russell Street and Waylen Street (David Neale)

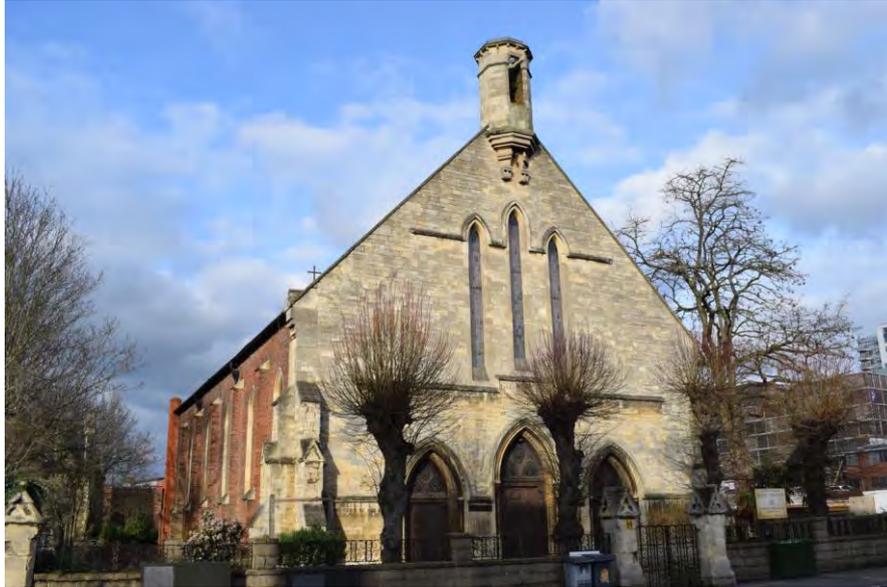
The austere Grade II Holy Trinity Parish church, built c.1826 but the stone façade to west front 1845, at the junction of Russell Street on the Oxford Road still maintains a heritage presence. The last renovation of the church was unable to fund the reinstatement of its centre spiralet which was removed in the last half of the 20th century. Current development directly to the church's east will affect the church's prominence on the road and the reinstatement of its spire could help to strengthen its presence significantly. The Grade II 118 Oxford Road, a circa 1845 villa to the rear of Bridge Hall, was once the manse.

Figure 6.2.10 The Grade II Holy Trinity parish church at the intersection of Russell Street (David Neale)

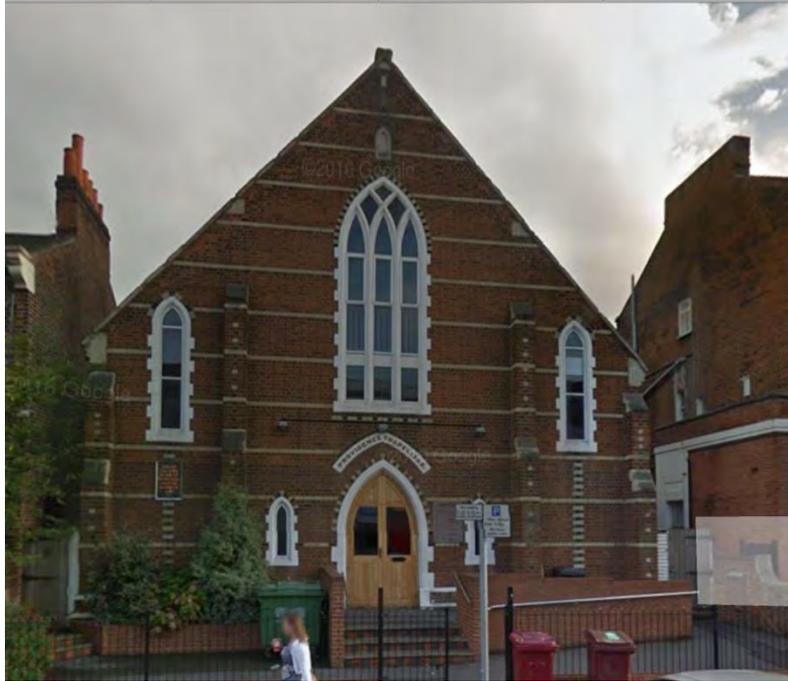
The rise and on-going strength of Nonconformist Churches in the area from the mid-19th century is part of the story of the Oxford Road and the Conservation Area south of Castle Hill. The Providence Chapel, dating from c.1859, is evidence of this societal activity. Sadly, its modern tarmac frontage and access ramp detract from its appearance.

Figure 6.2.12 Providence Chapel, c. 1859, 103 Oxford Road (Google Maps)

- Bridge Hall, which is currently housing a church although in a state of poor repair
- Providence Chapel with its polychrome brick façade
- The Pavilion, a well-restored former cinema, now home to the Lifespring Church

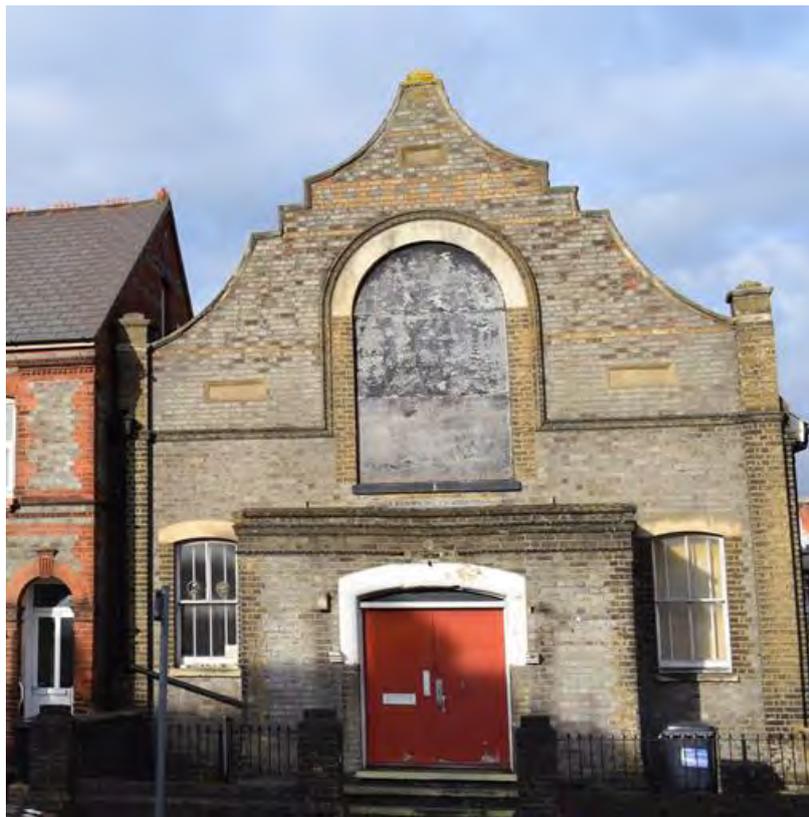
Figure 6.2.13 Bridge Hall, originally built for the Reading Open Brethren Group, in poor repair (David Neale)

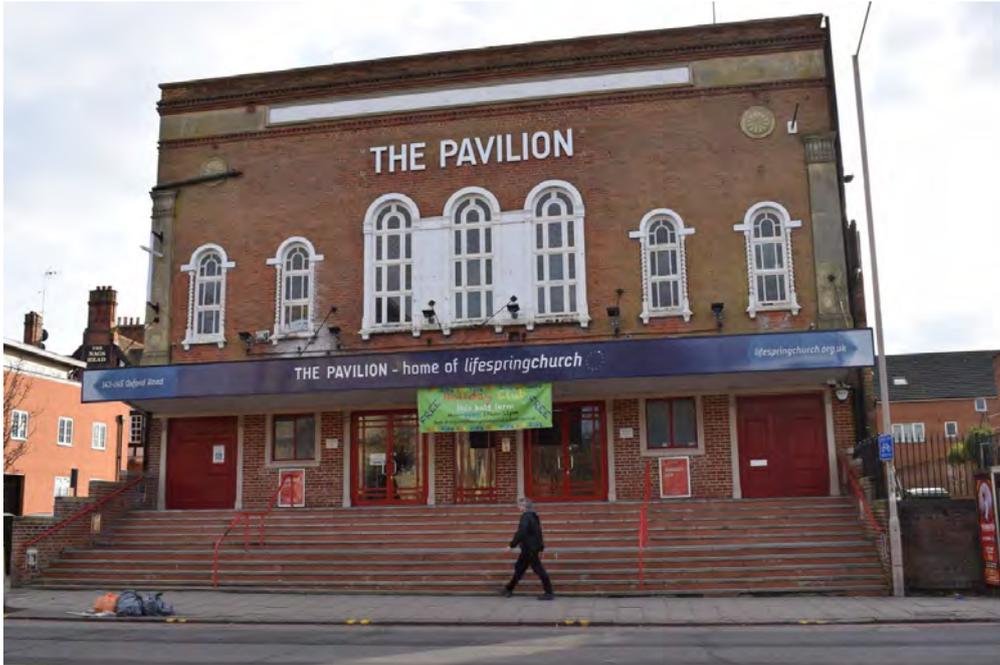
The Pavilion, originally an important cinema for Reading, opened in 1929. It was later known as the Gaumont, that closed in 1979. It was then a bingo hall (1979-1989) and Riley's Snooker Centre (to 2011). It is now home to the non-conformist Lifespring Church. The church has carefully restored much of the original cinema's interior detailing. In recognition of the Nonconformist tradition of the area, each of these buildings have been listed as Buildings of Townscape Merit.

Figure 6.2.14 *The Pavilion, a former popular Reading cinema, corner of Russell Street, now well restored and home to the Lifespring Church (David Neale)*

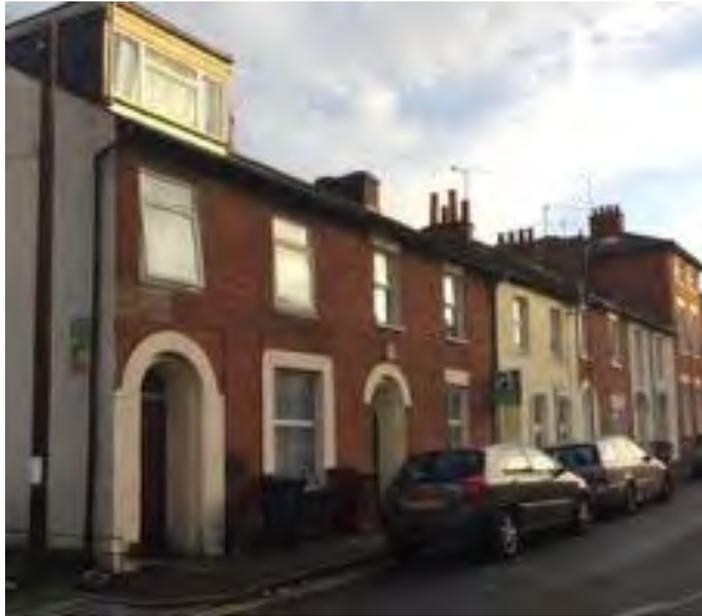
Figure 6.2.15 1-9 Prospect Street, a rare modest Georgian artisan terrace with the over-bearing modern dormer window at no. 1 (Karen Rowland)

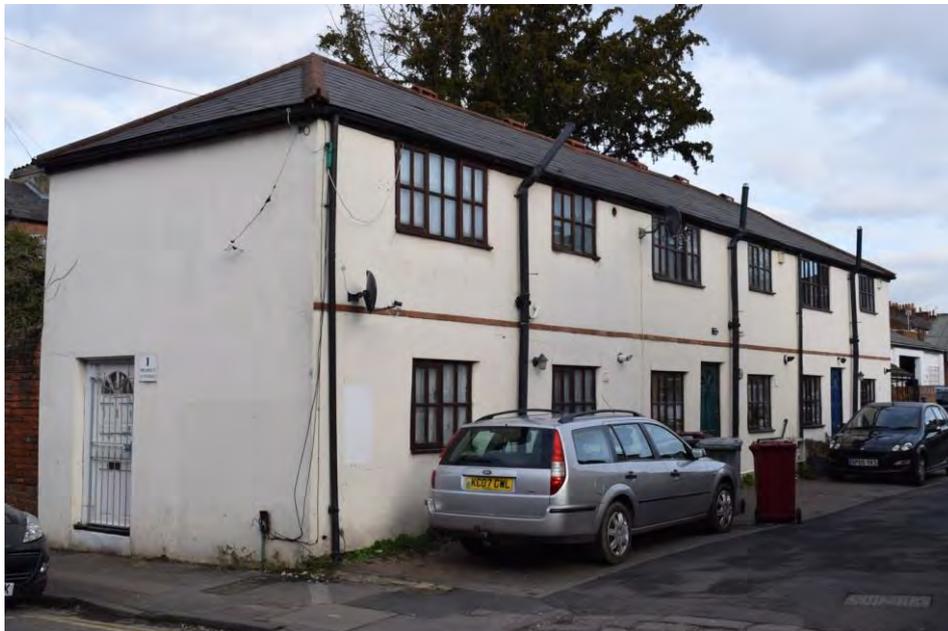
A rare, representative expanse of stone paving has been retained at the entrance into Prospect Mews. The modest terrace of Prospect Mews, directly behind Sidney Terrace is in fair condition, although the Mews itself is access for a car repair service at the back.

Figure 6.2.16 Prospect Mews, mews houses with an expanse of stone pavement at the entrance to the alleyway (David Neale)

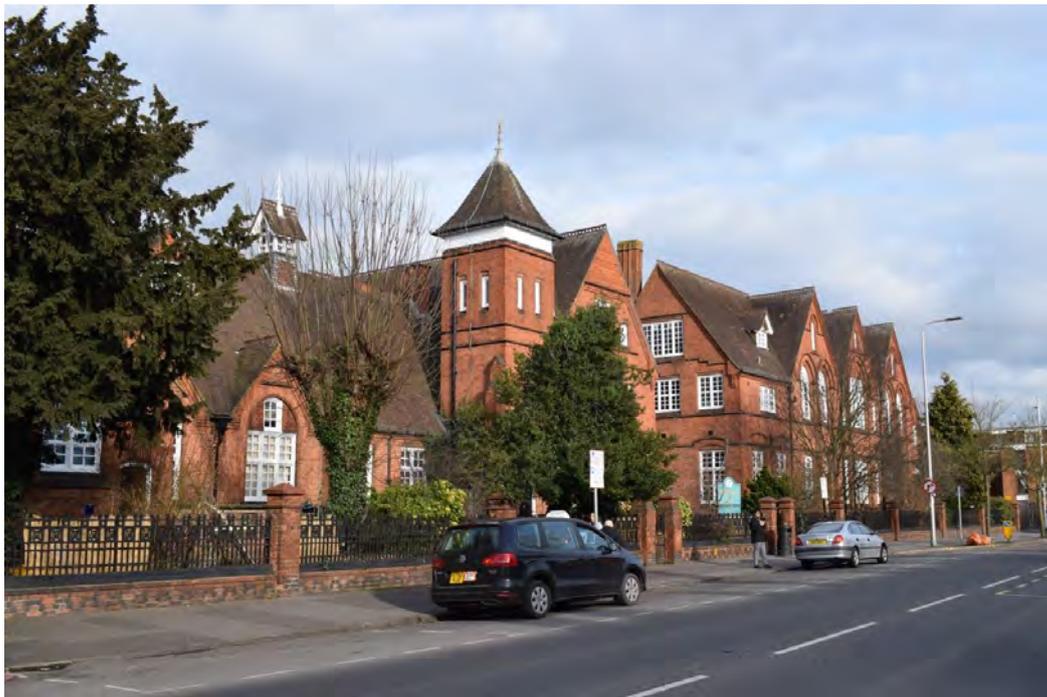
The striking Grade II listed Oxford Road Community School (architect: Morris and Stallwood, c. 1880-1883 and extended by Stallwood in 1884) anchors the route in a positive reminder of its proud past. It is well-maintained and provides a positive and active focal point for the surrounding neighbourhood. It retains original wooden windows and railings.

Figure 6.2.17 The well-maintained Oxford Road Community School (David Neale)

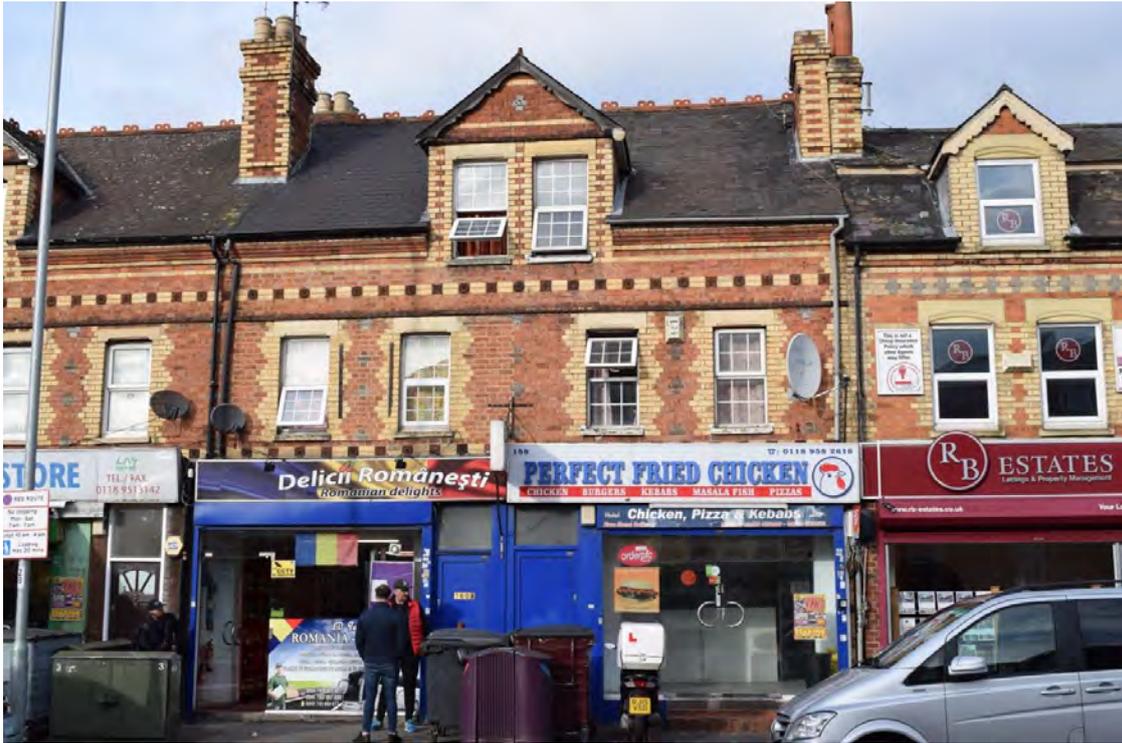
Figure 6.2.18 Long retail terrace, 152-180 Oxford Road, stunning polychrome and largely intact, although incompatible signage and store fronts detract from its appearance (David Neale)
