STRATEGIC ENVIRONMENT, PLANNING AND TRANSPORT COMMITTEE 16 MARCH 2020

<u>WARDS AFFECTED</u>	<u>Page No</u>
10. ADOPTION OF THE CASTLE HILL/RUSSELL STREET/OXFORD ROAD CONSERVATION AREA APPRAISAL - APPENDICES 2 TO 4	ABBEY; BATTLE; MINSTER	3 - 160

APPENDIX 2: STATEMENT OF CONSULTATION ON CONSERVATION AREA APPRAISAL FOR THE RUSSELL STREET/CASTLE HILL CONSERVATION AREA

Initial Statement

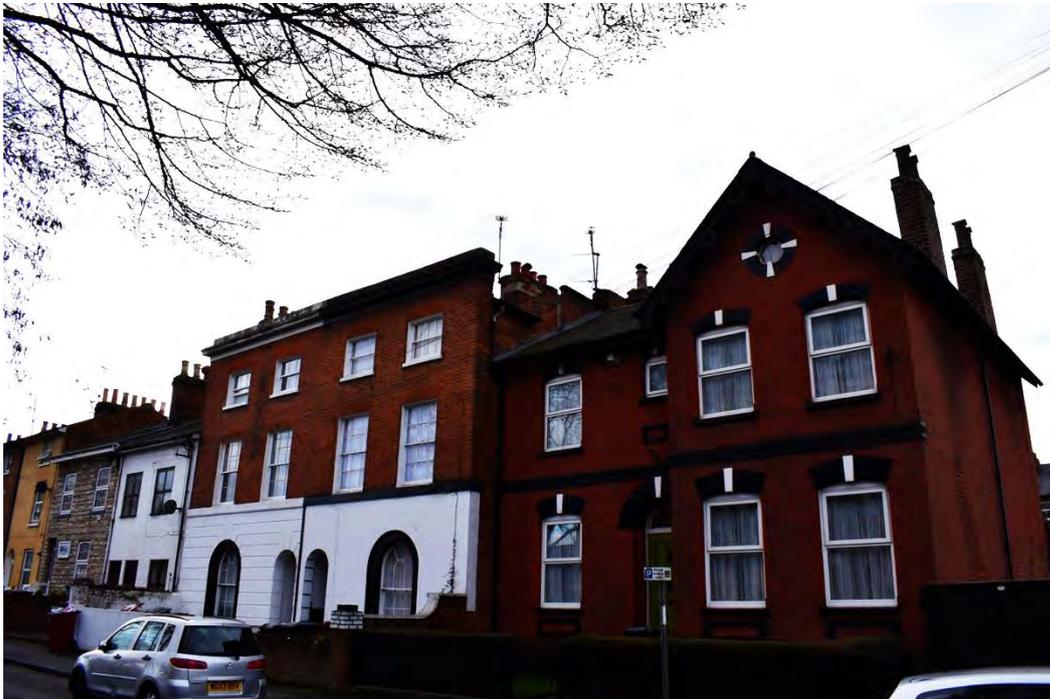
The creation of the IDR in the 1960s saw the original properties on the western side of Howard Street retained whilst the houses along the eastern half were demolished. 4-4A Howard Street is a listed Georgian semi-detached house and the original rustication on the ground floor of 4A has been retained. 2 Howard Street dates from c.1850-70s, and is an attractive single-family home of substantial size with a well-tended front garden that lends itself positively to the street scene.

Figure 6.3.4 2, 4 and 4A (listed Georgian semi-detached terrace) Howard Street showing the rustication on 4A (David Neale)

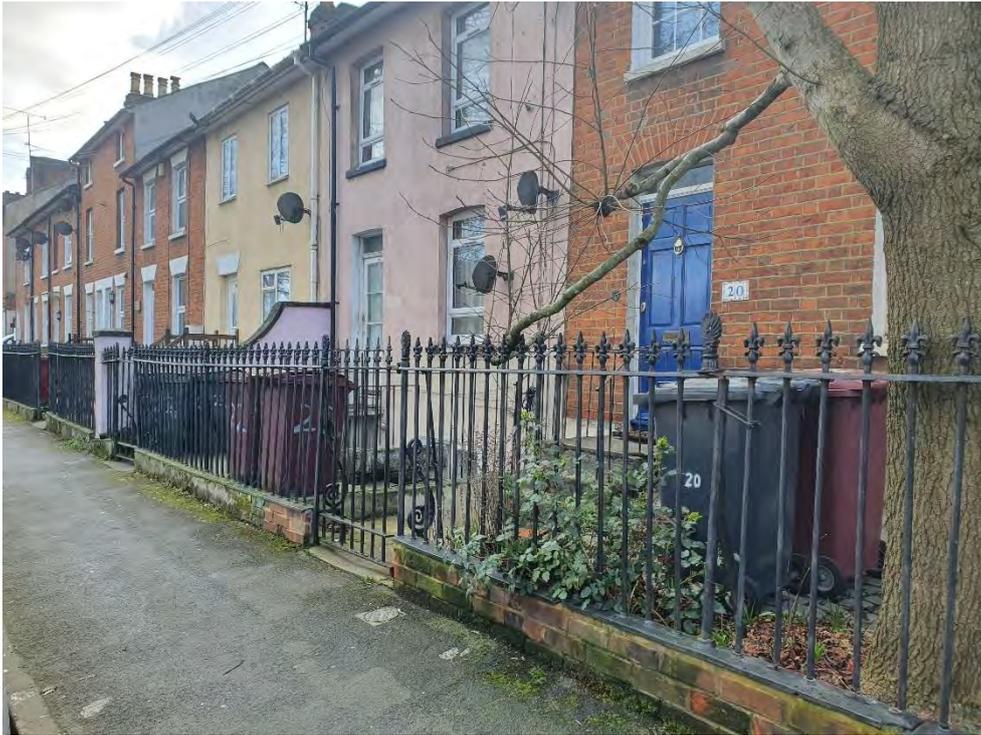
There are a number of original front garden cast iron railings at nos. 16-22 and two original curved stucco dividing walls at 4 and 22 Howard Street (figure 6.3.5). The modern faux-stone rendered façade at no. 8 and the irregular colours and over-painting of many of the houses are incompatible with the otherwise red brick simplicity of the rest of the houses, adding to a sense of disharmony along the street. The line of trees on the eastern side minimises the sight and noise of the IDR and provide reasonable tree coverage in the summer but affords less coverage in winter. Recently re-painted black cast-iron bollards line the street in front of the trees.

Figure 6.3.5 Original iron railings at 16-22 Howard Street and the curved stucco dividing wall at no. 22 (Mark Worringham)

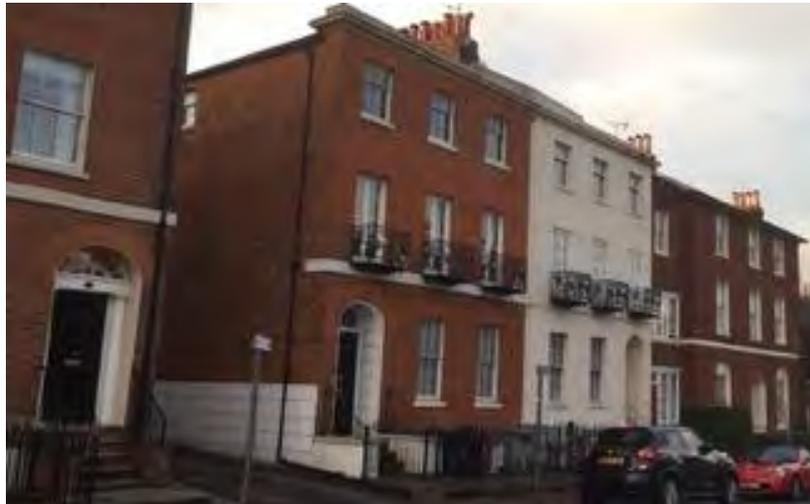
The large Georgian terraces located along the west side of Russell Street contribute significantly to the street's grand appearance. Most of these are in good condition and some are still retained as single-family homes on the south end near its intersection with Tilehurst Road.

Figure 6.3.6 Terraces along the west side of Russell Street (nos. 38-42) with Regency window balconies (David Neale)

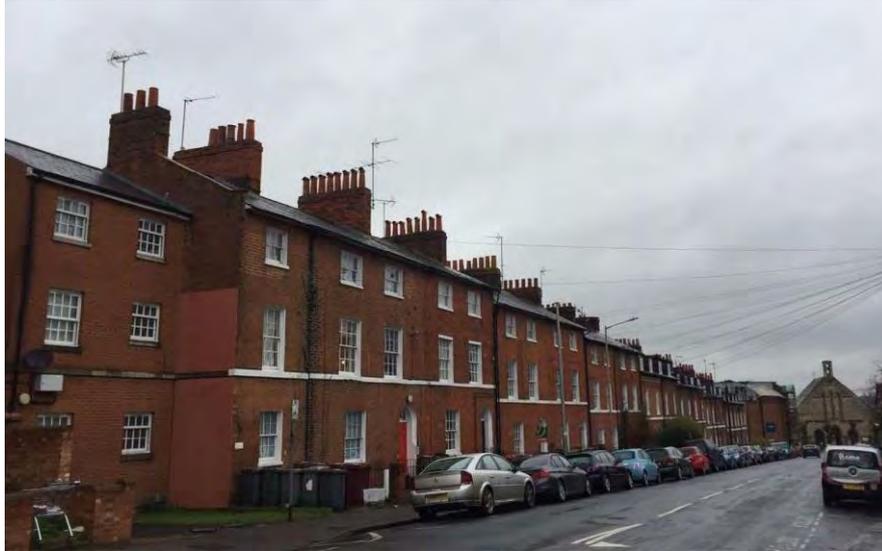
Figure 6.3.7a Georgian terraces at nos. 6-14 Russell Street. The Holy Trinity parish church forms an impressive view at the north end of the street from the Oxford Road (Evelyn Williams)

The listed 2-storey Georgian terraced properties between nos. 6-34 have been adversely affected by buy-to-let investment which has resulted in the poor maintenance of many of the properties. The removal of original windows at nos. 14 and 16 are a regrettable blight on the terrace and enforcement has been unable, to date, to get the developer to repair this damage.

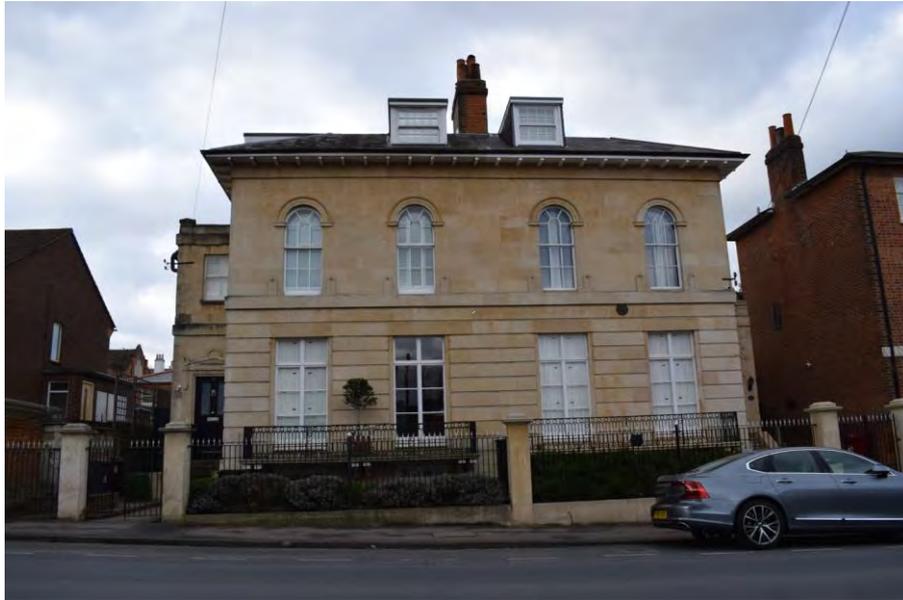
The semi-detached houses at nos. 48-50 Russell Street are striking and unique in the area with their use of Bath stone. They are the work of Nathaniel and Henry Briant whose work can also

be seen in Reading's Eldon Square Conservation Area where there are numerous houses that are of almost identical structure, planform and style. The Kennet and Avon canal made Bath stone a prestigious choice for houses in the 1830-40s.

Figure 6.3.8 48-50 Russell Street, Bath stone semi- detached houses, very similar in style to those in Eldon Square in east Reading (David Neale)

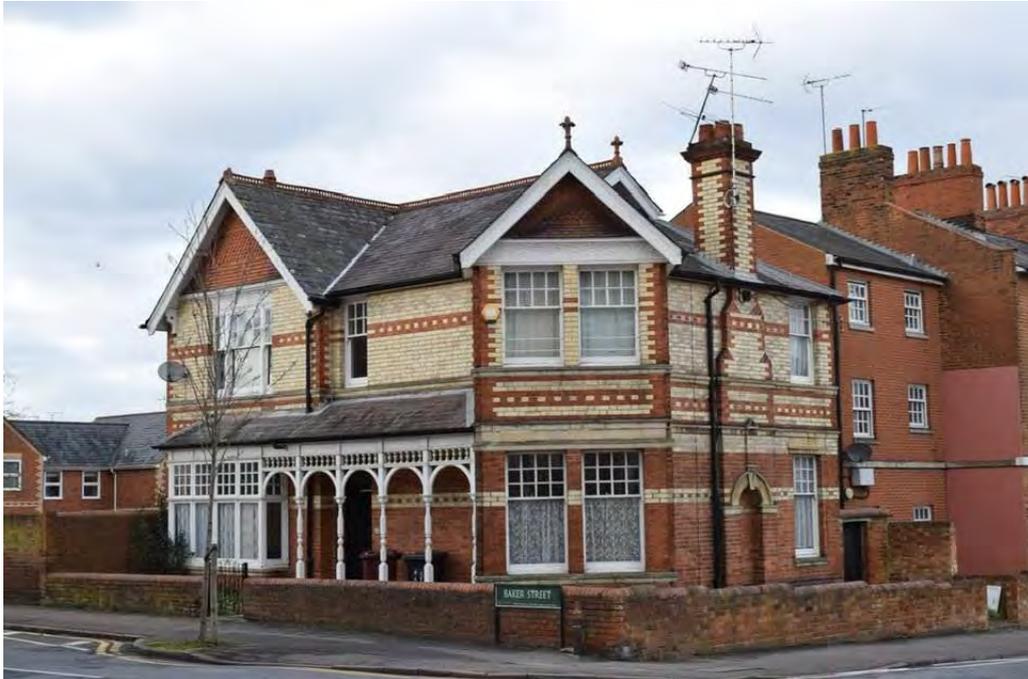
The Parsonage at 32 Baker Street, is a fine late-Victorian house, which sides on to Russell Street. It was created as the Vicarage for the Holy Trinity parish church and dates from c.1890. It has striking polychrome brick detailing and terracotta features and its front door, looking onto Baker Street, is set within an ornate late Victorian timber and tiled porch. Horizontal bars on the first-floor windows remain from the use of the upstairs room as a nursery. Improved landscaping could enhance the site.

Figure 6.3.10 *The Parsonage (c.1890) at the northeast corner of Baker Street and Russell Street with attractive polychrome and wood detailing (David Neale)*

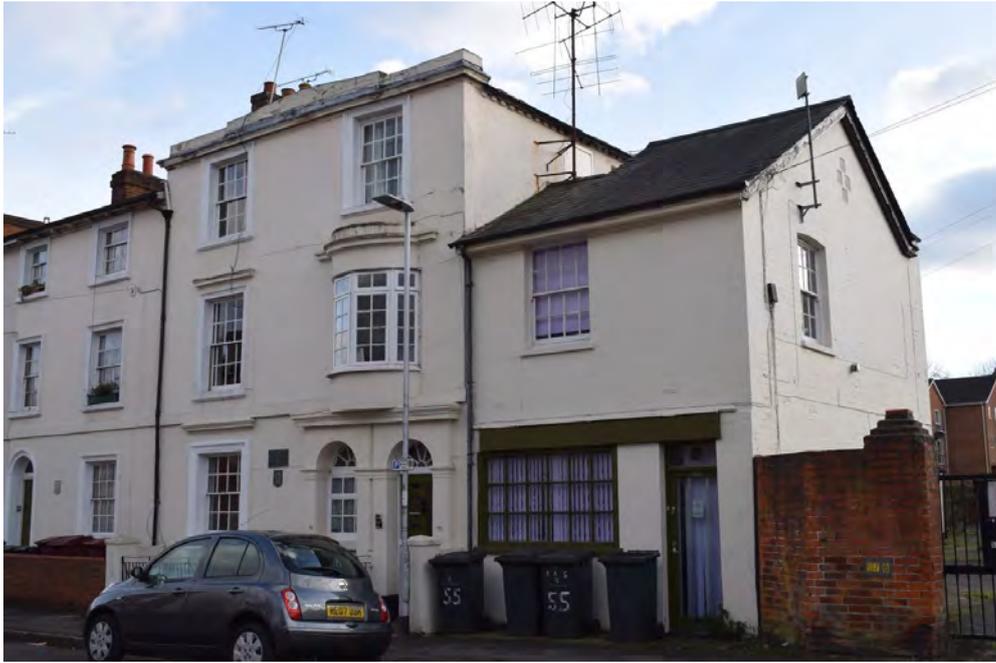
The stuccoed, late-Georgian terrace at 37- 55 Baker Street built prior to 1833, are the oldest houses on the eastern part of that street originally named Russell Terrace in this section. Their poor condition belies their historical importance. A significant pioneer of early photography, Henry Fox Talbot had his "Reading Establishment" studio at 55 Baker Street. The site is worthy of enhanced designation.

Figure 6.3.12 Fox Talbot's 'Reading Establishment' studio at 55 Baker Street. (David Neale)

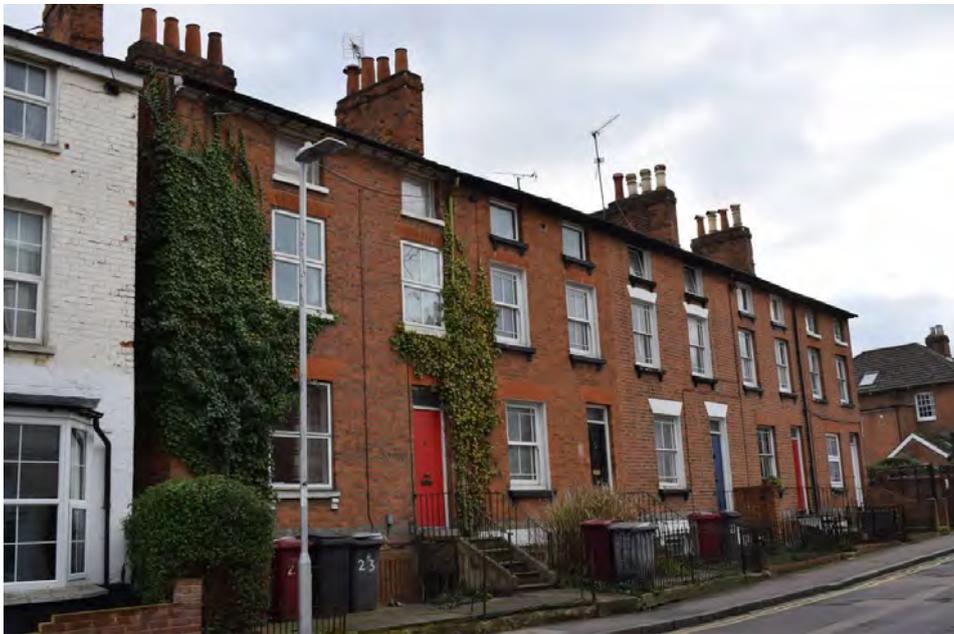
Alexandra Terrace at nos. 23-31 is a straightforward, red brick terrace with many original windows and details intact and dates from prior to c.1853. Some original iron fencing and gates remain, notably at no. 29. The property at no. 23 is in poor condition and no. 31 has seen a recent loss of its original windows.

Figure 6.3.13 23- 31 Baker Street, Alexandra Terrace, c.1850, red brick terrace, overall well-preserved with majority of original windows and doors intact (David Neale)

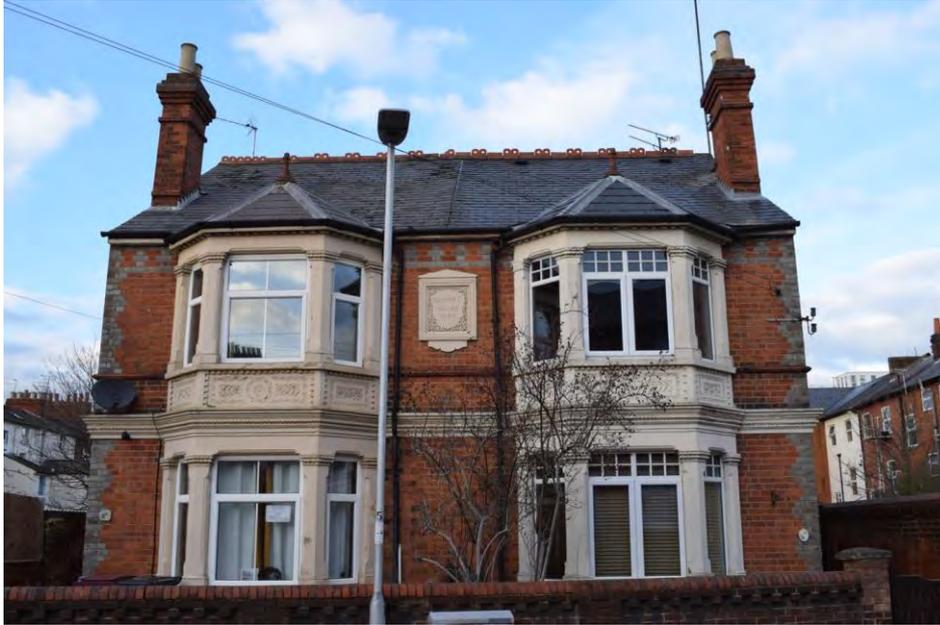
Other buildings of note along Baker Street include the semi-detached Rednirt Villas, which have attractive stonework and a centre plaque with its name and the date of 1904.

Figure 6.3.14 Rednirt Villas 1904, developed by Mr. Trinder, bay windows, polychrome and stone work detailing. Rednirt is Trinder spelt backwards. (David Neale)

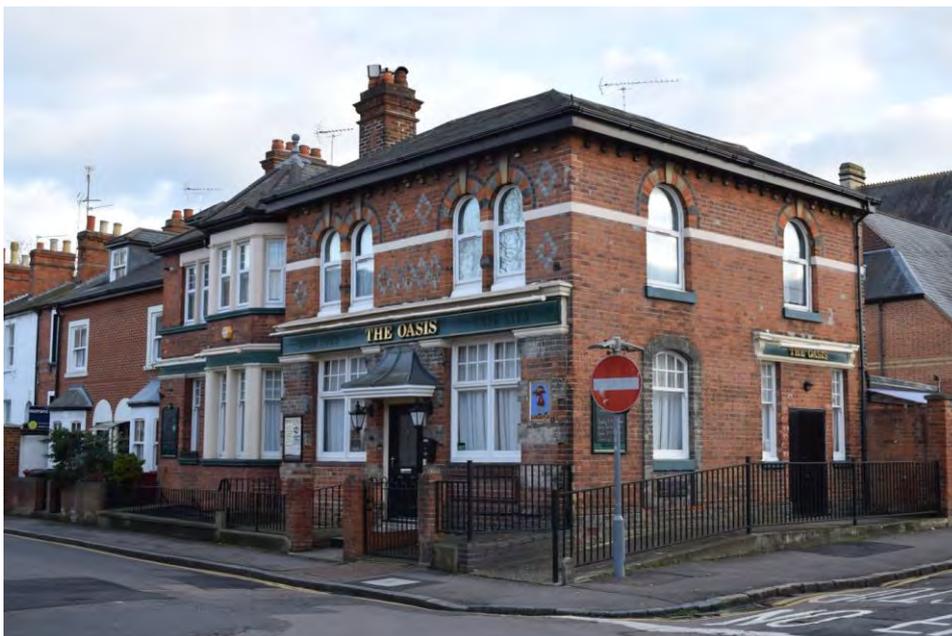
The Oasis Community Centre dates from c.1860s. It was originally the Eagle public house, inn, spirits retailer and warehouse in the late 1800s. It closed in 2009. Now well-restored and maintained by the Carey Baptist Church, it serves a current benefit to the area as a community meeting place. A small section of surviving sett stones are located on the pavement in front of the cast iron door opening to the cellar. Its old Morland advertising sign along with this cellar entrance affirm its past use. Inside, the ghost image of an advertising sign from the last decades of the 1800's proclaiming "Ferguson's Pale Ale, Stouts & Porter, Wine & Spirits" is located on the first floor, along an east-facing brick wall that originally formed the exterior wall of the original building. The sign is currently covered by plasterboard. The building's well-maintained polychrome detailing and wooden original windows further reinforce its heritage context and positive value to the streetscape.

Figure 6.3.15 The Oasis Community Centre, c.1860s Inn and Public House (Karen Rowland)

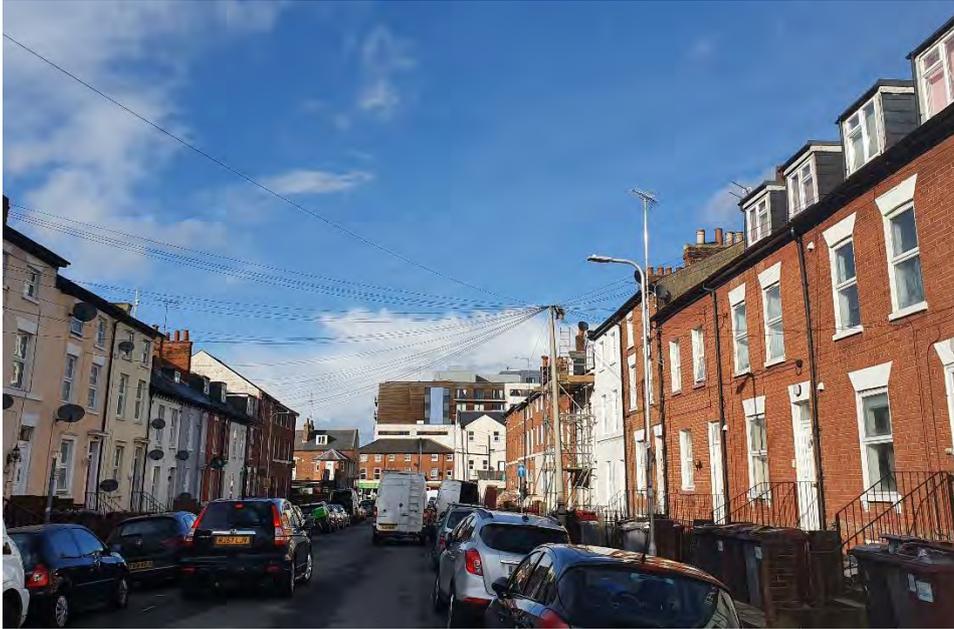
Figure 6.3.17 The conditions of terraced housing looking north along Zinzan Street with poor quality modern dormers, overhead wires, excessive bins and satellite dishes. (Mark Worringham)

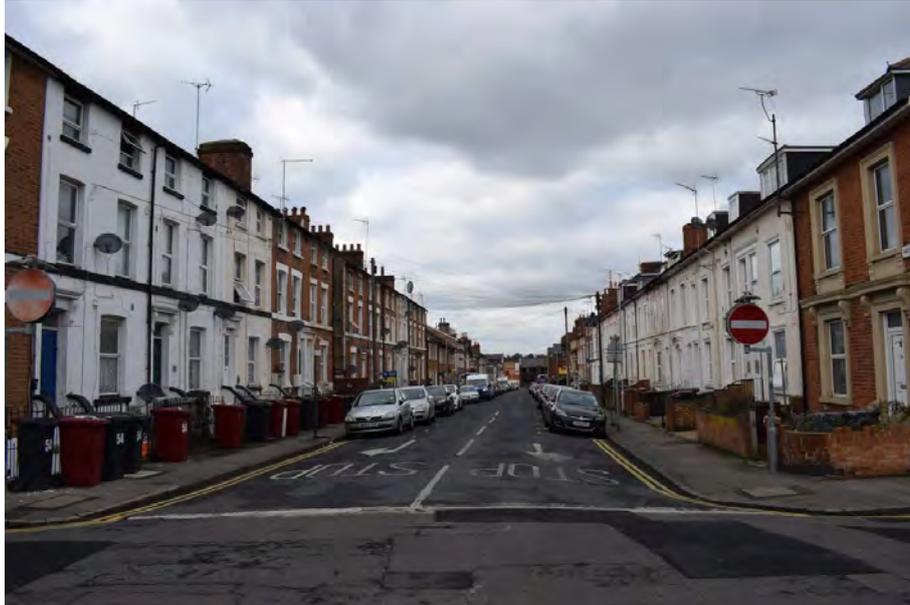
Figure 6.3.18 Looking north along Waylen Street with its overall poor conditions. The **street's earliest** houses, nos. 43-61, are on the right c.1840 (Karen Rowland)

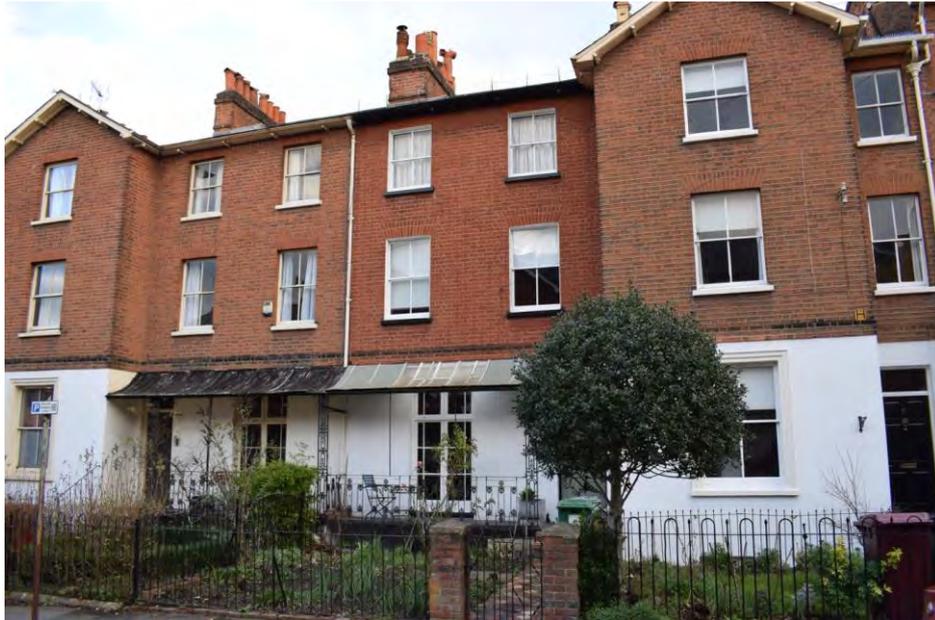
The well- cared for Jesse Terrace across Baker Street from Waylen Street, sits in strong contrast to Waylen Street and is **arguably the Jesse family's most impressive development**. The street forms one of the finest streetscapes in the Conservation Area. The terraces date from c.1853 to the mid-1870s and largely remain in single family occupation to this day. Only a few have been converted for multiple occupation as flats and HMOs, and an Article 4 Direction was put in place in 2016 which has protected the single-family balance of the street. The houses have striking, uniform metal verandas on both sides of the street and are set back from the street, most with well-tended gardens. An Article 4 direction, put in place in 2004, now protects the house façades from uncontrolled alterations and, with few exceptions, original windows, doors and chimneys remain to create a pleasing harmony along the street.

Figure 6.3.19 Close-up of terraces and gardens in Jesse Terrace (Karen Rowland)

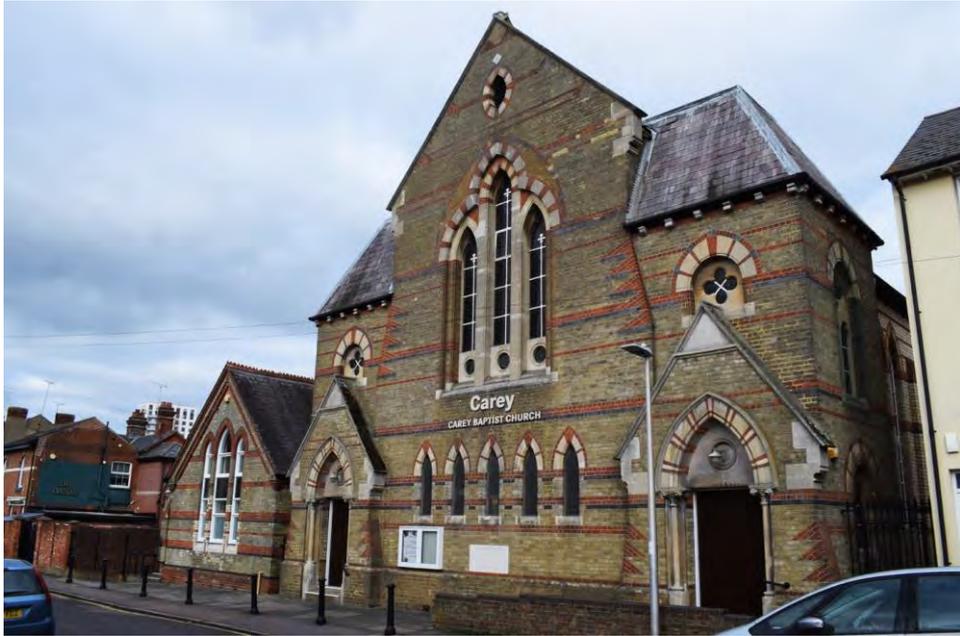
The Carey Baptist Church (opened 15th June 1871) along the street has an impressive polychrome frontage, is well maintained and provides a visual highlight along the street. Some interior details remain inside its main worship hall. The view to the backs of the large Georgian houses that front Castle Hill and the tall brick dividing wall along Carey Street is one of the more striking views from the street.

Figure 6.3.20 Carey Baptist Church chapel with its polychrome frontage, 1869 (David Neale)

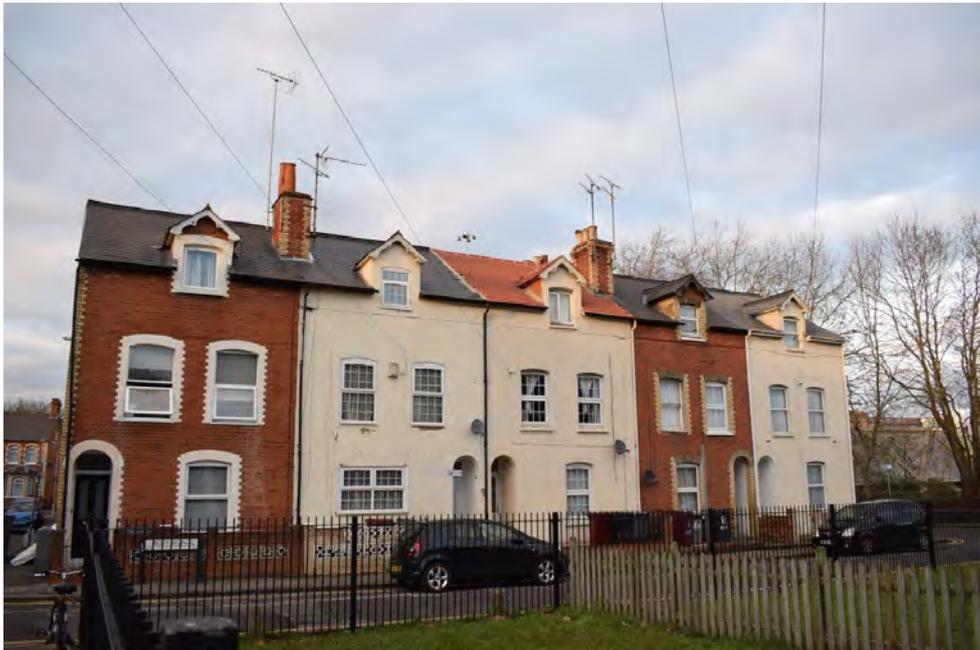
Figure 6.3.21 6-12 Body Road, the new red tile roof was installed in 2017 during the time protection of a conservation area did not apply (David Neale)

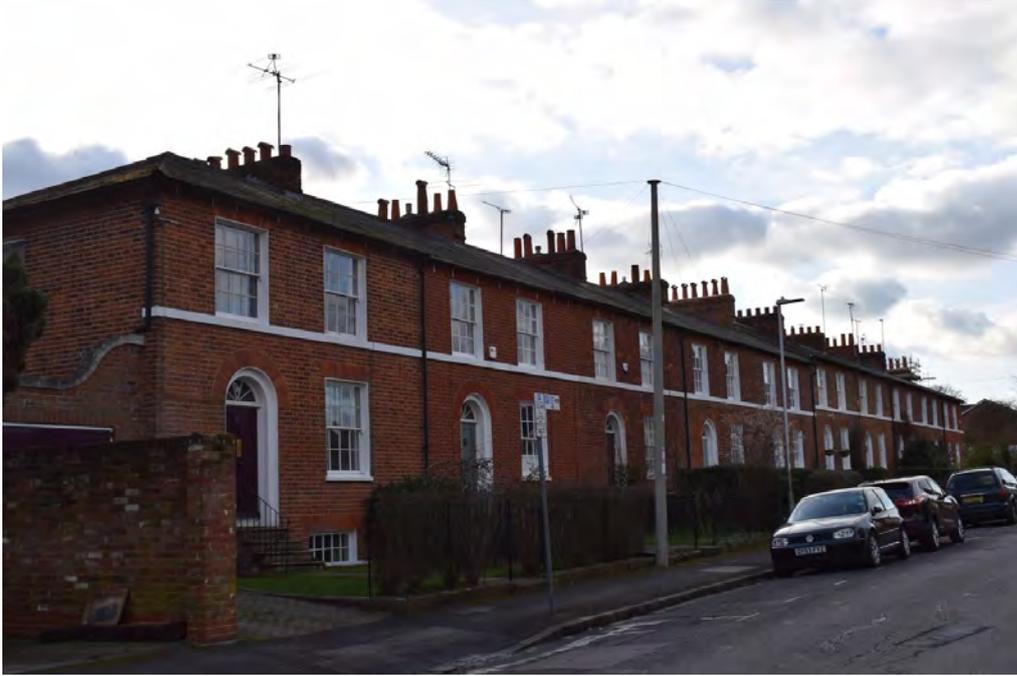
The Georgian terrace of houses at 61-79 Baker Street were the first buildings constructed in the late 1820s/ early 1830s. The features of the terrace are notable, with its classic and clean Georgian styling and its retention of original windows, doors and fanlights. The iron railings at no. 69 were recast from the original arrowhead railings that once existed along the terrace.

Figure 6.4.3 The listed Georgian terraced houses from 61-79 Baker Street, complete with original doors, fanlights and windows (Mark Worringham)

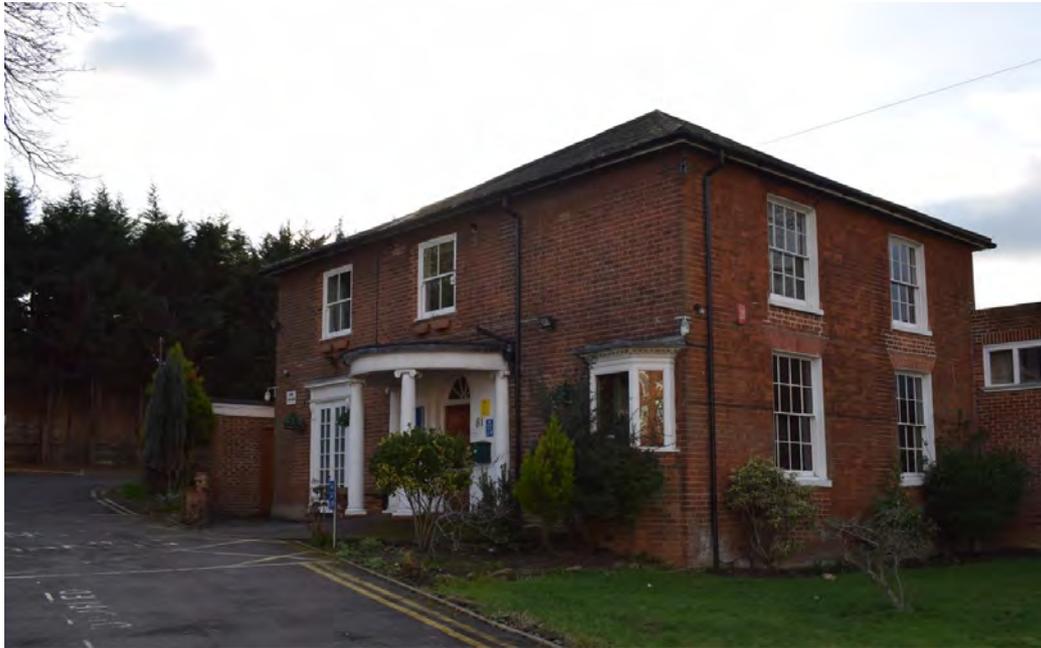
The National Spiritualist Church at 81 Baker Street, formerly York Lodge, is the only one remaining of three similarly scaled early 19th century villas. The surviving garden is a rare green space in the Conservation Area and provides a visual reminder of the unusual layout of these three villas wherein the entrance faced on to the garden and not towards the road, with a drive leading from Baker Street. The property has a garage built in 1925 with the initials of the owner – ALH (Arthur Lee Humphreys) – in the keystone.

Figure 6.4.4 The listed National Spiritualist Church, 81 Baker Street, originally York Lodge, one of an early 19th century group of three villas (David Neale)

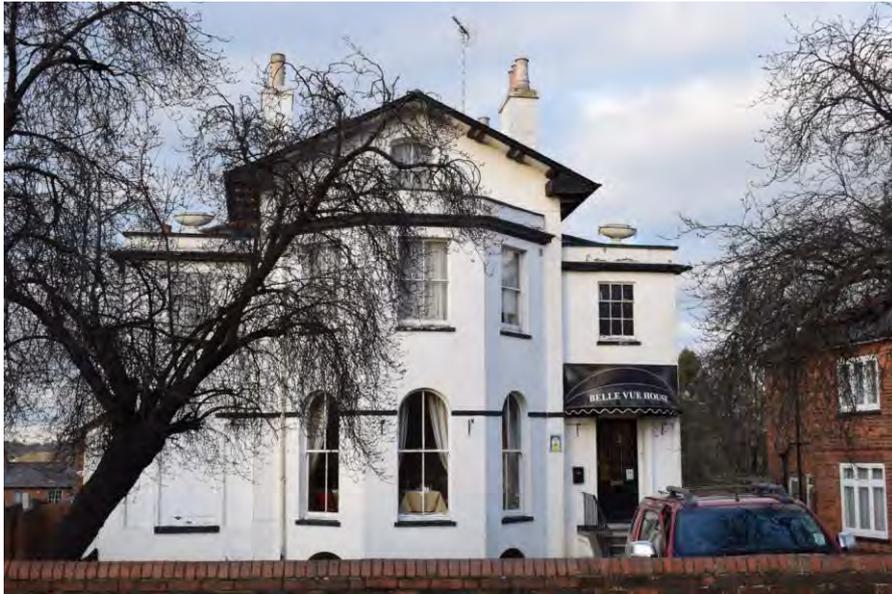
The Grade II Bellevue Villa is the only other remaining early estate house of this type in the character area and is located on Tilehurst Road. It functions currently as a bed and breakfast. Its exterior is reasonably well maintained, although the garden is given over to parking and could be more sensitively landscaped. It still retains original windows and has two Regency styled Coade stone decorative urns set on the roofline at each side.

Figure 6.4.5 *Bellevue House, 2 Tilehurst Road, built prior to 1839, listed, with decorative urns possibly of Coade stone. (David Neale)*

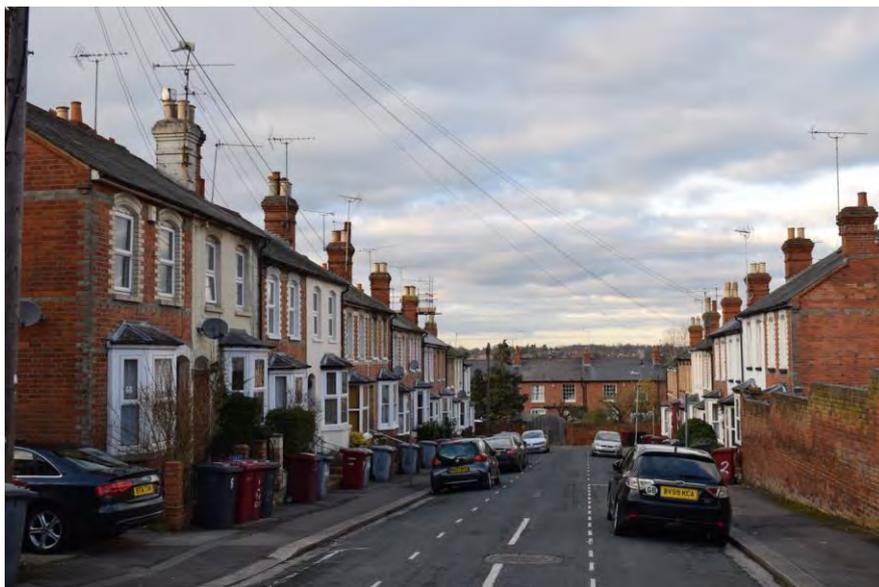
The short, quiet cul-de-sac of Belle Vue Road, was created prior to the 1890's from the side garden of Bellevue Villa. Belle Vue Road is associated with two-up, two-down, terraced polychrome houses creating a harmonious effect along both sides of the road. Regrettably, some of the façades have been painted, disrupting the once continuous polychrome detailing along the street. However, original windows have been retained on several properties and the doorways have attractive stone-arched in-set porches. There is still a fine high wall down the east side of Belle Vue Road separating the Villa from the development. At the far end of Belle Vue Road, the modern tarmac road surface has eroded to reveal several square metres of the original cobbles or sett stones, which were laid in a traditional fan pattern. This small bit of original paving is worthy of continued maintenance.

Figure 6.4.6 *Belle Vue Road, (c.1880-90) diminutive polychrome terraces with a high brick wall to the right separating the development from the original Bellevue Villa. The view is north to the backs of the listed 61-79 Baker Street and the Caversham escarpment beyond (David Neale)*

- Modern meeting hall attached to the Synagogue
- Overpainting of polychrome houses destroying the brick patterning on Franklin Street, Clifton Street and Belle Vue Road
- Overall poor condition of 1-9 Prospect Street and the larger dormer at no. 1

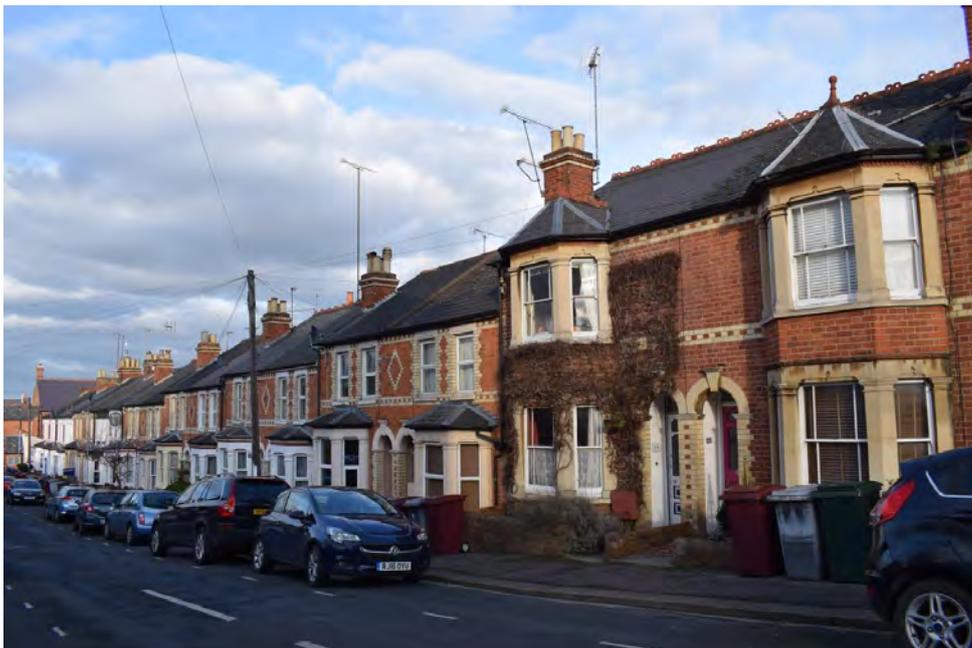
The west side of Clifton Street is largely mid-20th century terraced and semi-detached housing, with many that are attractive and well-cared for. Here, intact front walls and regular pavement lines preserve the finer street grain better than the irregularly fronted east side of Franklin Street does.

Figure 6.4.7 Terraced polychrome houses along Clifton Street, the ones to the south with double bay fronts (David Neale)

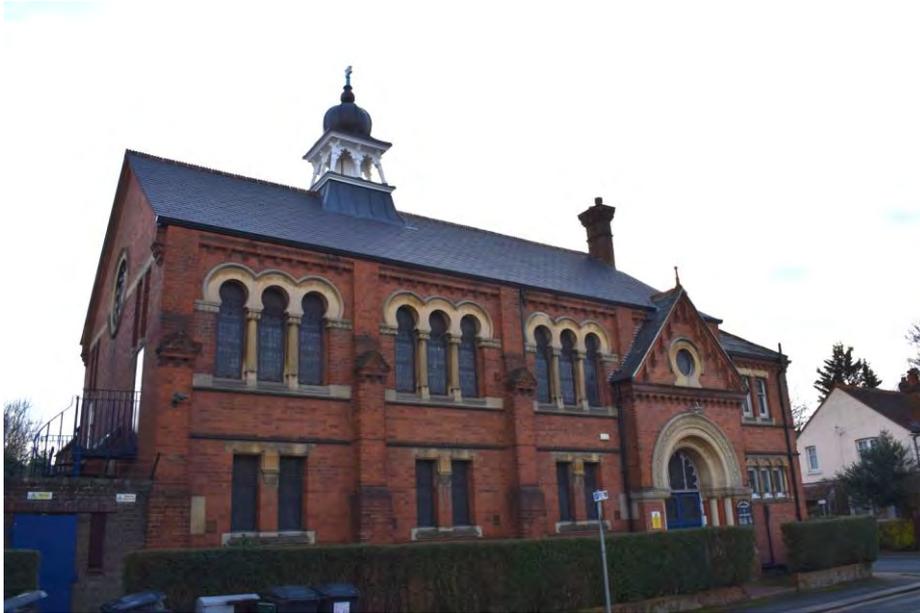
Reading Synagogue in Goldsmid Road is Grade II listed in recognition of its significance and high quality. It dates from 1900 and is a fine expression of Moorish design in polychrome brickwork and stone, topped with a wood and lead cupola. Whilst the original synagogue is one of the Conservation Area's finest buildings, the 1950s Sir Herman Gollancz Hall attached to the original building, facing Clifton Street is out-of-keeping stylistically, and if redevelopment were to take place on the site, a building more respectful of the impressive structure that it is attached to would be advised.

Figure 6.4.9 Listed Moorish style synagogue with fine brick and stone detailing and bell tower, Goldsmid Road at the corner of Clifton Street (Karen Rowland)

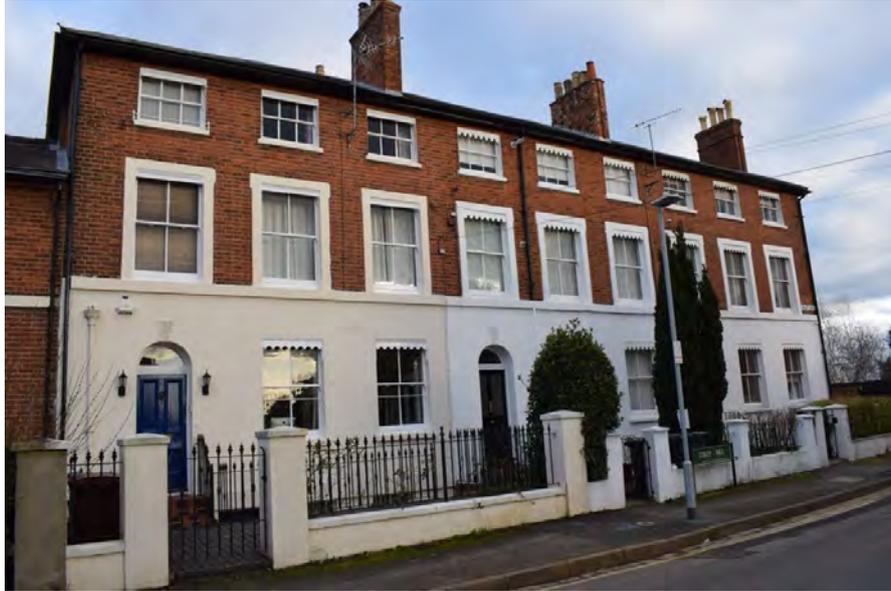
Coley Hill dates to circa 1820, with a grouping of fine, varied Georgian terraces along the east side of the street. These terraces are predominantly red brick, though some have stuccoed façades. Many of the houses have original railings, doors and arched windows that add to the heritage significance of these buildings. The survival of some of these details is at greater risk as several of these large buildings, subdivided into flats for multiple-occupation use, are showing signs of poor maintenance.

Figure 6.5.3 31-35 Coley Hill, stuccoed lower ground floor and later Victorian trimmed windows, 1820-30s (David Neale)

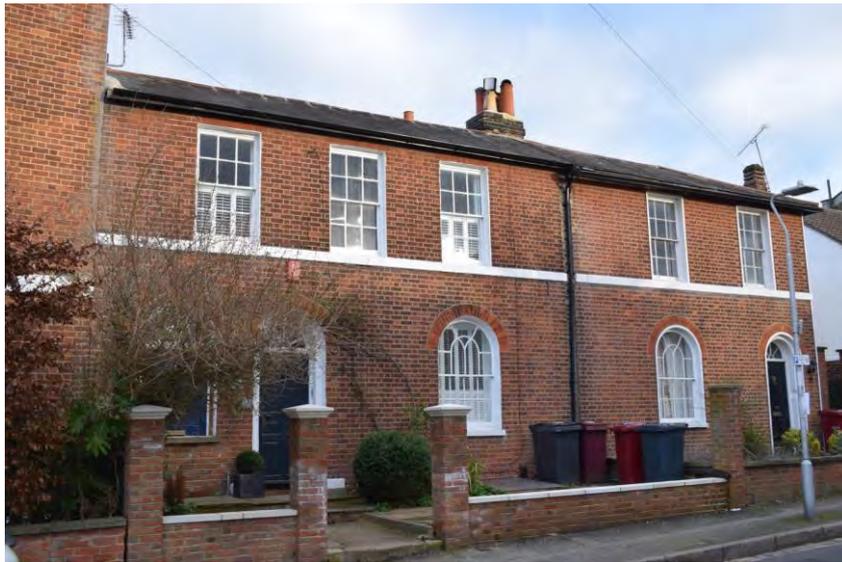
Figure 6.5.4 Arched windows and fanlights on two storey Georgian houses, Coley Hill (David Neale)

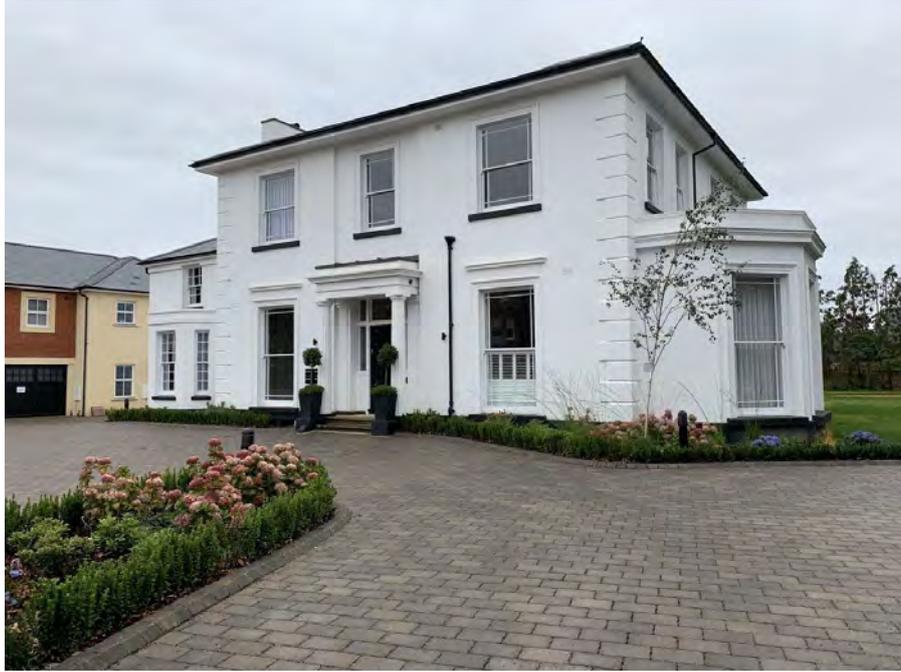
Number 3 Castle Crescent which dates from c. 1835-1840, is notable for the size of its intact original garden area. Several TPO trees screen the southwestern perimeter at the rear of the site. Despite recent renovation, additions to the main house and large mews-style building additions to the plot layout, it remains one of only a few substantial detached villas within the Conservation Area whose grounds reflect their large original garden layout.

Figure 6.5.5 3 Castle Crescent after recent renovations (David Neale)

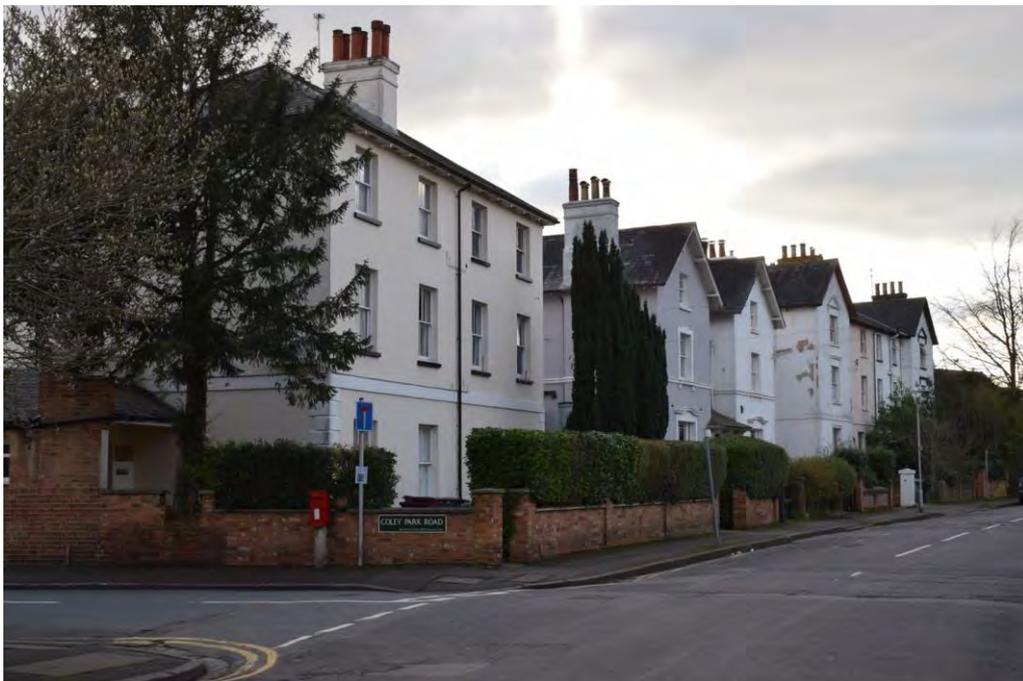
Figure 6.5.6 Stucco 3-storey houses- south side of Castle Crescent near Coley Avenue, c. 1840 (David Neale)

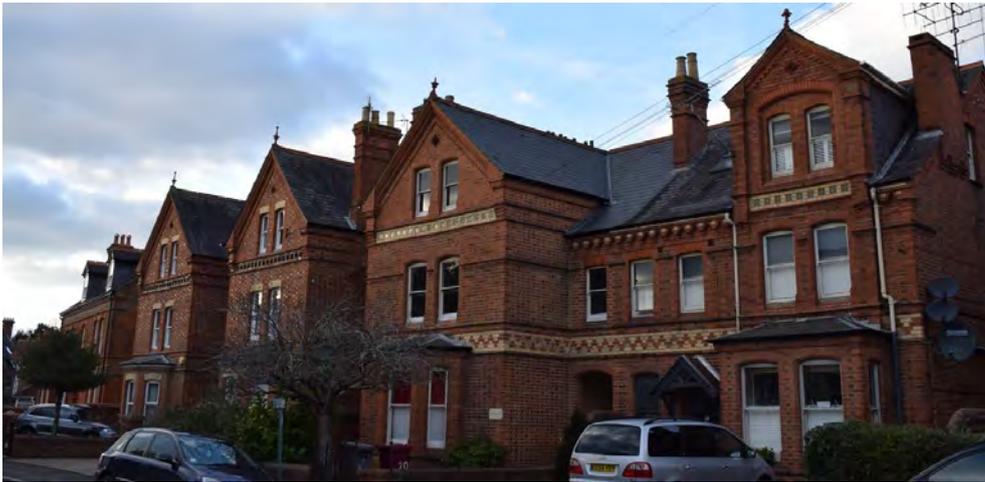
The later Victorian properties, c. 1880-1900, on Castle Crescent and Mansfield Road date from a single wave of development and are noted as an impressive collection of villas. Each is individually detailed with polychrome, stone, and tile embellishments and many maintain their brick boundary walls. Many are in multiple occupancy and numerous front gardens have been hard-surfaced to provide off-street parking which is detrimental to the original

layout of the sites. However, the properties are otherwise well-managed and maintained, which contributes to the streets' still grand appearances.

Figure 6.5.7 Polychrome houses along the north side of Castle Crescent (David Neale)

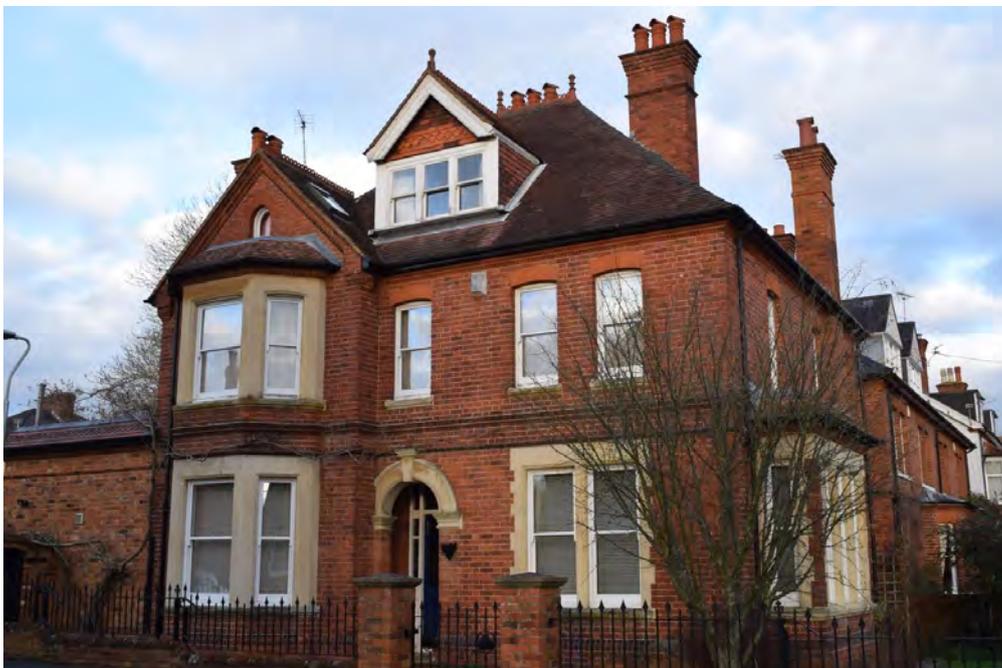
Coley Park Road links Mansfield Road to Castle Crescent and the attractive high red brick walls along the road link the two streets together in a unified appearance. The modern infill along this short road is of a sensitive design in terms of massing, materials and detailing and the brick walls help to harmonise with historic built environment. In the same way as the red brick walls located along Coley Avenue, Castle Crescent and Mansfield Road unify the appearance of the entire area, the red brick walls of Coley Park Avenue are worthy of further protection.

Figure 6.5.8 Attractive stone and tile house at the corner of Mansfield Road and Coley Park Road (David Neale)

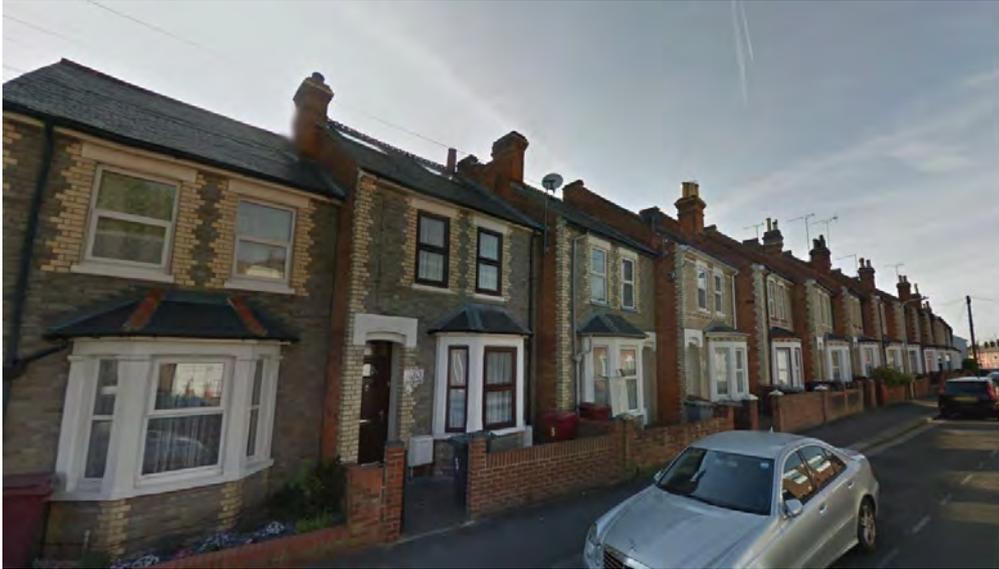
The small, artisan terraces along the east side of Field Road date to circa 1900 and their façades are decorated with three distinct polychrome colour patterns. The terrace is un-

painted, attractive and well maintained, despite an almost total loss of original windows. The polychrome brick patterning is worthy of further protection. These features of 3-49 Field Road are subject to an Article 4 direction, dating from January 1986. The modern housing and business premises detract from this view along the west side of the street. There are fine views from Field Road below, up to the gardens and backs of the large Georgian terraces along Coley Hill along the edge of the chalk and clay ridge.

Figure 6.5.9 Field Road polychrome terrace (Google Maps)

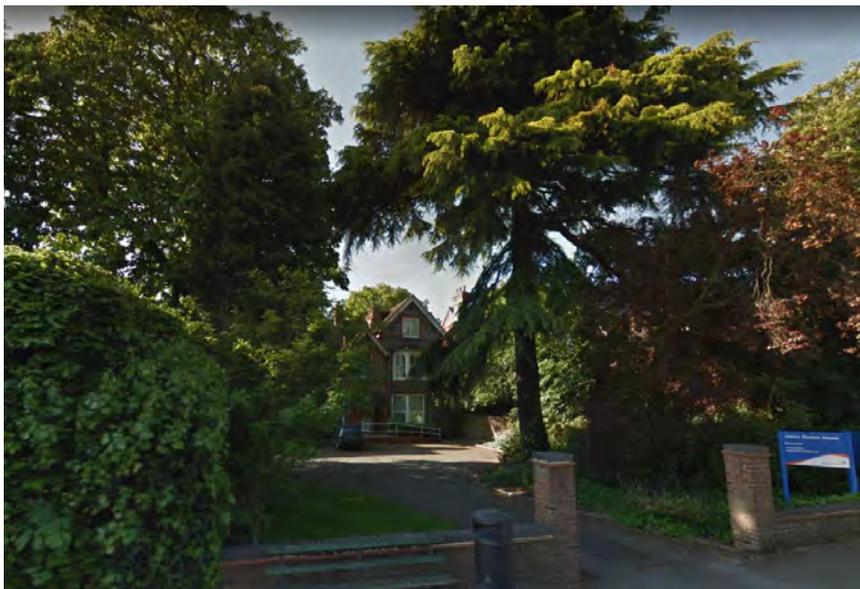
5, 7 and 9 Bath Road, date from c.1880-90 and were incorporated into the Conservation Area in the 2004 Appraisal. Each has a similar appearance to the villas of the same time period on Castle Crescent. The houses are set back from Bath Road, following a similar alignment to the grand housing present on the road earlier in the 19th century. These polychrome brick properties have attractive, deep front gardens with striking trees that are safeguarded by TPO's.

Figure 6.5.10 Large polychrome villa set back amongst striking TPO trees, Bath Road (David Neale)

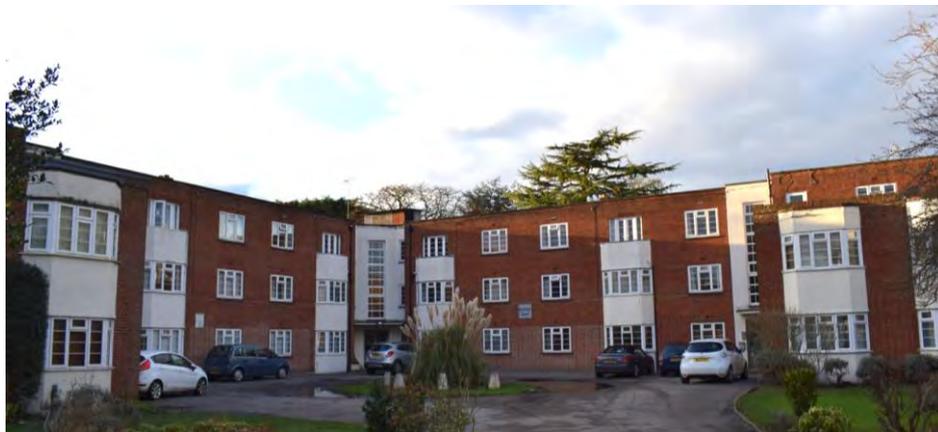
The listed building at the south east corner of the junction of Castle Crescent and Coley Avenue functions as a bed and breakfast but is poorly maintained. The mid-20th century Berkeley Court opposite, is set well back in an attractively kept garden. Its rear portion is the former entrance of an earlier manor house on the site. Newer windows detract from its otherwise attractive mid-20th century design, which is unique to the area.

Figure 6.5.11 The mid 20th century Berkeley Court, Coley Avenue (David Neale)
