STRATEGIC ENVIRONMENT, PLANNING AND TRANSPORT COMMITTEE 16 MARCH 2020

<u>WARDS AFFECTED</u>	<u>Page No</u>
10. ADOPTION OF THE CASTLE HILL/RUSSELL STREET/OXFORD ROAD CONSERVATION AREA APPRAISAL - APPENDICES 2 TO 4	ABBEY; BATTLE; MINSTER	3 - 160

APPENDIX 2: STATEMENT OF CONSULTATION ON CONSERVATION AREA APPRAISAL FOR THE RUSSELL STREET/CASTLE HILL CONSERVATION AREA

Initial Statement

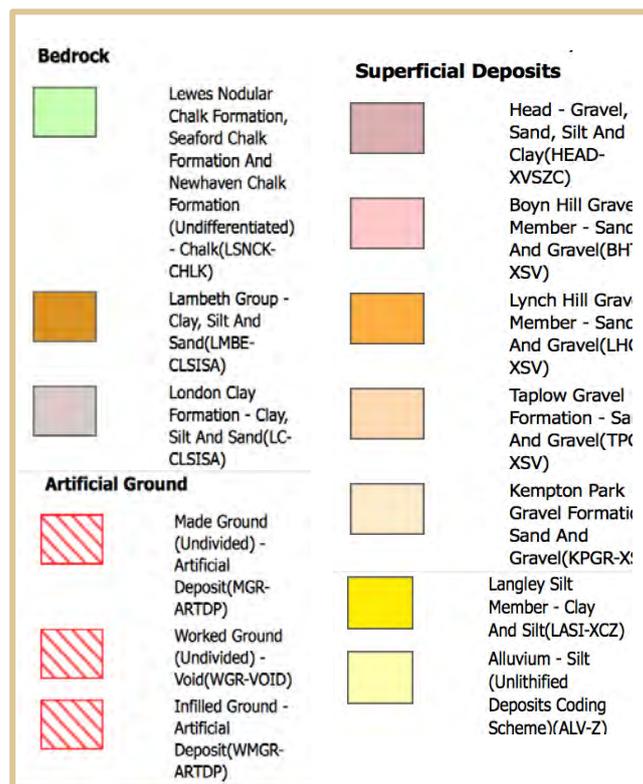
Figure A2.1 Geology of the area (Conservation Area outline approximate)

The area sits atop a high mound of clay, silt and sand covering most of the southern portion of the conservation area. Castle Hill sits along the high ridge of that clay. As the land falls away from this ridge towards the north and to the south east, the clay ridge gives way to underlying chalk. The northern most part of the conservation area is made up of sand and
