Reading Flood Investigation - January 2024

Flood Investigation Report – Full Version

On behalf of **Reading Borough Council**

Project Ref: 332611243/001 | Rev: AA | Date: May 2024

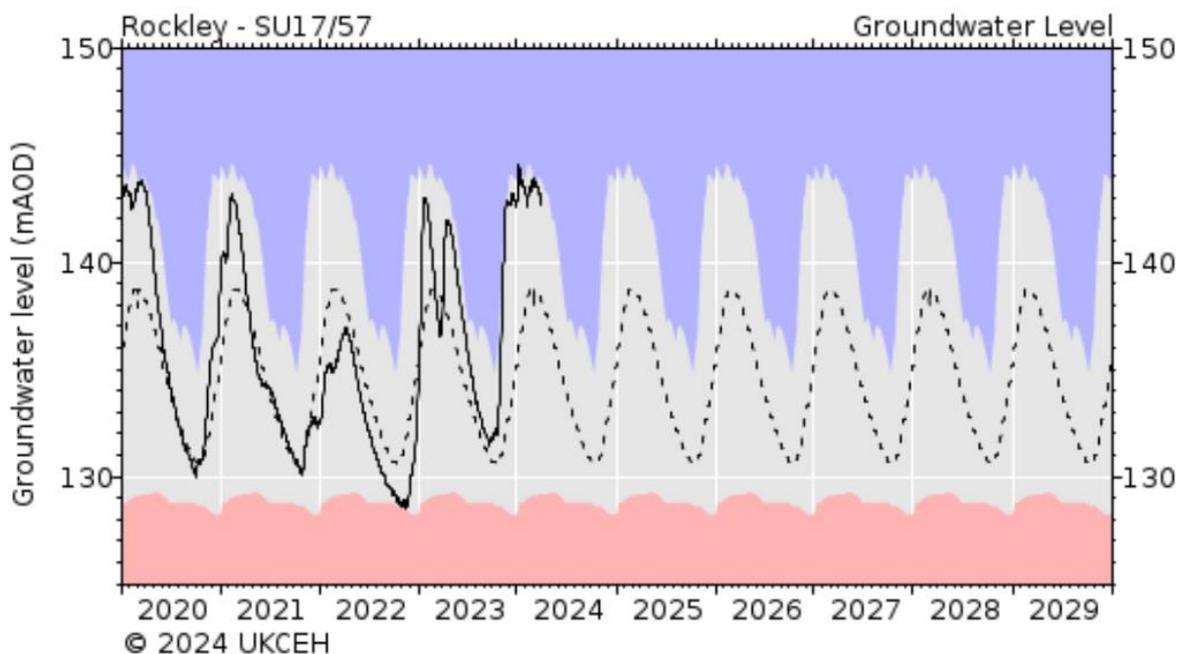
Figure 2-1: BGS/UKCEH graphical representation of groundwater levels at Rockley borehole, 2020-2024

- 2.6.3 The groundwater monitoring borehole at Rockley (ID: SU17/57) is located in a chalk valley north-west of Marlborough, within the upper Kennet catchment. Groundwater levels are recorded by the UK Centre for Ecology and Hydrology (UKCEH) and reported by the British Geological Survey (BGS). BGS records note significant evidence of surface water - groundwater interaction at this borehole location and provide a graphical representation of groundwater levels per decade, where the grey area represents the area between the highest and lowest levels ever recorded, and the black dotted line represents an average level. **Figure 2-1** shows data from the 2020s thus far.

- 2.6.4 Groundwater levels are expected to rise between autumn and spring as part of normal seasonal variations, but it is notable that groundwater levels rose particularly steeply from a just above average level in October 2023 to almost the maximum level ever recorded (purple area) in late December/early January 2024. Data from previous decades shows a similar rapid peaking of groundwater levels in December/January 2002/3 and 2013/14, which coincides with previous significant flood events in the region.

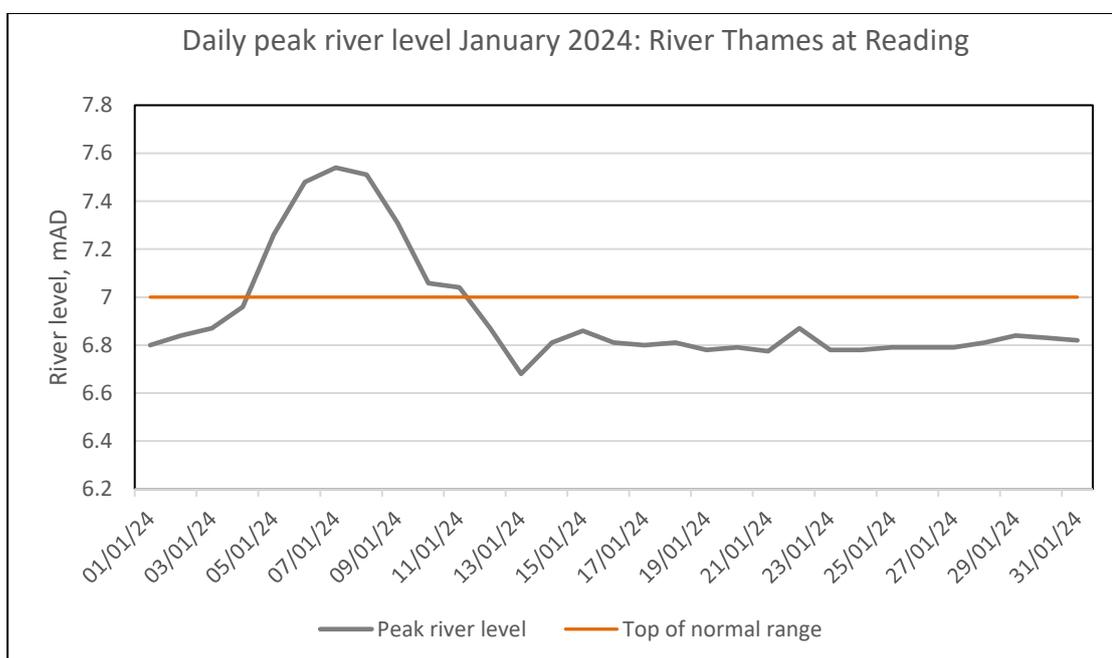
Figure 3-1: River levels in Central Reading recorded at River Thames at Reading gauge, January 2024

3.1.2 The water level at the 'River Thames at Reading' river level gauge has a normal range of up to 7.00m above local datum (AD), with flooding of low lying land considered to be possible above this level, and property flooding possible when levels exceed 7.25m AD. This level was exceeded on 5th January 2024 with a recorded level of 7.26m AD, peaking at 7.54m AD on the 7th January, and returning to a level consistently below 7.00m AD on the 11th January, as shown in **Figure 3-1**.

3.1.3 The previous highest ever recorded river level at this gauge was 7.41m AD, which was recorded on 4th January 2003. This level was exceeded from 6th – 8th January 2024.

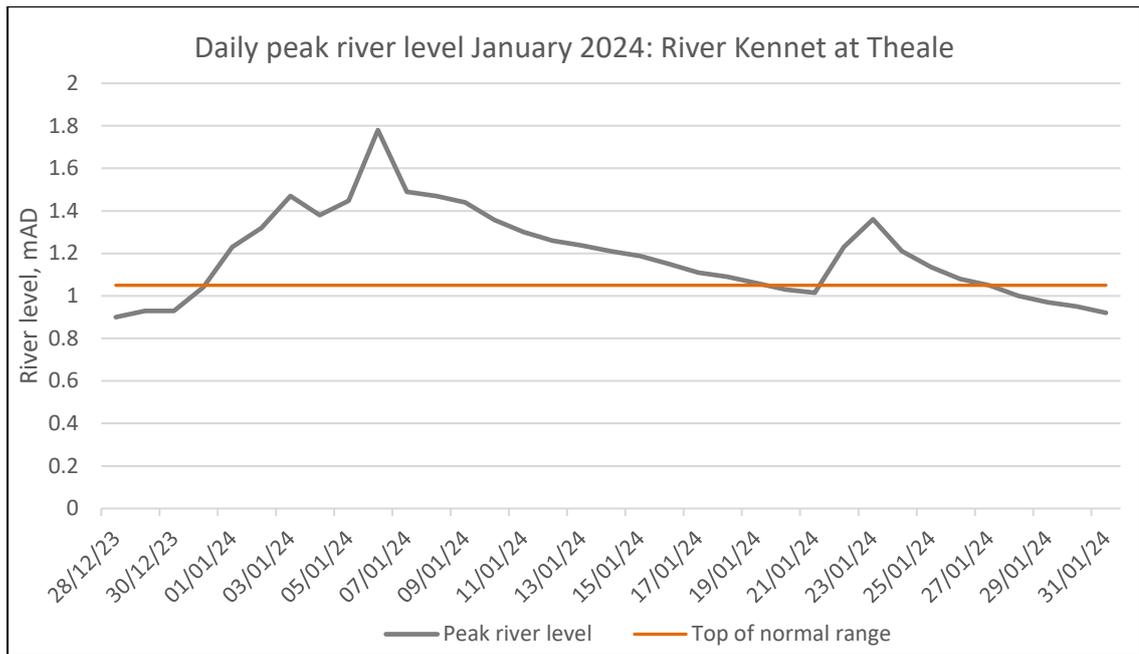
Figure 3-2: River levels upstream of Reading recorded at River Kennet at Theale gauge, January 2024

3.1.5 The water level at 'River Kennet at Theale' gauge has a normal range of up to 1.05m AD. **Figure 3-2** shows that this level was exceeded on 1st January 2024 and rose to a maximum level of 1.78m AD on 6th January 2024, a notable level rise of 0.33m from the previous day's peak level. Water levels in the River Kennet remained consistently above the normal range from 1st - 27th January 2024, other than a brief fall to levels of just over 1.00m AD from 20th -21st January.

- 3.1.6 The previous highest ever recorded river level at the River Kennet at Theale gauge was 1.65m AD on 15th February 2014. This level was exceeded on 6th January 2024.
- 3.1.7 River levels and flood extents in the January 2024 flood event were compared to previous major flood events and available flood mapping and modelling data, to establish the probability of the flood event. This was estimated to be between a 1 in 30 and 1 in 50 year (2% – 3.3% annual probability) flood event and it is represented in **Figure 3-3**.

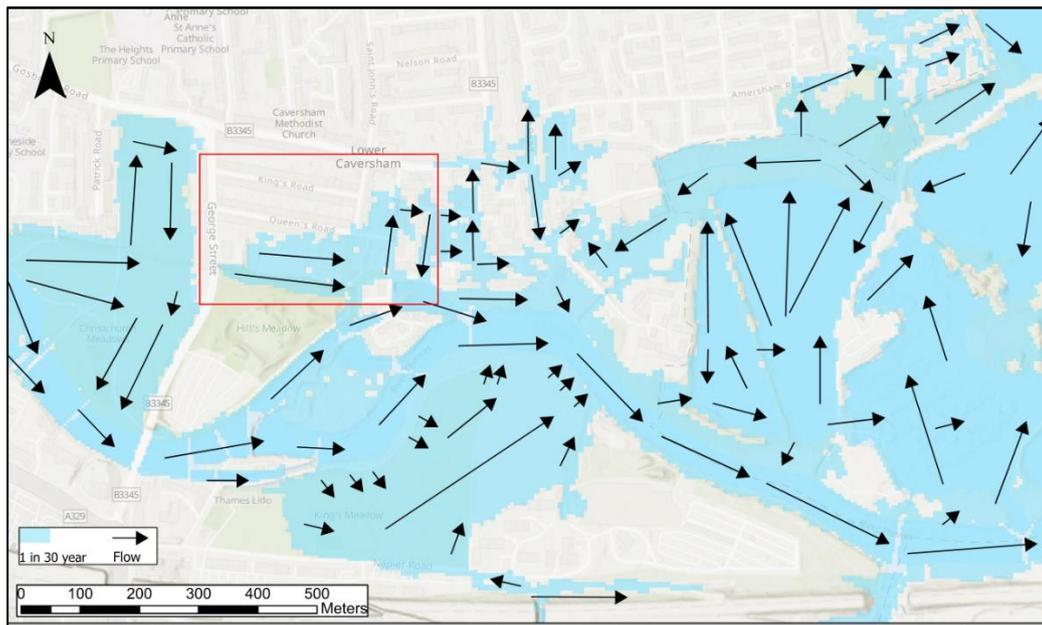
Figure 3-4: Modelled flood flow paths for a 1 in 30 year flood event in Lower Caversham: EA River Thames (Pangbourne to Sonning) flood model

- 3.3.4 **Appendix A** contains a sketch of the flood flow path described above, provided by a resident of Queens Road. Stantec flood modelling, which was undertaken using the EA Thames (Pangbourne to Reading) 2019 hydraulic model for a 1 in 30 year event, confirms the resident's description of the flood flow path during the event and is shown in **Figure 3-4**. The area of Lower Caversham primarily affected by internal flooding is highlighted within the red box in this figure. A larger version of the figure is available in **Appendix F**

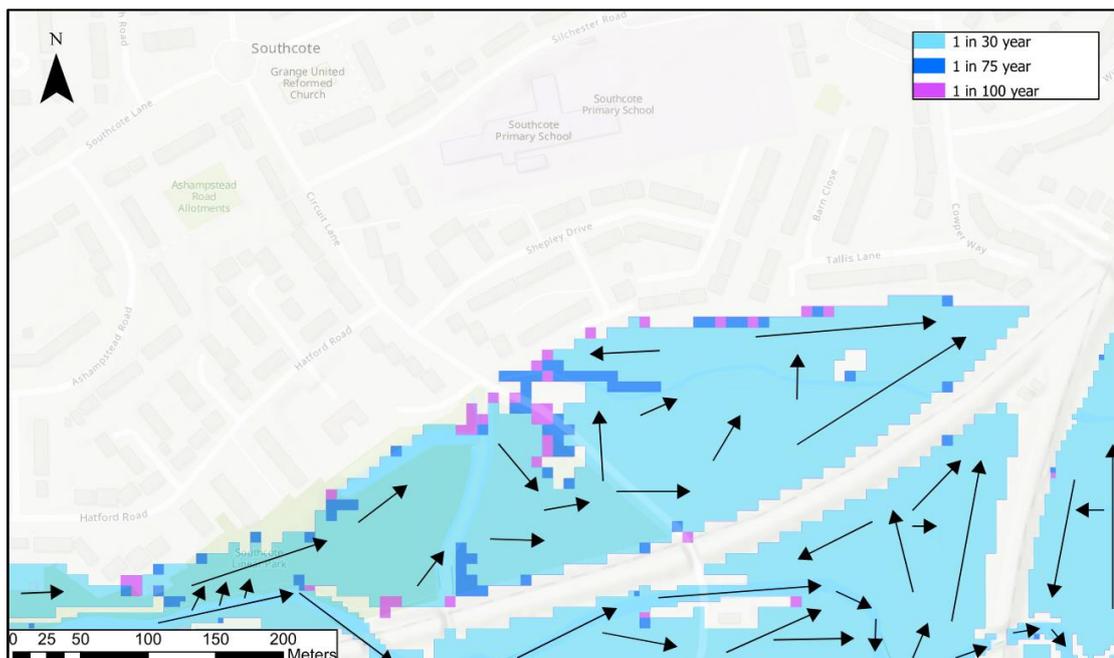
Figure 3-5: Modelled flood flow paths for a 1 in 30 year flood event in Southcote: EA Lower Kennet Tyle Mill to Thames Confluence flood model

- 3.4.4 Stantec modelling of flood flow paths undertaken using the EA Lower Kennet (Tyle Mill to Thames Confluence) 2018 hydraulic model for the 1 in 30 year flood event (**Figure 3-5**) indicates a potential for backflows from the floodplain towards residential areas, which supports the reports of local residents about flood mechanisms in this area.

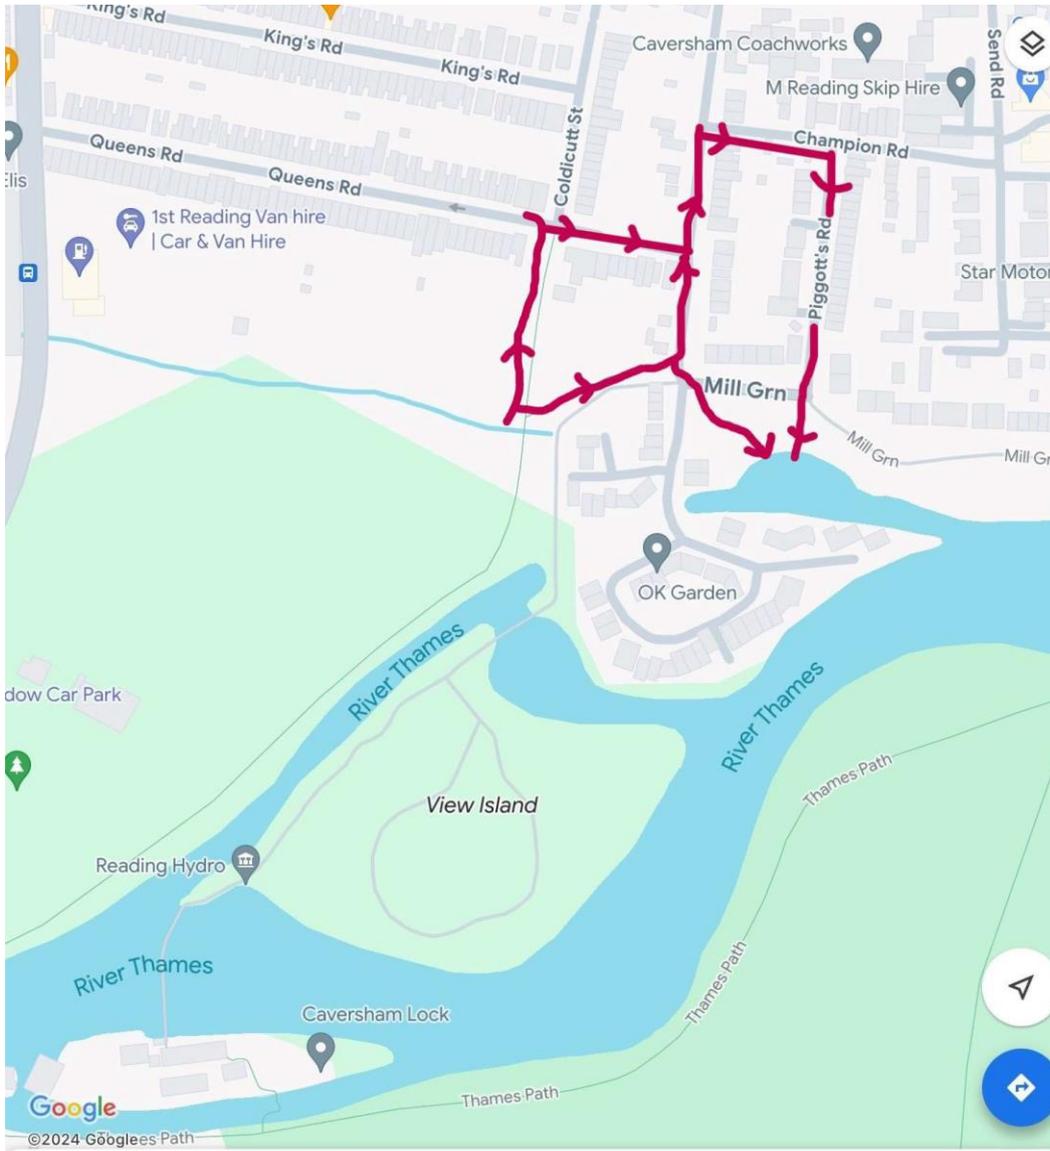
- 3.3.3 Residents at the eastern end of Queens Road reported flooding from multiple sources. The flooding to the rear of these properties was reported to arise from exceedance of the capacity of Christchurch Ditch, and debris causing blockages of culverts within the ditch. The flood pathway from Christchurch Ditch was recorded by a local resident as flowing via residential gardens, public footpaths and public roads into Queens Road, then extending northwards and eastwards to Mill Road, Coldicutt Street, Champion Road, Piggott's Road and Mill Green.

Information provided by a Queen's Road resident regarding the observed flow path of floodwater from Christchurch Ditch northwards into Lower Caversham:

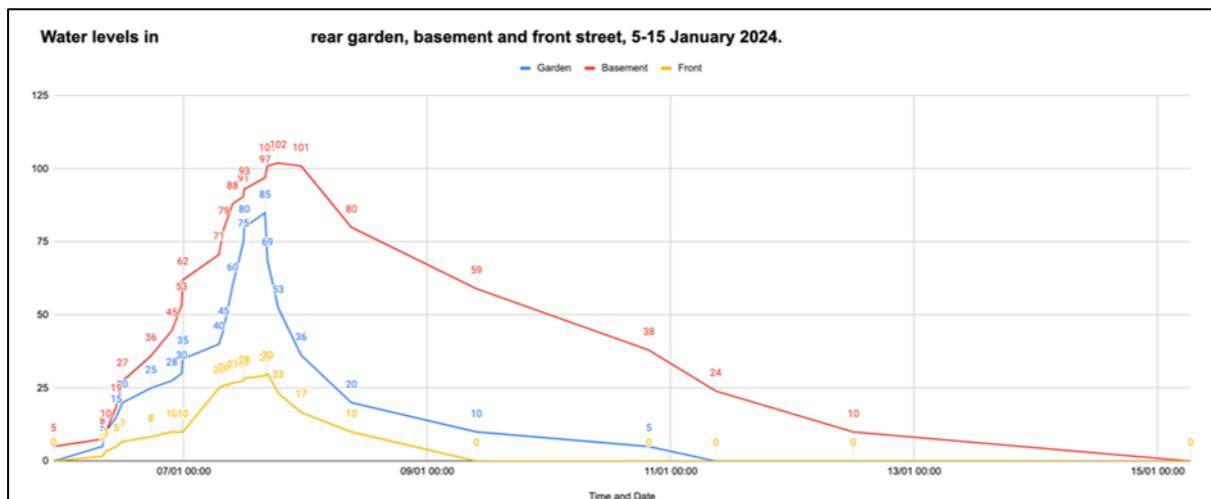
Information provided by a Queen’s Road resident regarding water levels in and around their property between 5th – 15th January 2024, and a timeline of flooding to their property and adjacent properties:

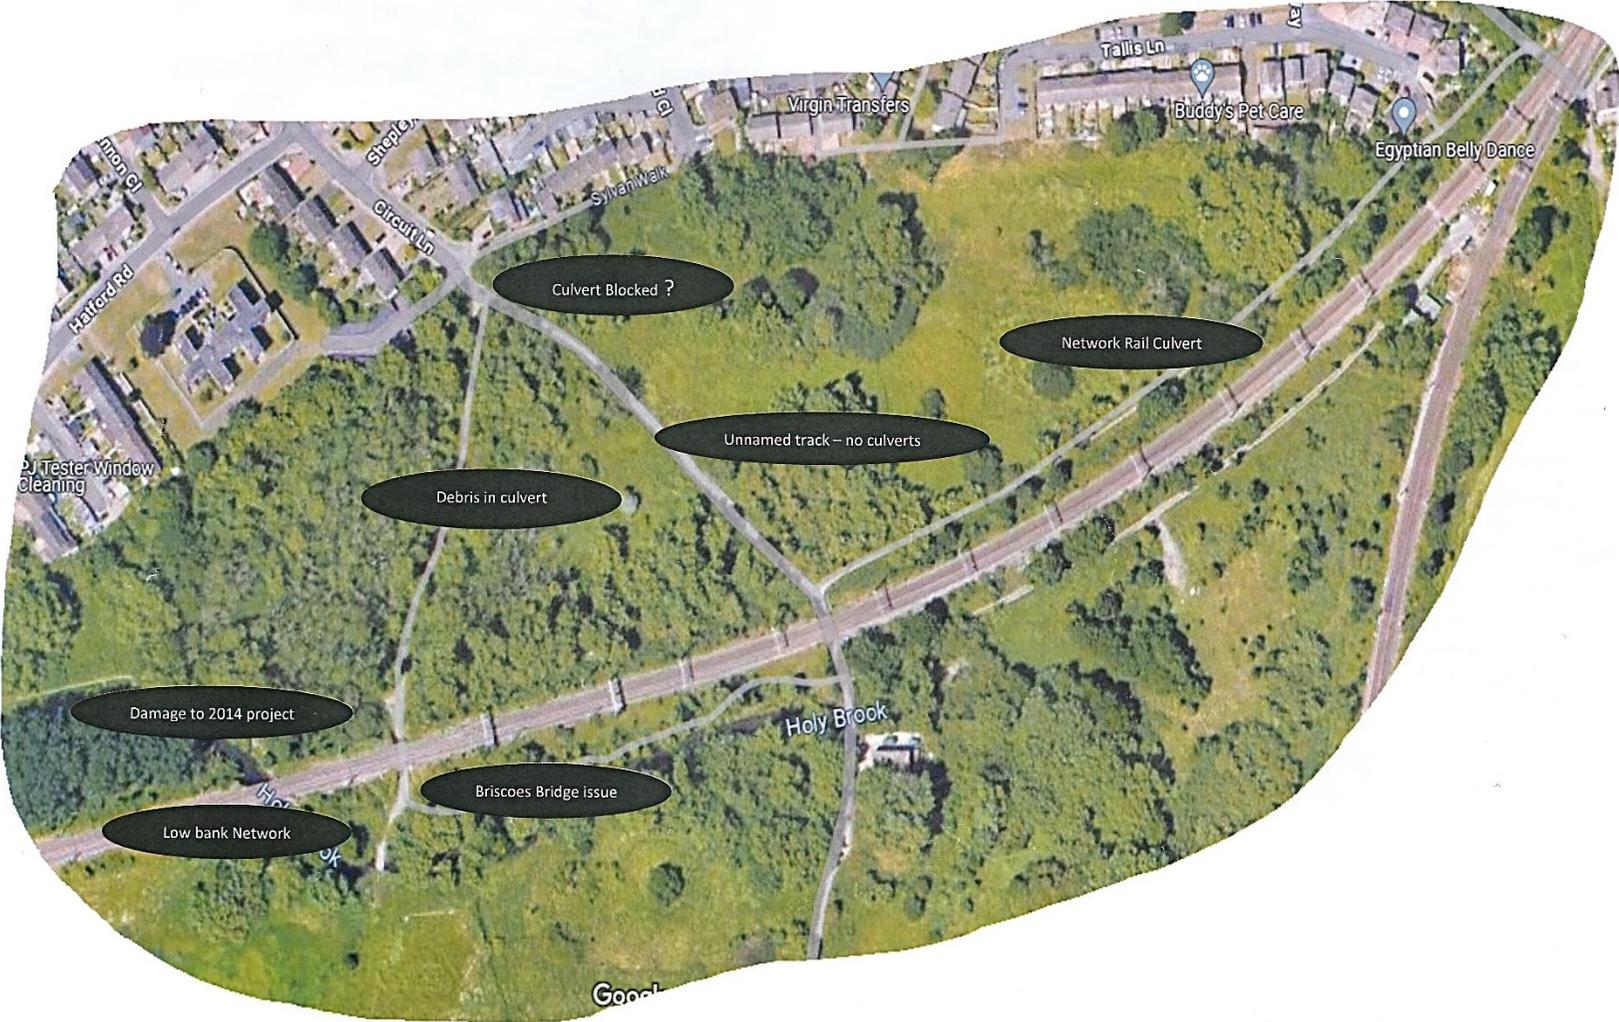
- Residents in Southcote noted that several ditches and culverts in the area around Circuit Lane did not appear to have been maintained for some time prior to the flood event, and that some banks and paths had been damaged/lowered by previous flood events. Residents reported that accumulated debris reduced the capacity of the local ditch network to hold and transport floodwater, leading to overtopping.

Information provided by a Southcote resident about ditches and watercourses impacted by recent and previous flood events to the south of Circuit Lane.

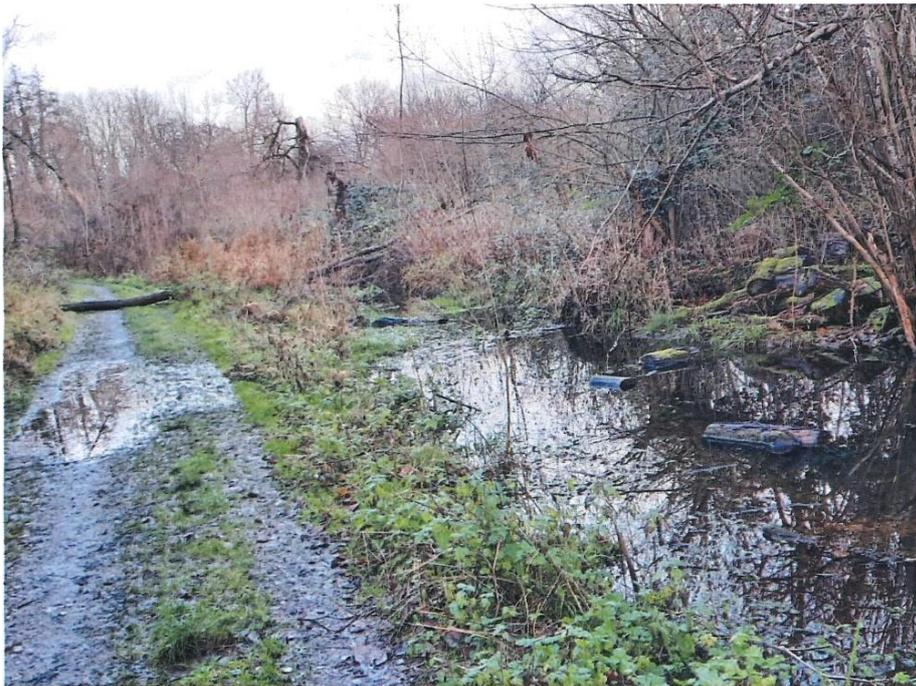
Debris build up north of railway bridge (Briscoe's Bridge), Southcote – 5th January 2024

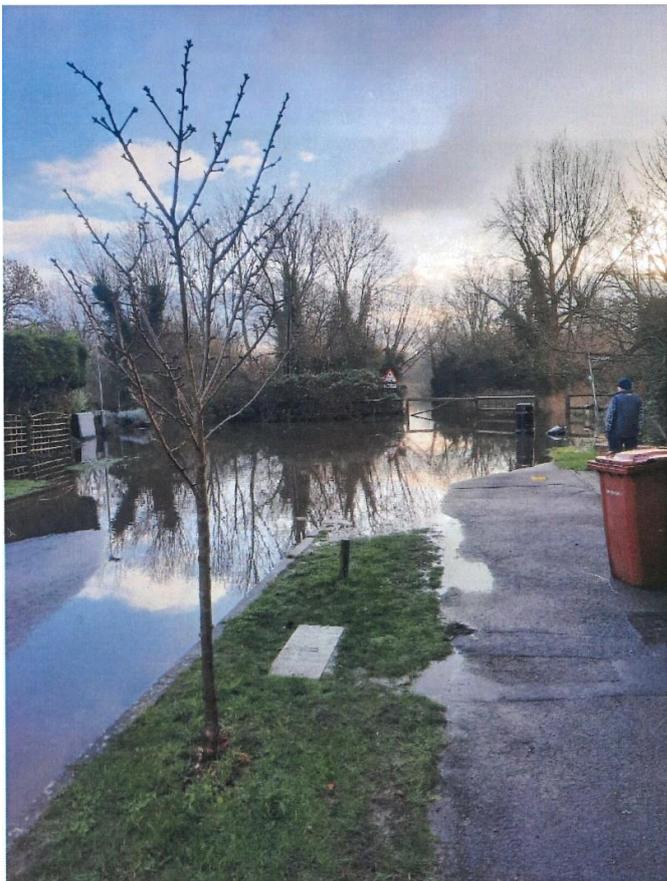
Flooding at southern end of Circuit Lane

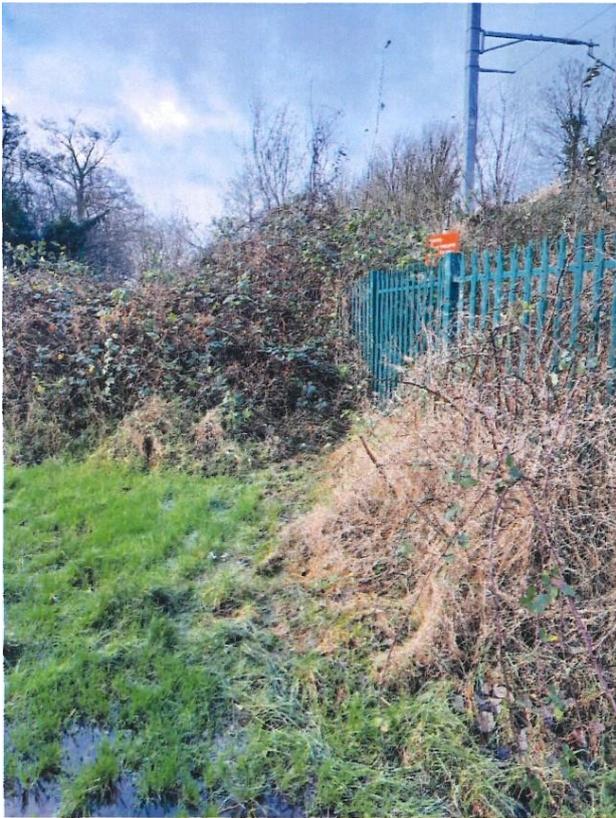
Network Rail low bank at Briscoe's Bridge.

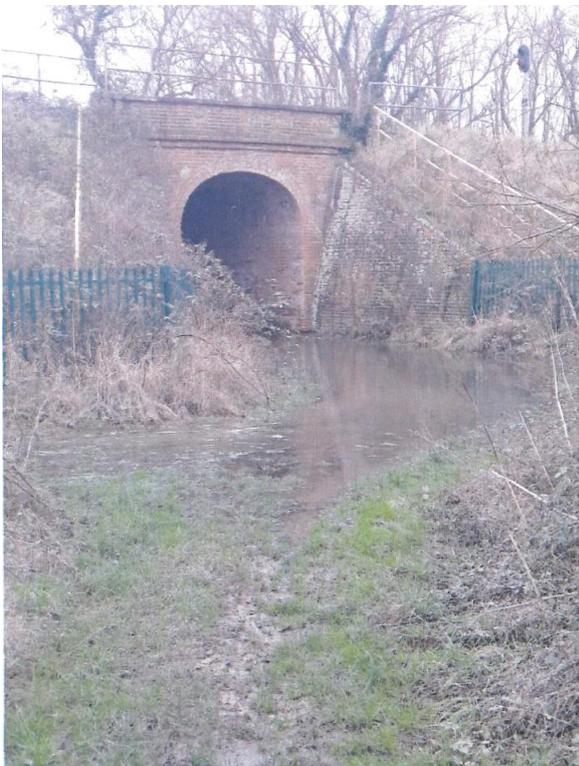
Water flowing from River Kennet flood plain northwards under Briscoe's Bridge.

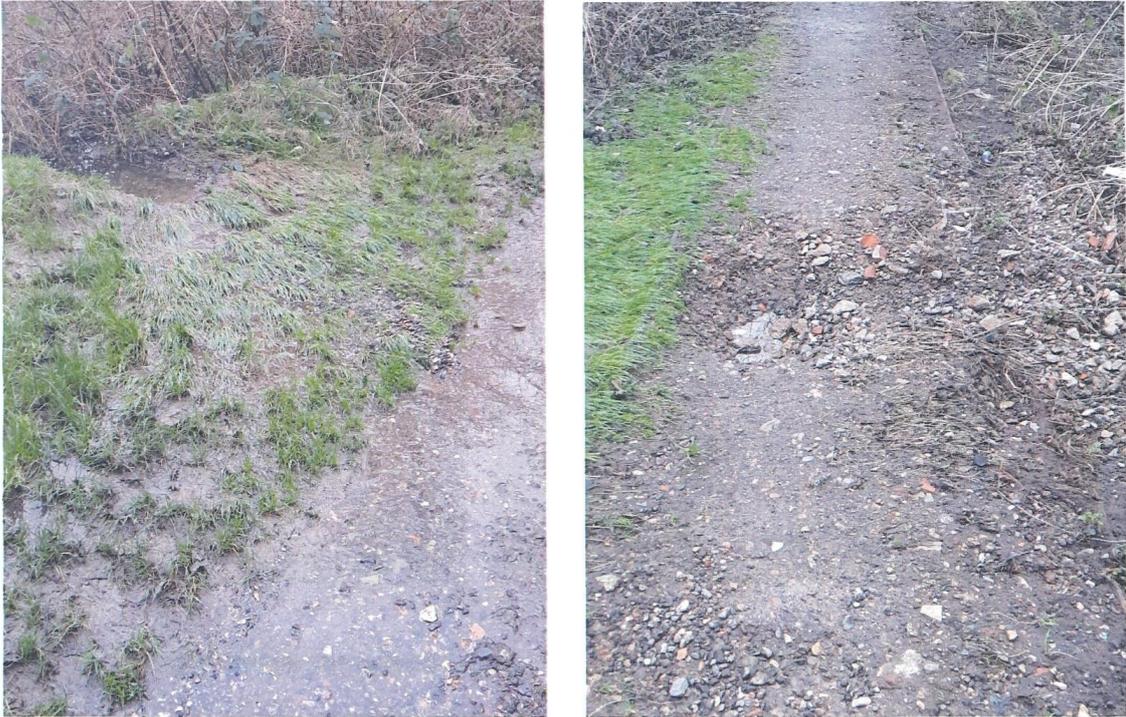
- 3.4.7 Four residential properties on Circuit Lane and Sylvan Walk reported internal flooding (ground floor) on 6th January 2024.
- 3.4.8 Collapse of bank and footpath damage to an area of the Holy Brook north of the railway line.
- 3.4.9 Flooding occurred at the allotment site south of Brunel Road, impacting on allotment holders.

Damage to post-2014 bank and path repairs near Holybrook overbridge, Southcote

- Further bank and footpath works to the Holy Brook and associated ditches will require consultation with and consent from the EA.
- Further investigation of requirements for ditch and culvert clearance, in consultation with relevant landowners, and providing reminders to riparian owners of their repair and maintenance responsibilities.

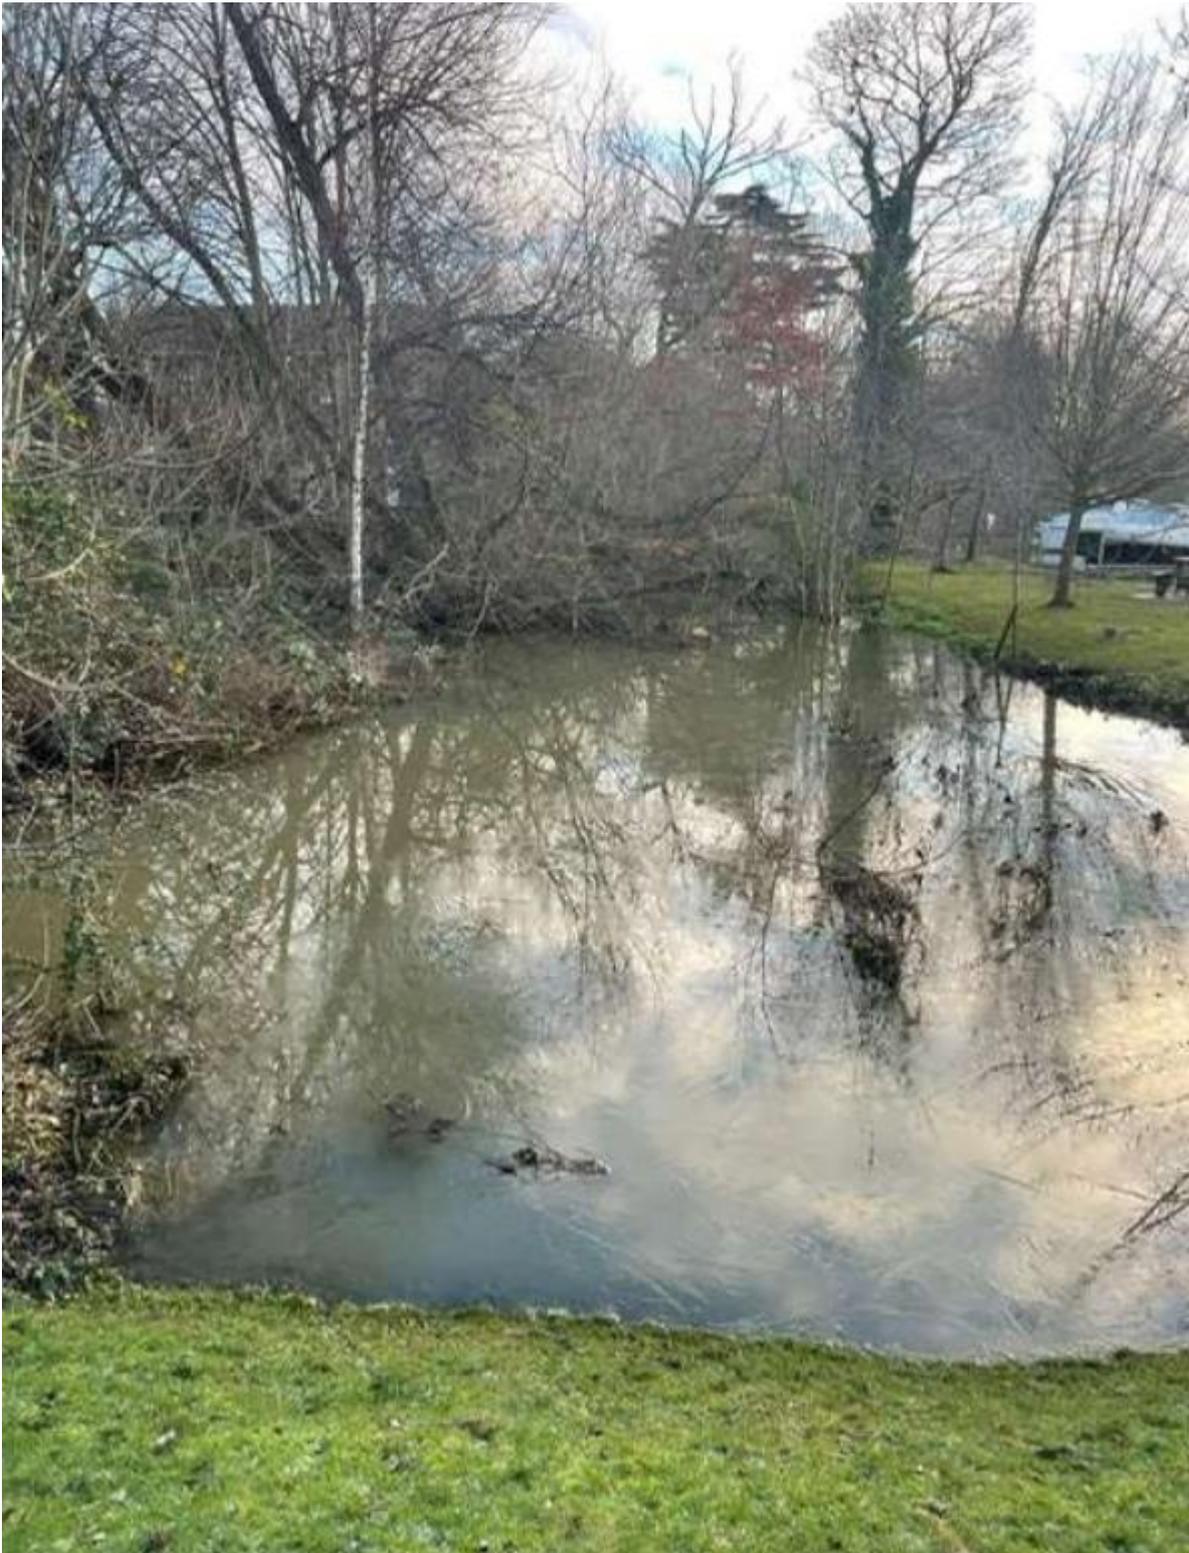
Outfall location of Christchurch Ditch at Heron Island. Access to outfall blocked by vegetation.

- CCTV drainage survey of the closed section of the Christchurch Ditch culvert from the footbridge at the eastern end of Hills Meadow to the Heron Island outfall point, to investigate its state of repair and capacity. The outfall structure at Heron Island is overgrown with vegetation and cannot be viewed at present. This will be subject to the agreement of the private landowners. There are also ecological constraints due to nesting swans in this area.

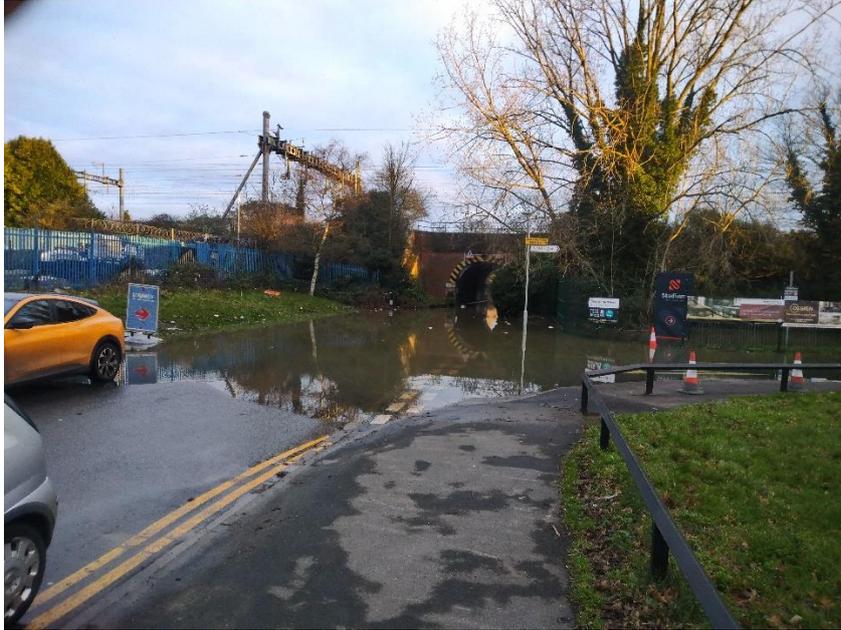
- 3.6.3 RBC staff visited affected residents living in park homes at Scours Lane. The entire site was observed to be flooded. One property at the site reported internal flooding and this is included in the total in paragraph 3.10.1.

Scours Lane at junction with Stadium Way, Tilehurst

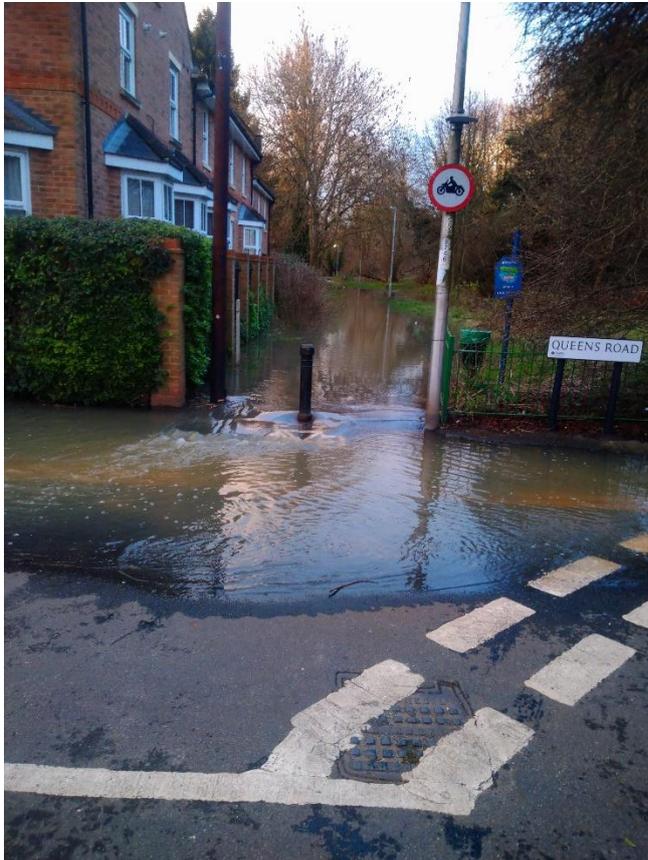
Queens Road opposite Coldicutt Street (facing south), Lower Caversham

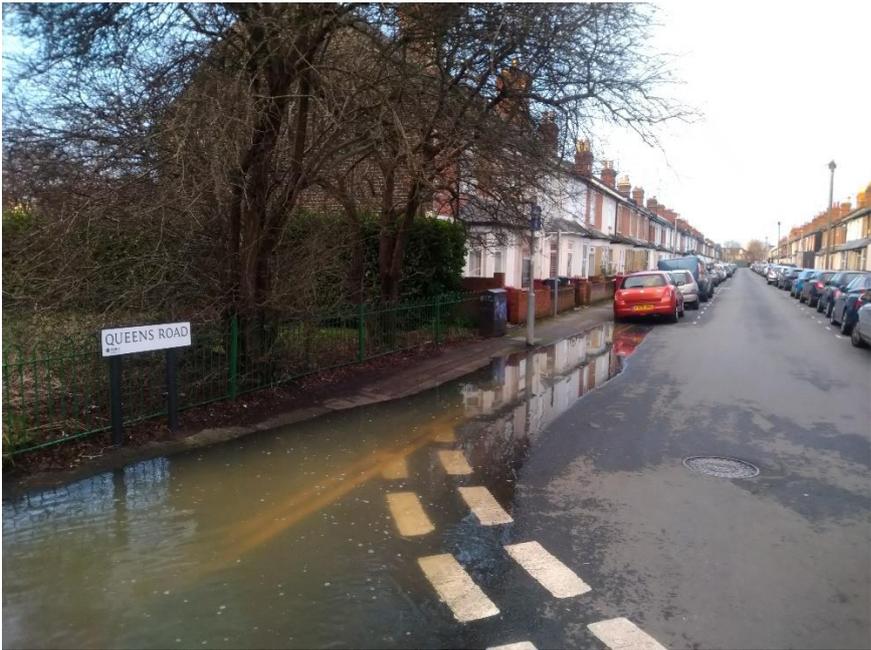
Queens Road opposite Coldicutt Street (facing west), Lower Caversham

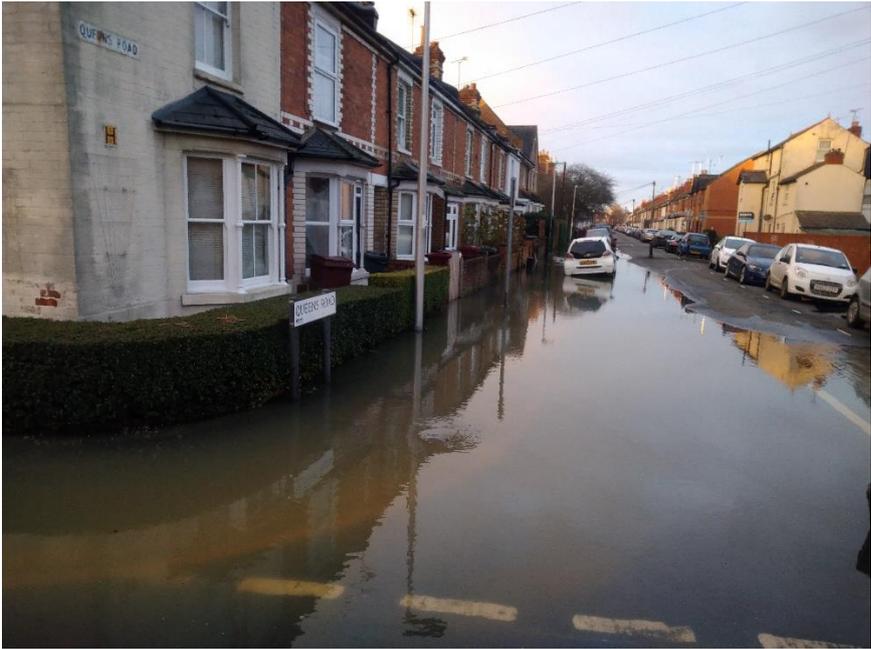
Queens Road/Mill Road junction, Lower Caversham

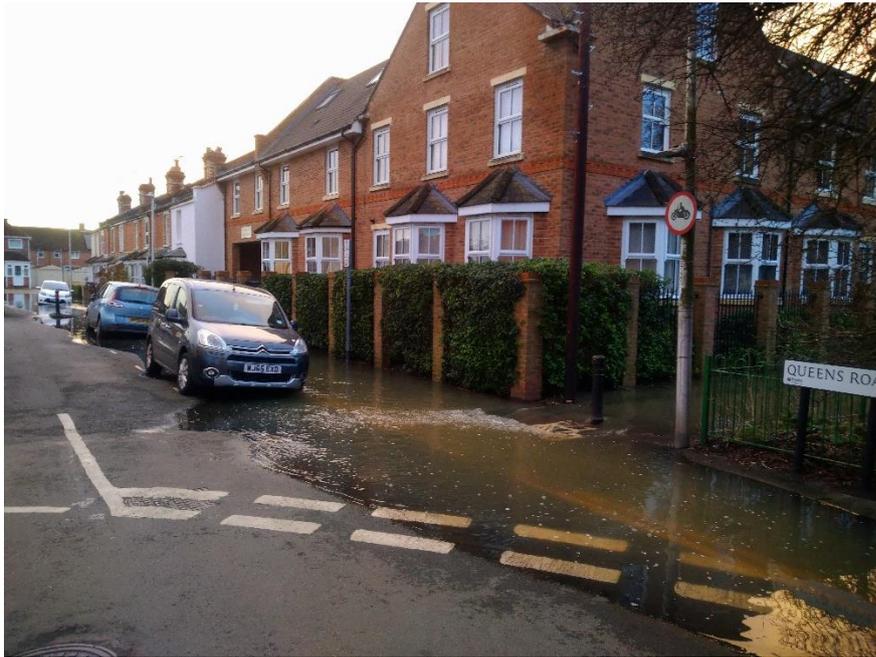
Eastern end of Queens Road (opposite Coldicutt Street, facing east), Lower Caversham

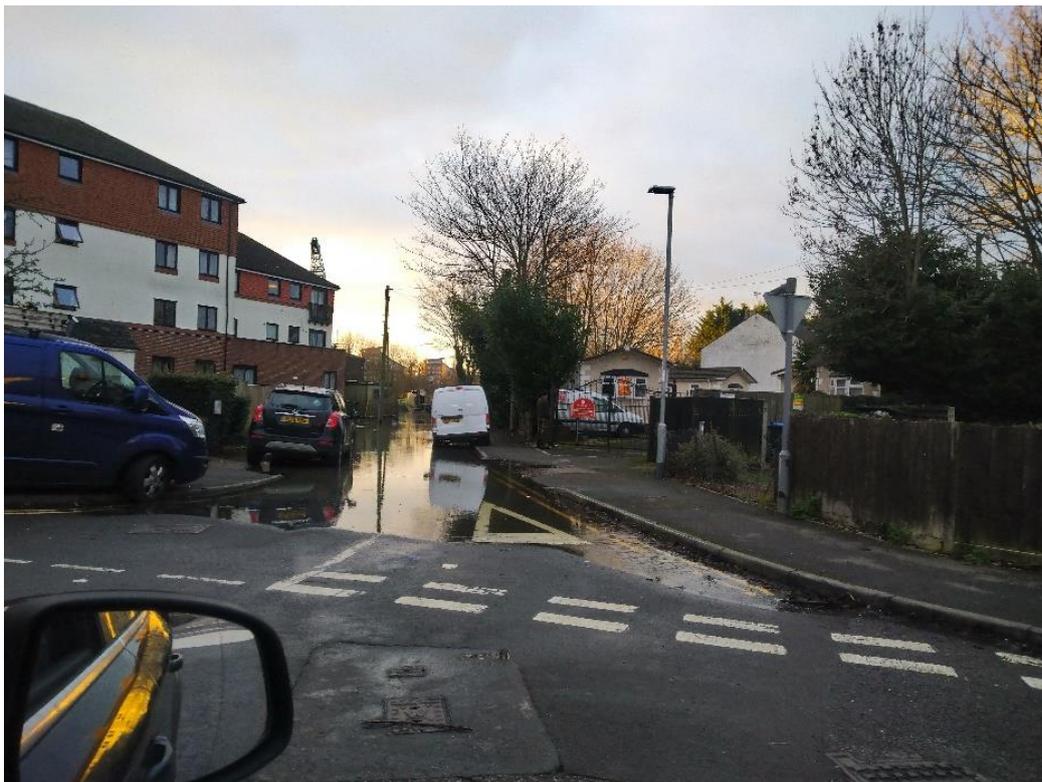
Mill Green, Lower Caversham

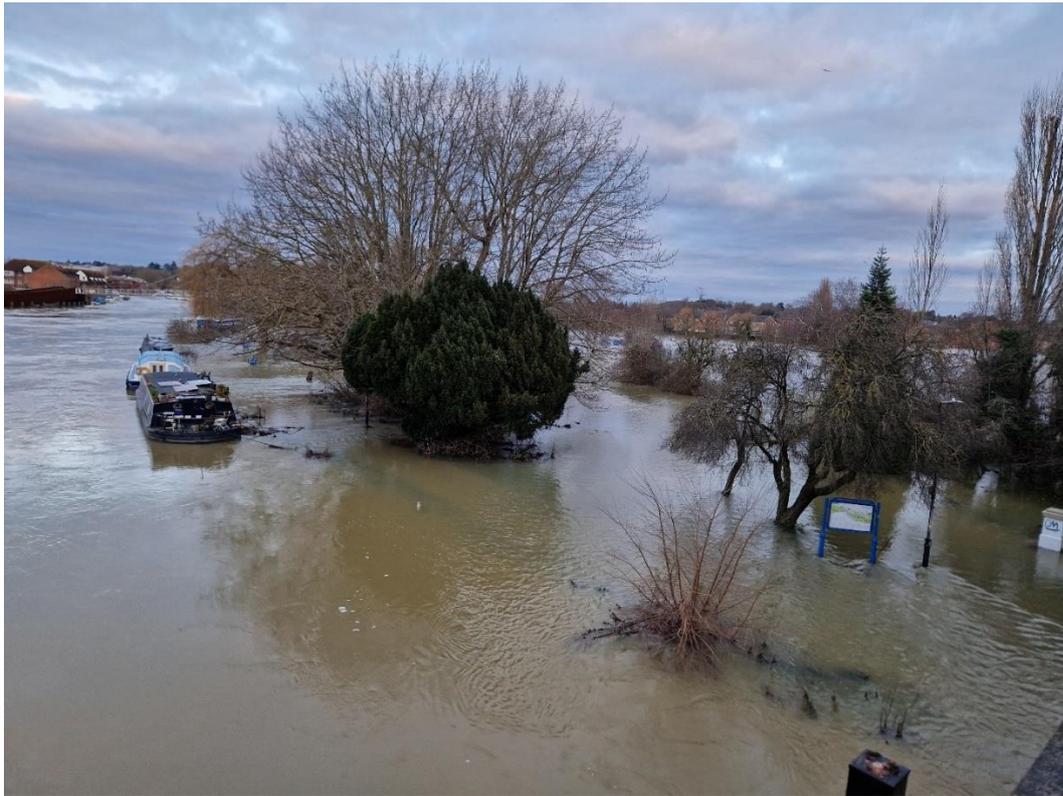
Extent of flooding of Caversham Meadow including Christchurch Ditch (from Reading Bridge), Monday 8th January 2024, 08:15 (photo taken by report author)

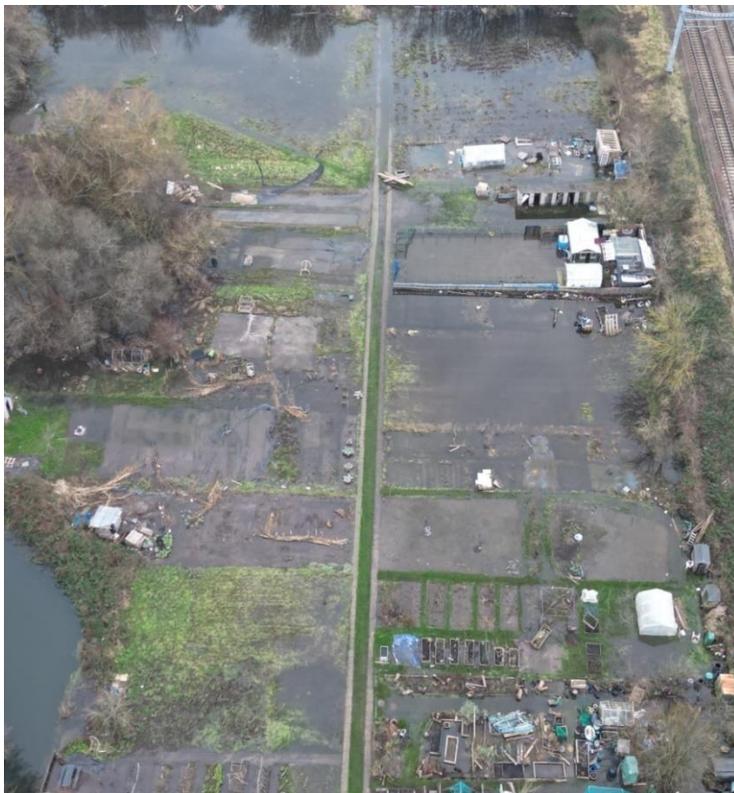
Flooding of allotment site south of Brunel Road, Southcote (photo provided by RBC, date/time unknown)

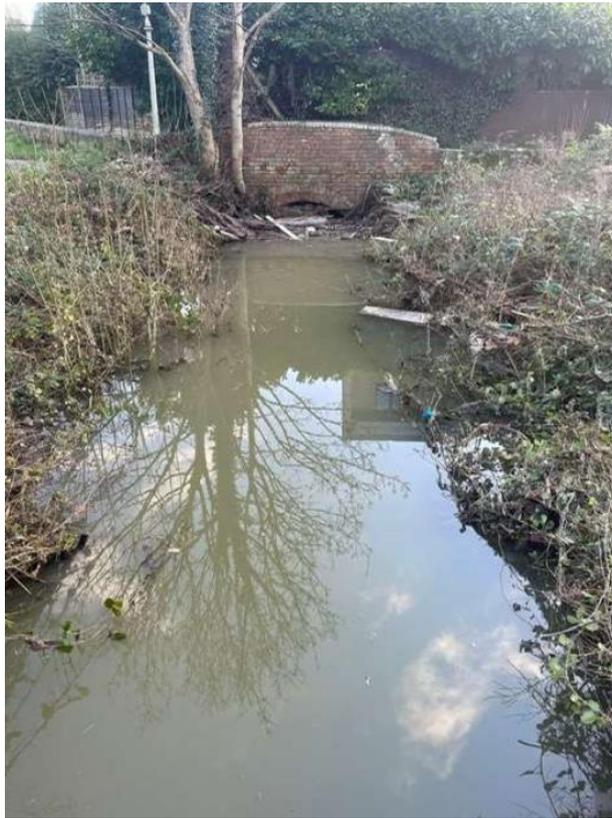
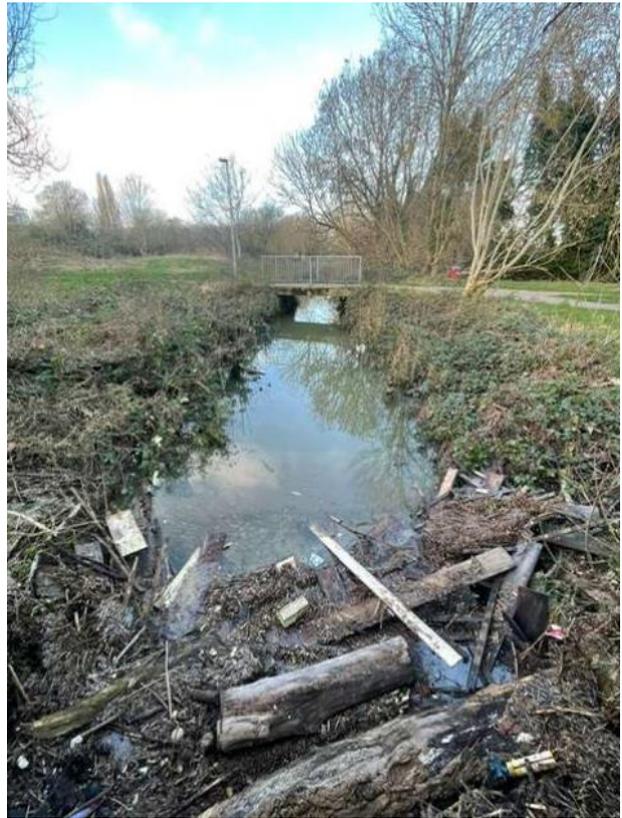
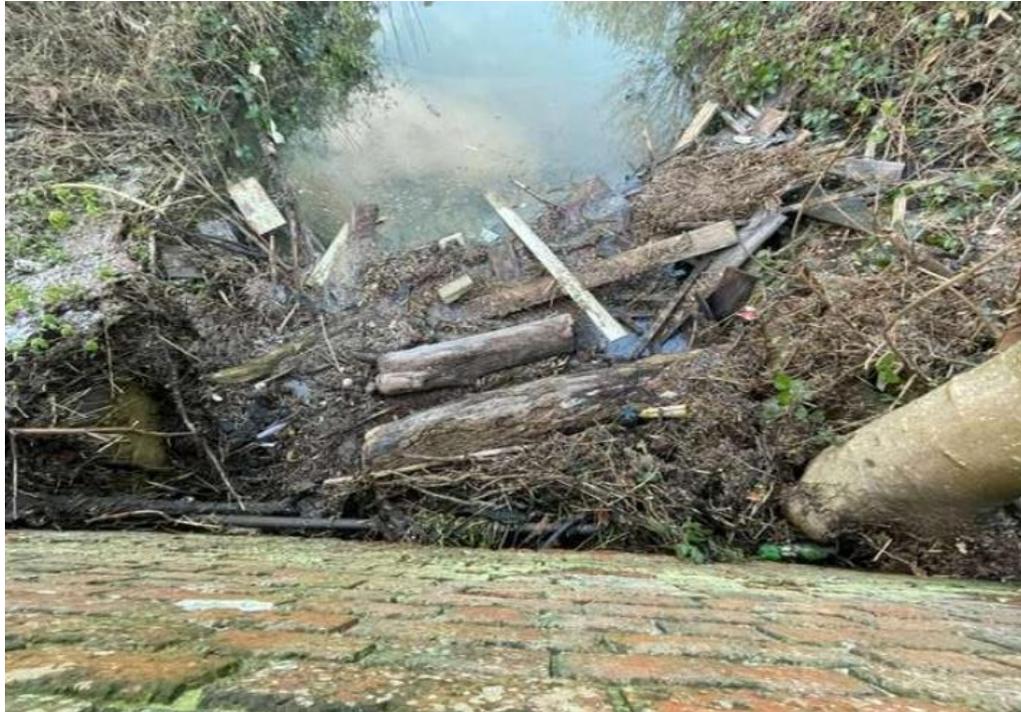
Blockage of culvert by woody debris, eastern end of Hills Meadow, Lower Caversham

- Review if there is any requirement for localised repairs to the footbridge at the eastern end of Hills Meadow and/or wingwalls following removal of the tree and review the need for localised repairs to damaged banks.

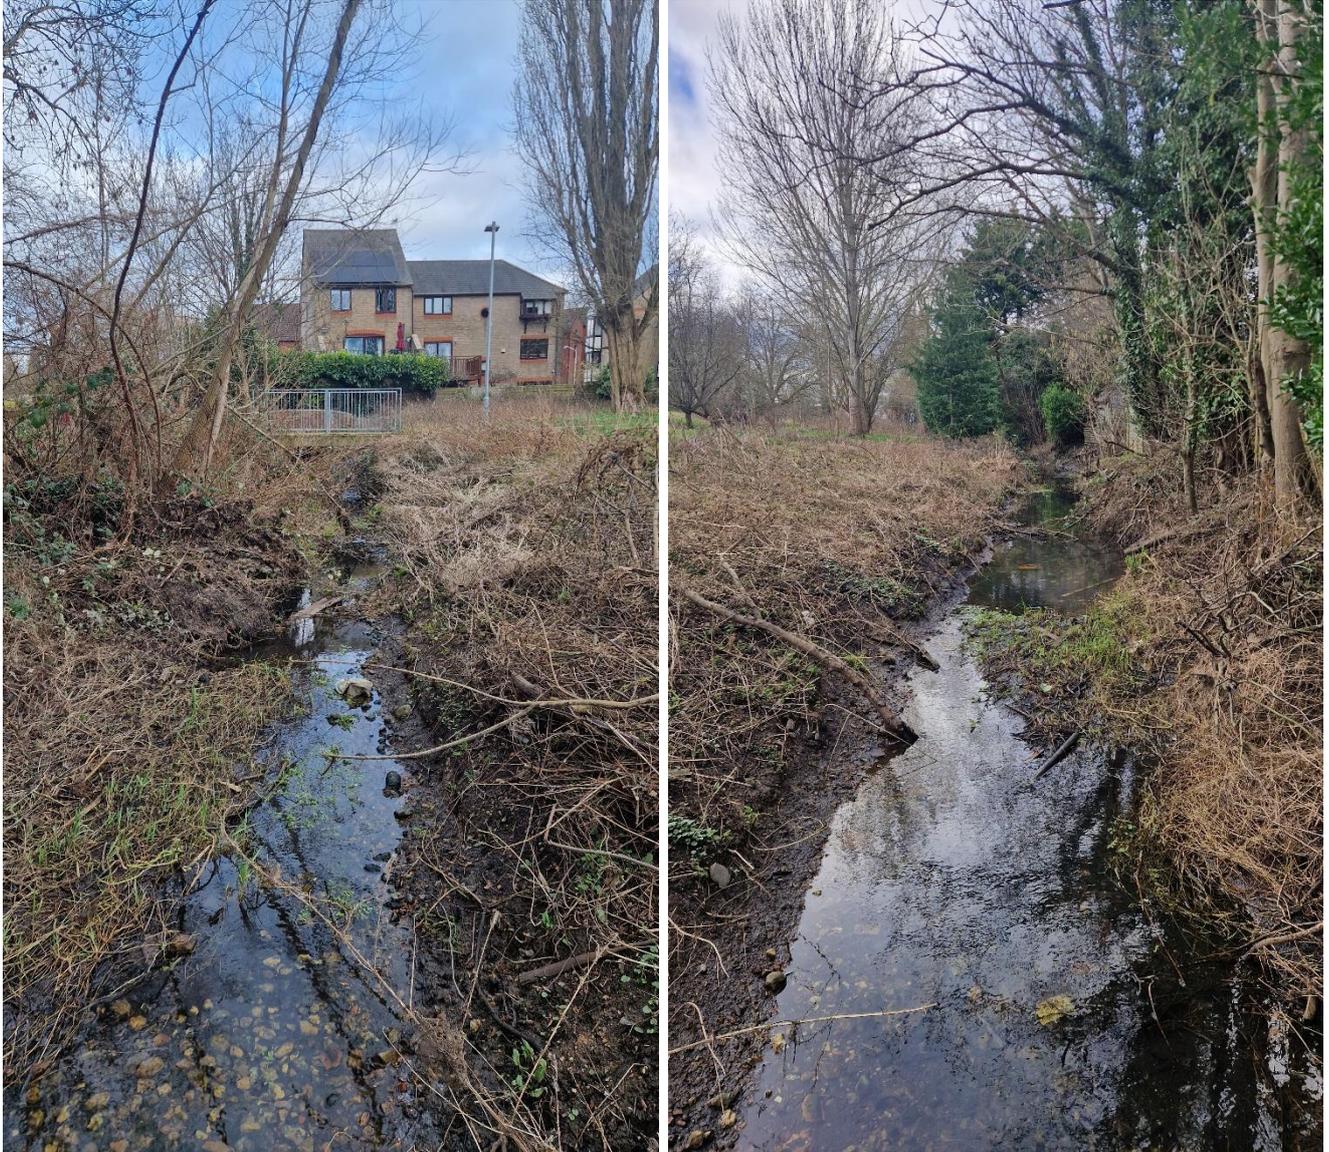
Christchurch Ditch upstream of Heron Island, eastern end of Hills Meadow, Lower Caversham
