Reading Flood Investigation - January 2024

Flood Investigation Report – Full Version

On behalf of **Reading Borough Council**

Project Ref: 332611243/001 | Rev: AA | Date: May 2024

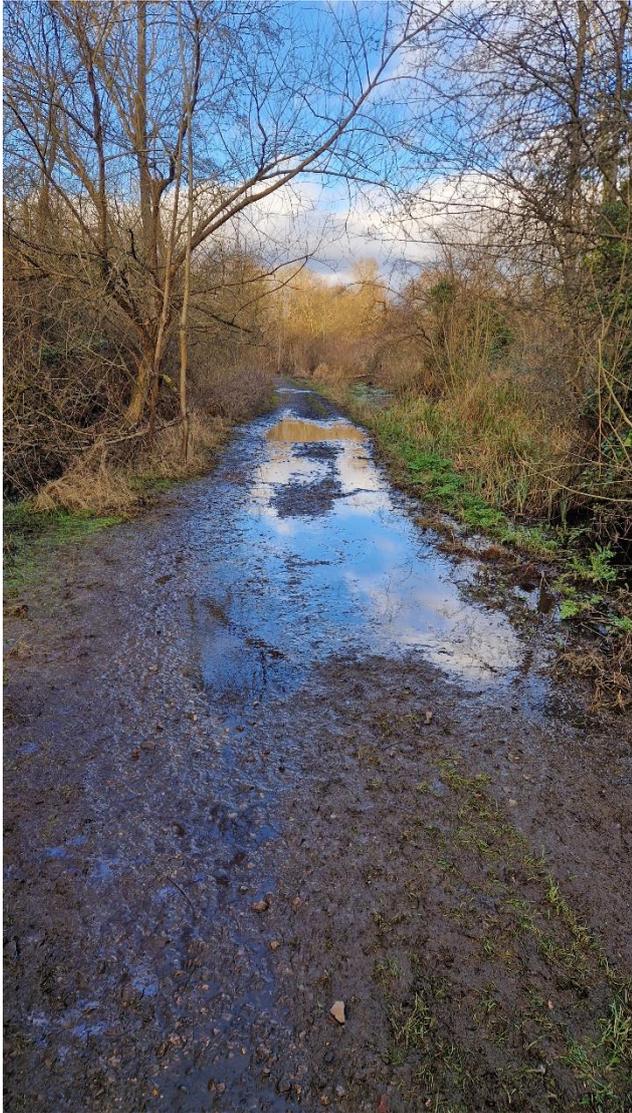
Floodwater in the River Kennet floodplain, on the road north of Briscoe’s Bridge, Southcote

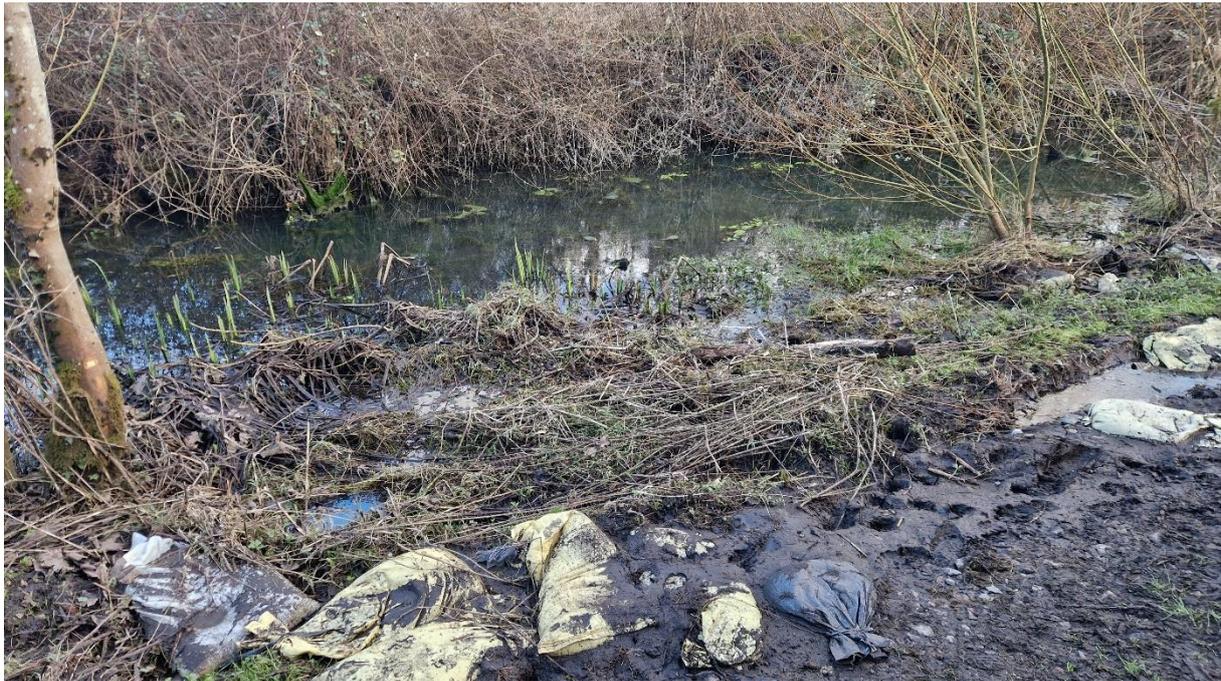
Southern banks of Christchurch Ditch upstream of footbridge, Hills Meadow, Lower Caversham

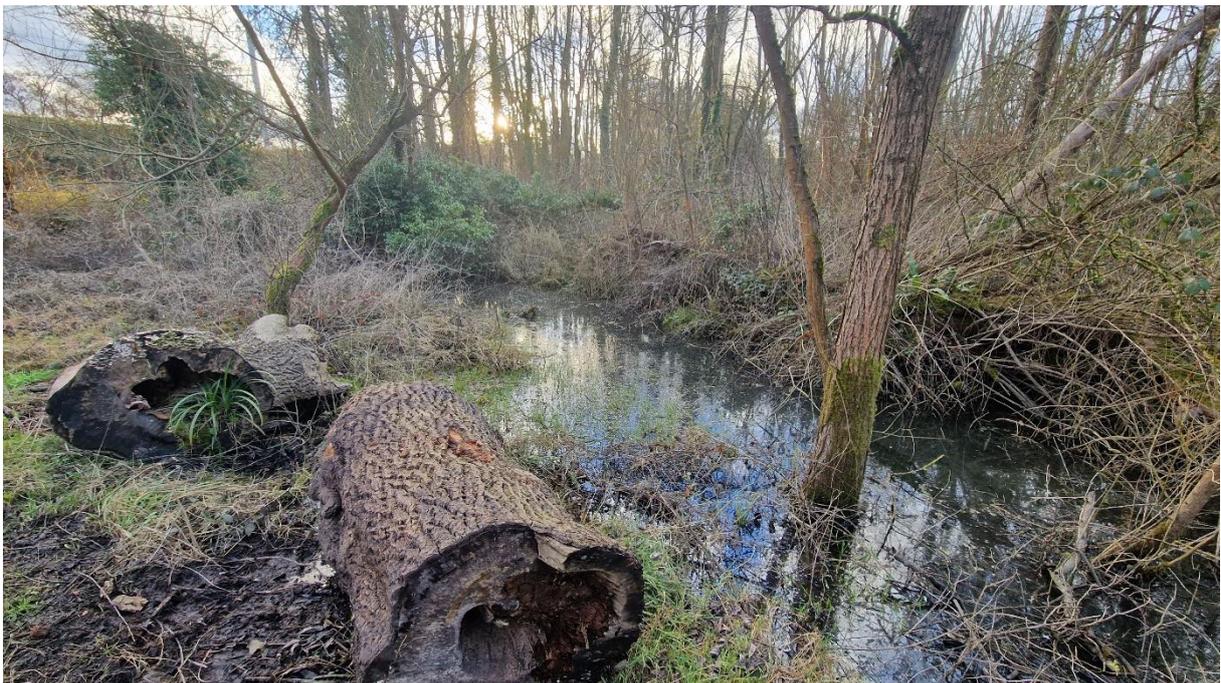
Backflow of floodwater from the River Kennet floodplain, north of Briscoe's Bridge, Southcote

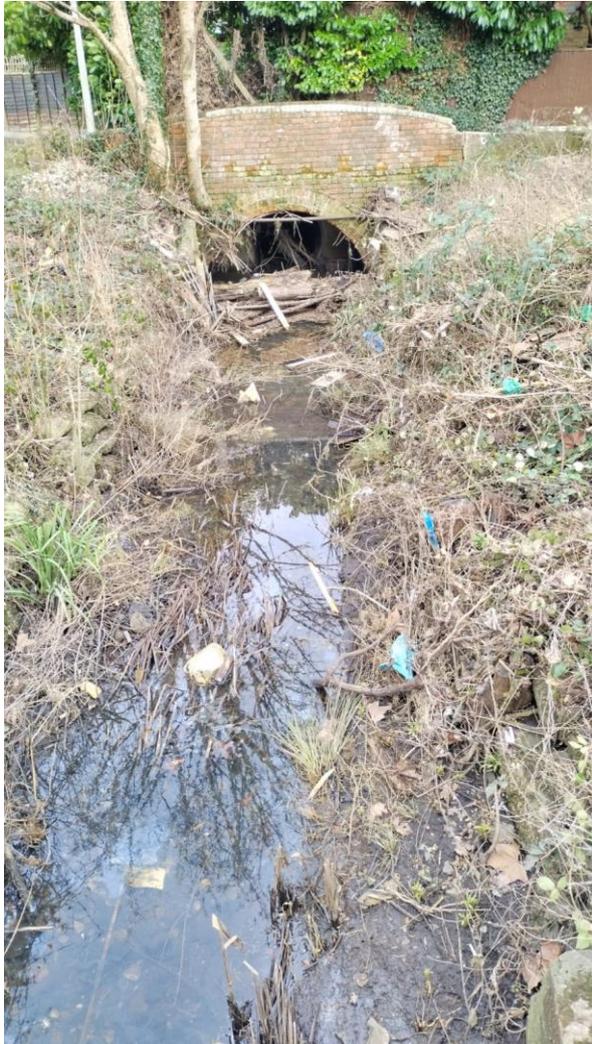
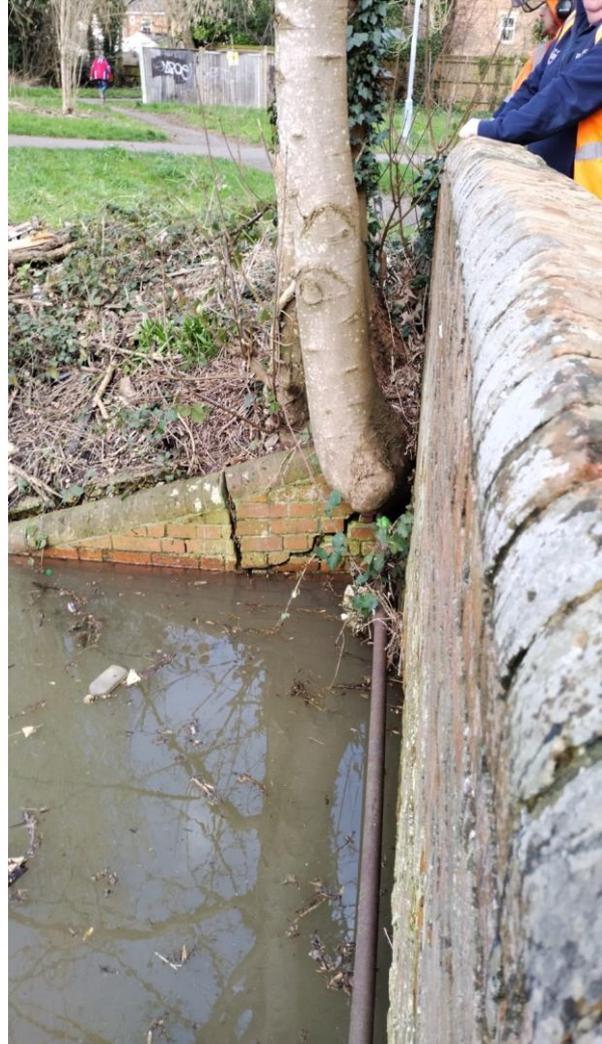
Partial blockage of culvert by woody debris and tree growing into footbridge, eastern end of Hills Meadow, Lower Caversham

- Review if there is any requirement for localised repairs to the footbridge at the eastern end of Hills Meadow and/or wingwalls following removal of the tree and review the need for localised repairs to damaged banks.

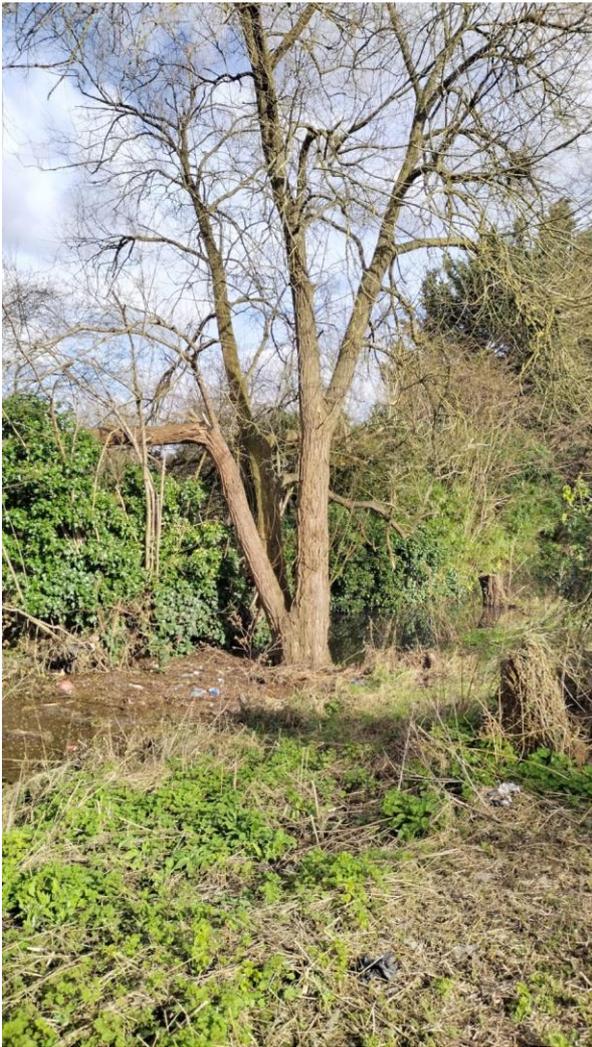
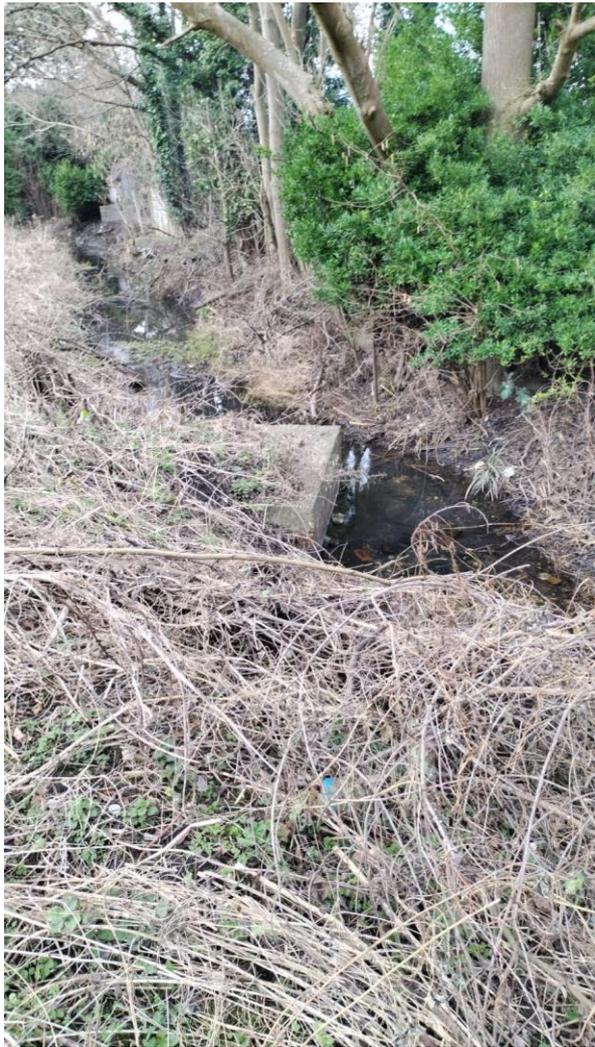
Tree, debris and vegetation in Christchurch Ditch, Hills Meadow, Lower Caversham

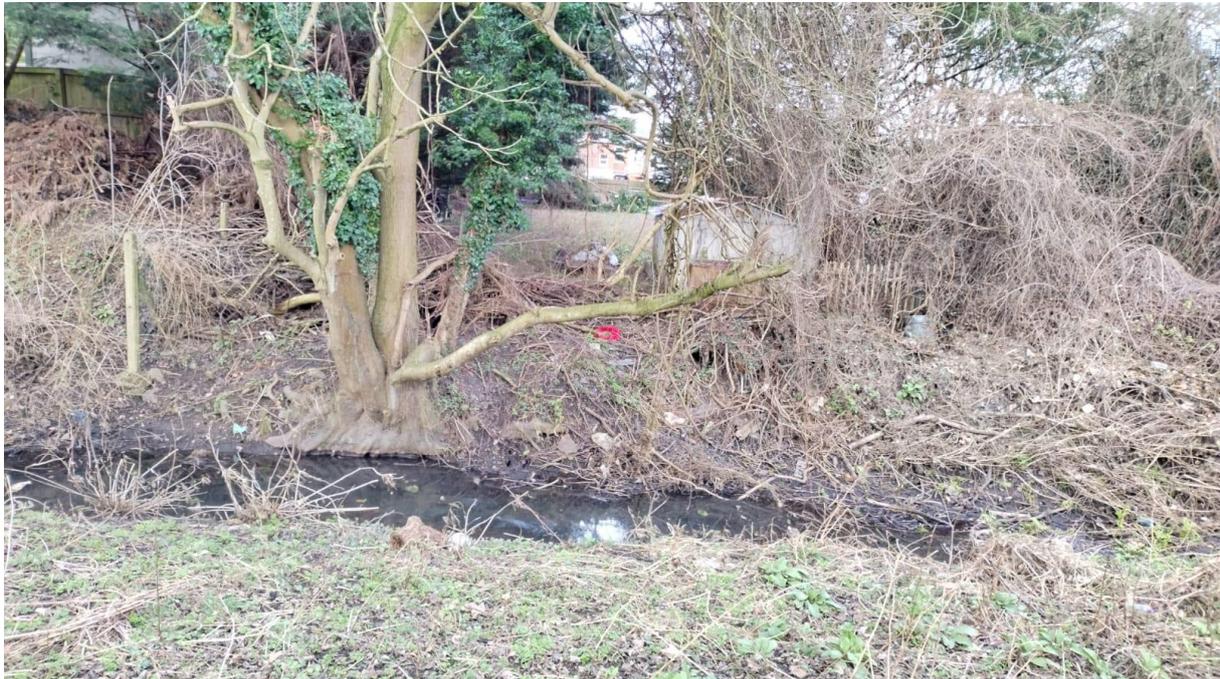
Accumulated debris in Christchurch Ditch, Hills Meadow, Lower Caversham

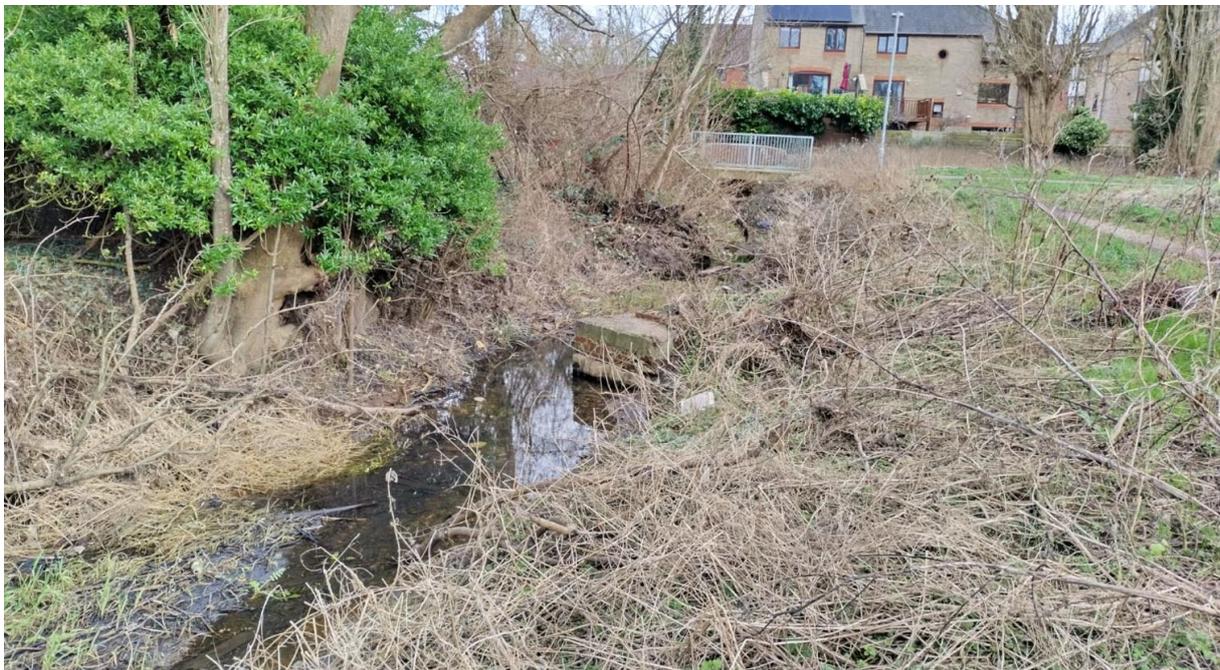
Evidence of excessive weed and debris covering the banks in Christchurch Ditch, Hills Meadow, Lower Caversham

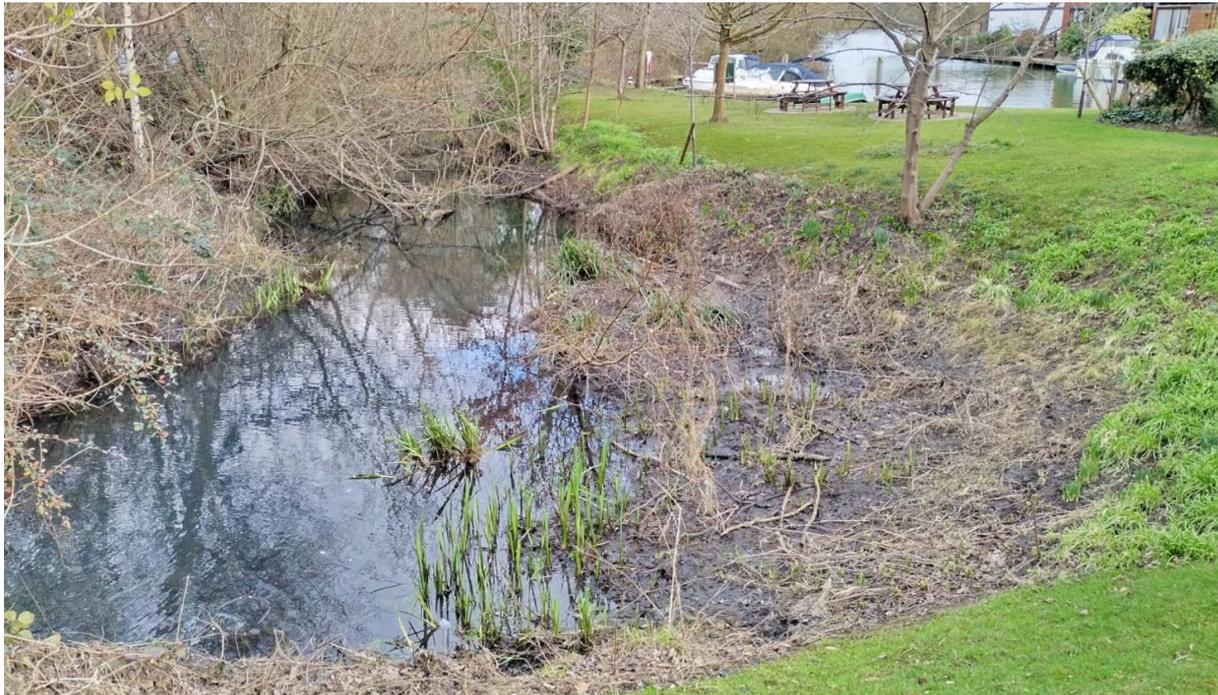
Christchurch Ditch outlet location showing silt and vegetation accumulation, downstream of the closed section of the culvert at Heron Island.

- CCTV drainage survey of the closed section of the Christchurch Ditch culvert from the footbridge at the eastern end of Hills Meadow to the Heron Island outfall point, to investigate its state of repair and capacity. The outfall structure at Heron Island is overgrown with vegetation and cannot be viewed at present. This will be subject to the agreement of the private landowners. There are also ecological constraints due to nesting swans in this area.

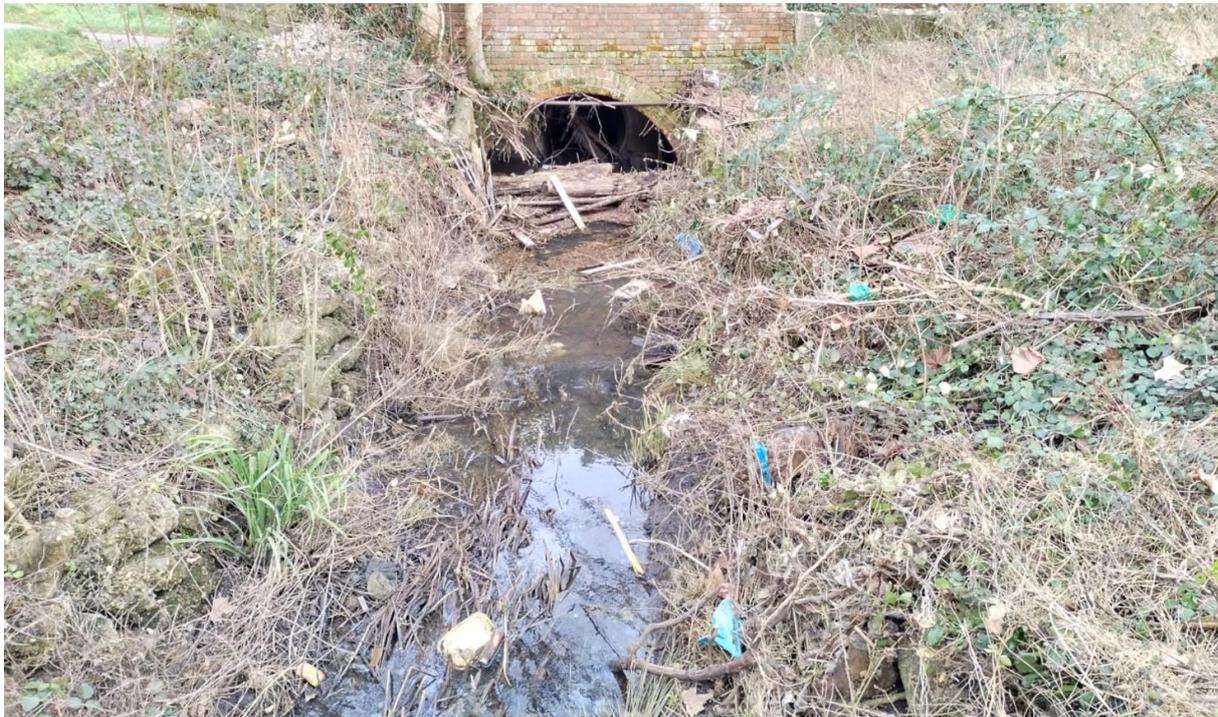
The accumulation of excessive woody debris along the channel leading to the culvert entry upstream of Heron Island.

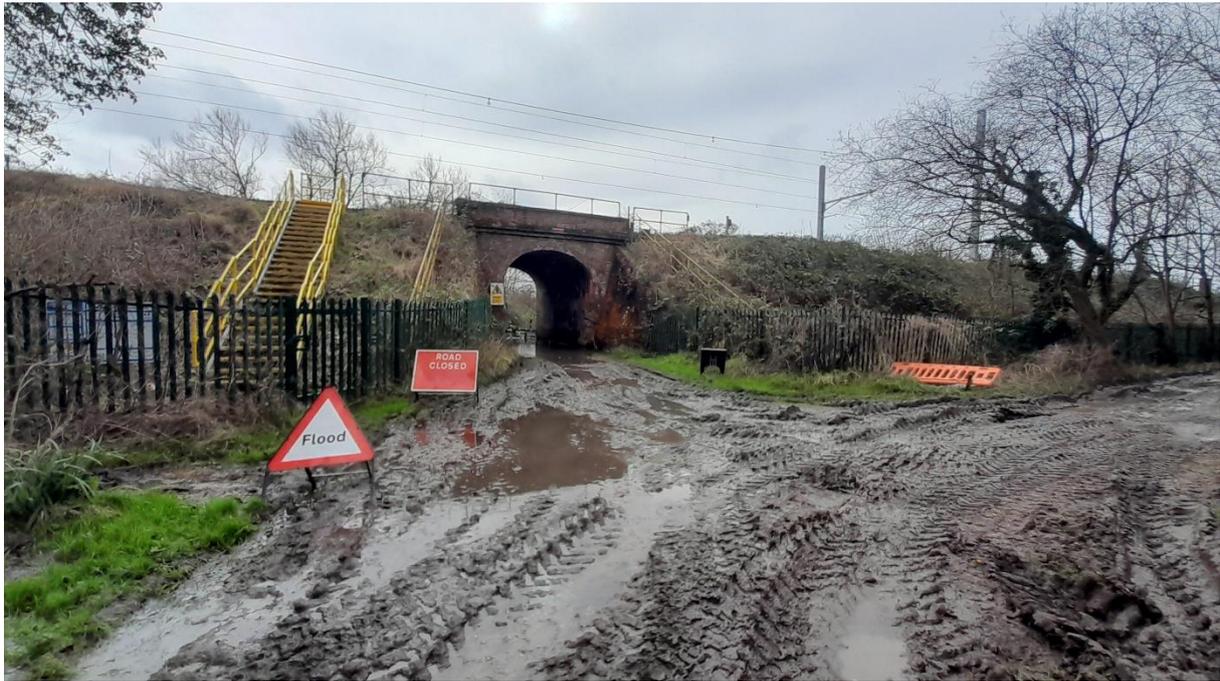
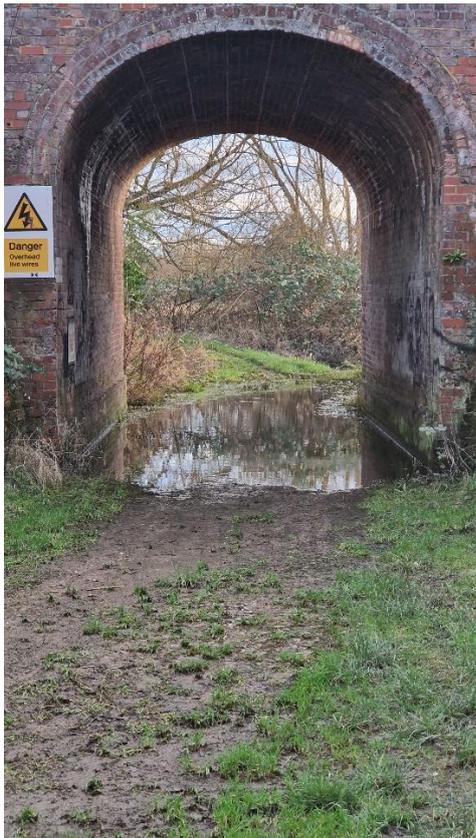
Backflow of floodwater from the River Kennet floodplain northwards under Briscoe's Bridge, Southcote

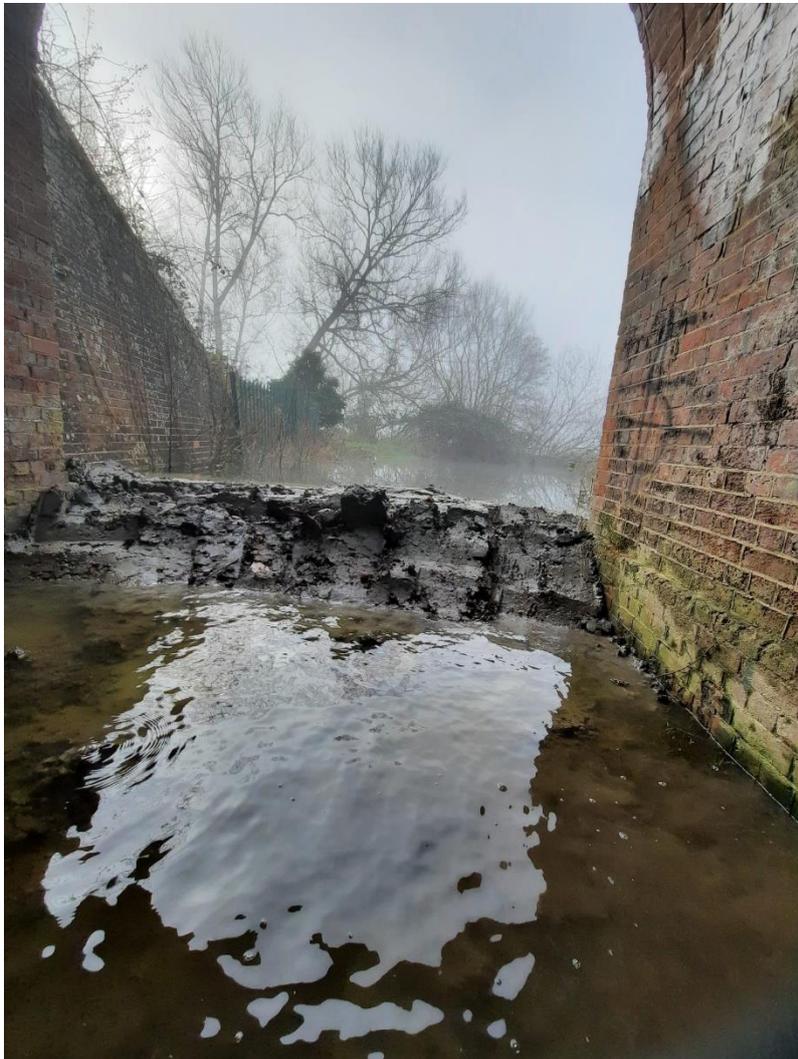
Photo provided by local resident, 8th March 2024, showing effectiveness of temporary bund holding back water from floodplain under Briscoe's Bridge

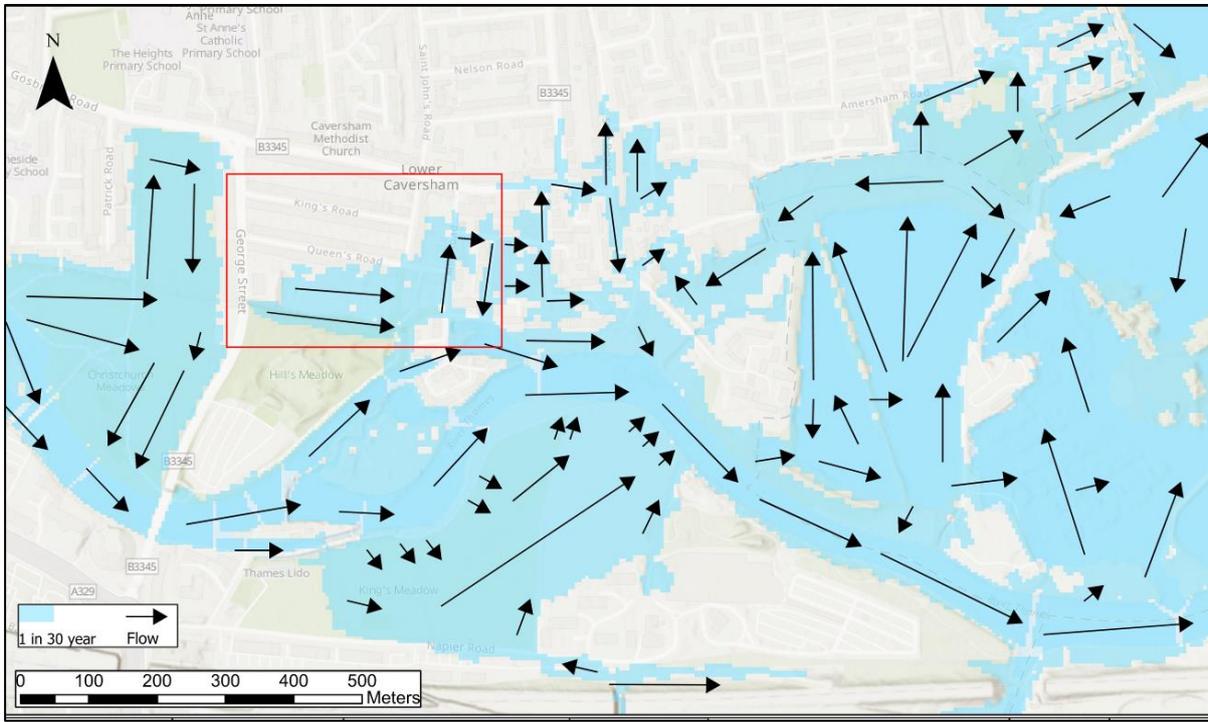
Lower Caversham flood flow direction modelling indicating 1 in 30 year event flood flow paths.

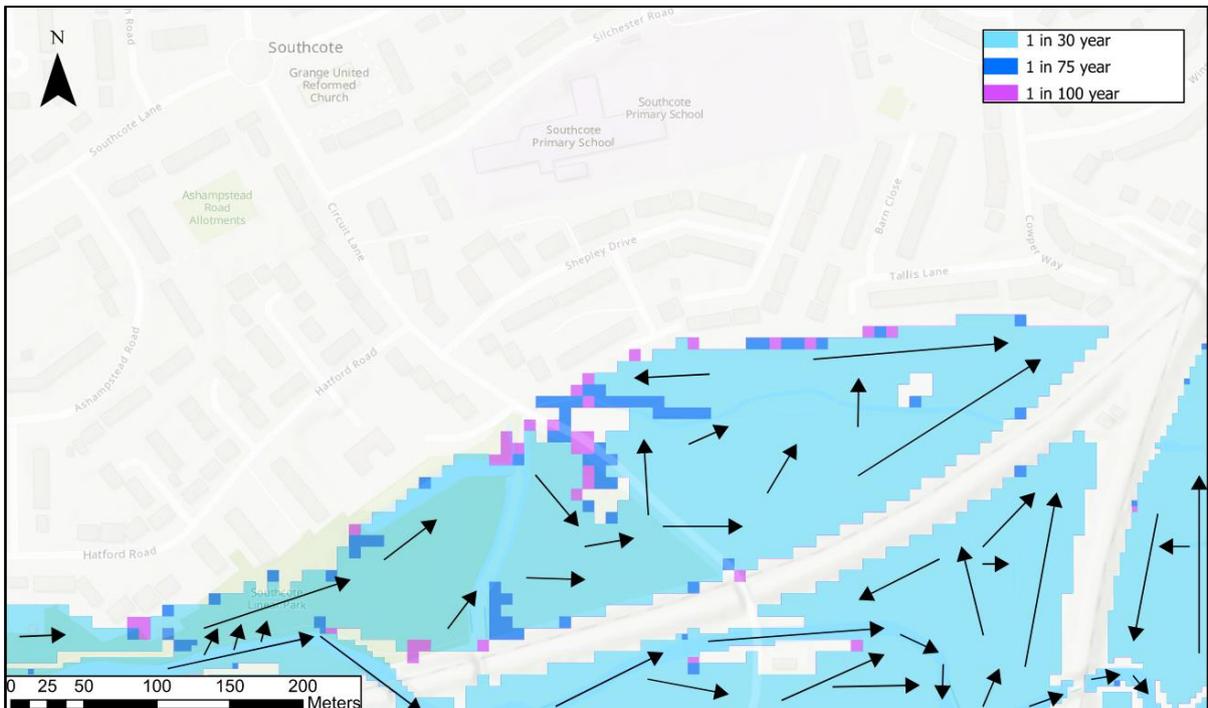
Southcote flood flow direction modelling indicating 1 in 30 year event flood flow paths.

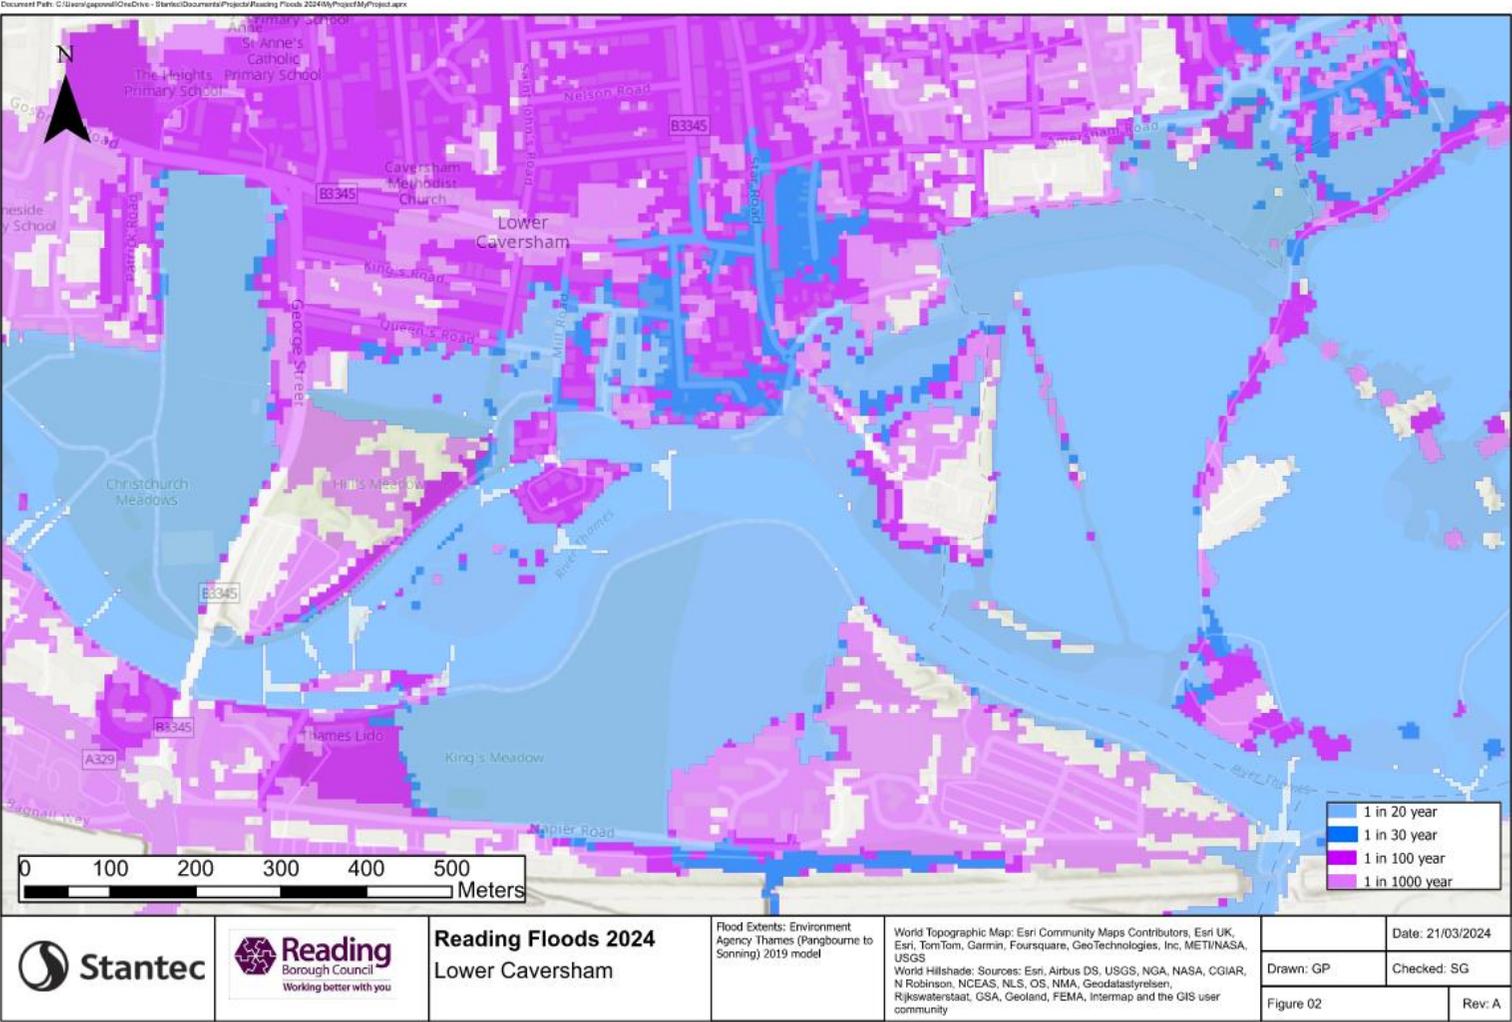
Lower Caversham: Present day flood map showing the modelled 1 in 20 to 1 in 1000 year flood extents

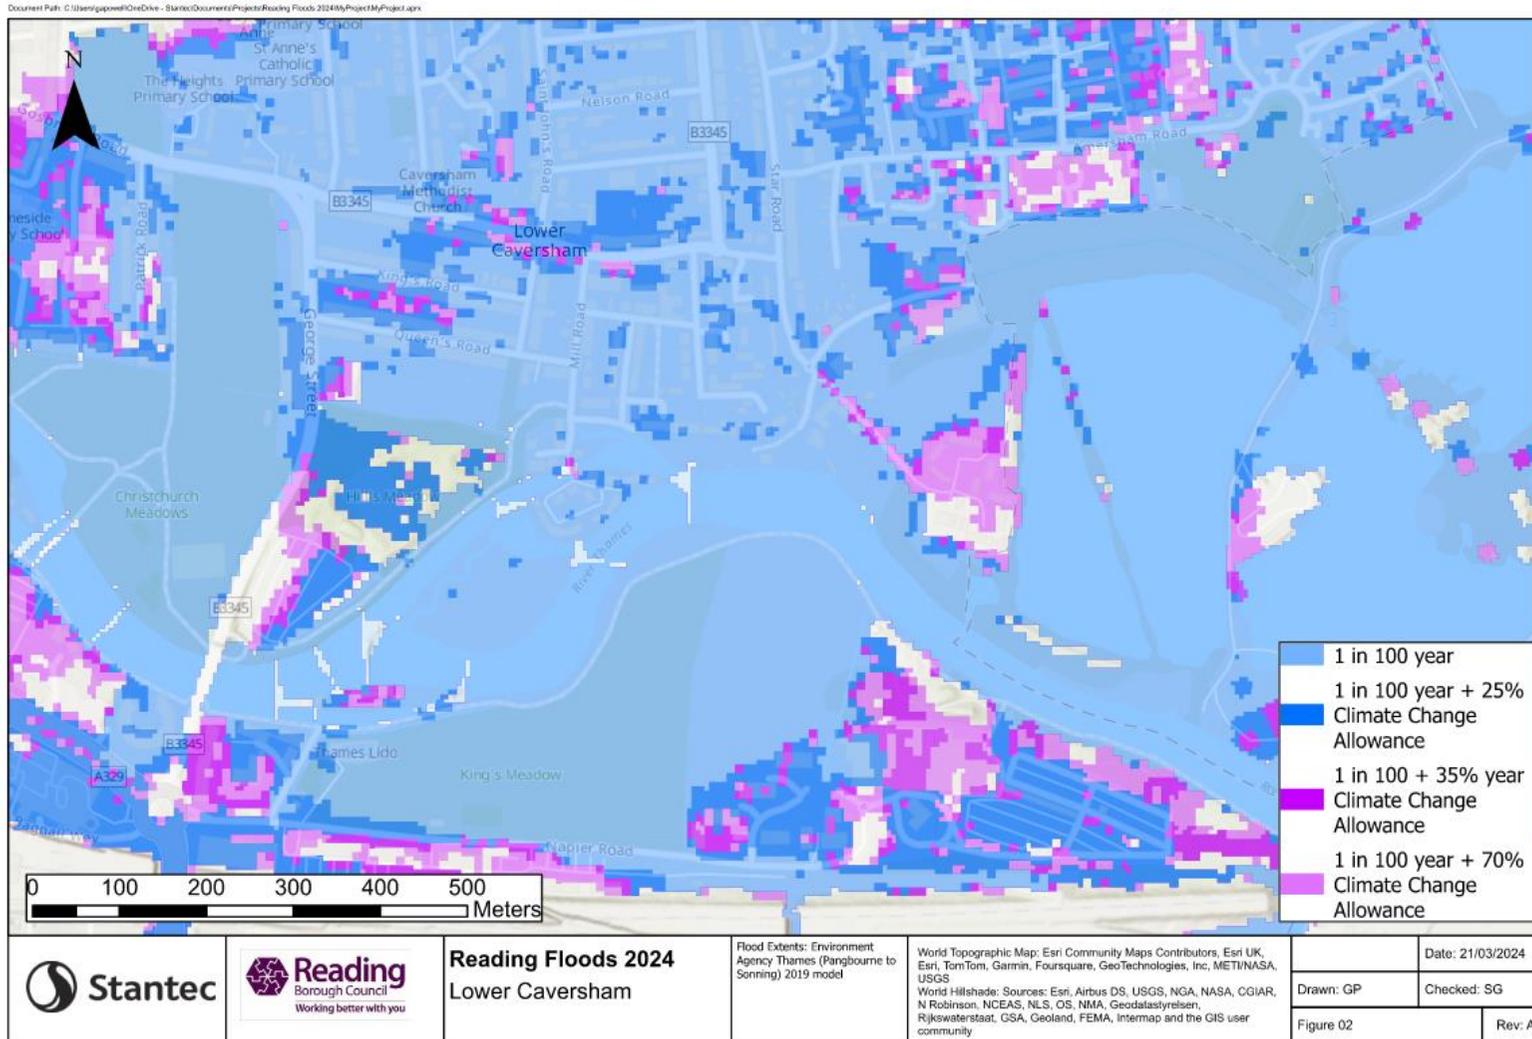
Lower Caversham: Climate change flood map showing flood extents for the 1 in 100 year event with climate change allowances between 25 – 70%

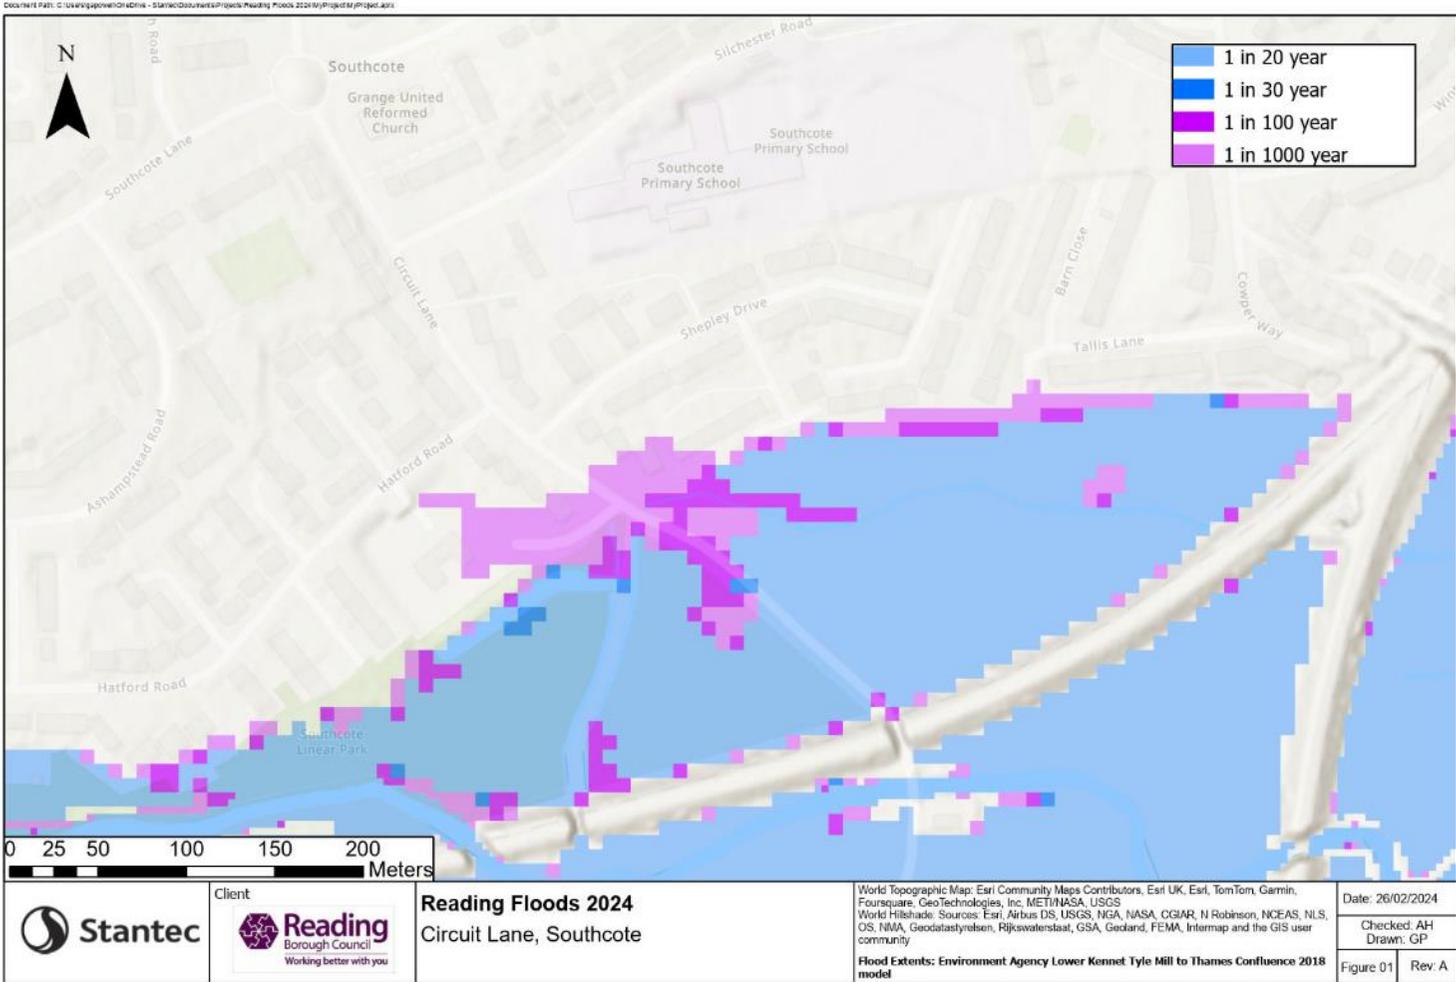
Southcote: Present day flood map showing the modelled 1 in 20 to 1 in 1000 year flood extents

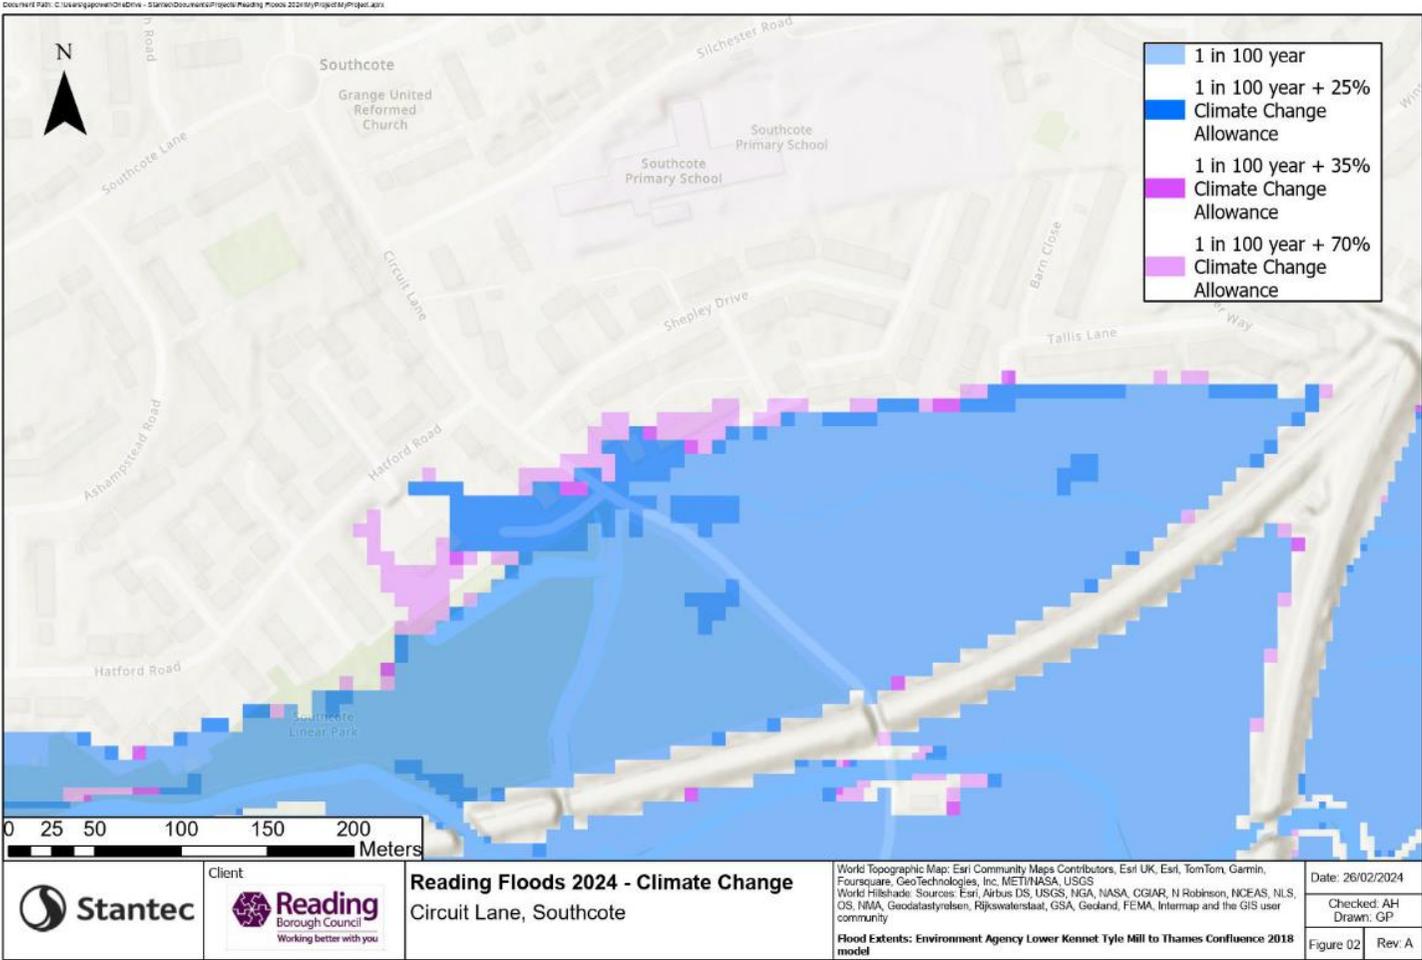
Southcote: Climate change flood map showing flood extents for the 1 in 100 year event with climate change allowances between 25 – 70%
