The Mount Conservation Area Draft Conservation Area Appraisal, June 2026

A community-led Conservation Area Appraisal

Reading Conservation Area Advisory Committee on behalf of Reading Borough Council

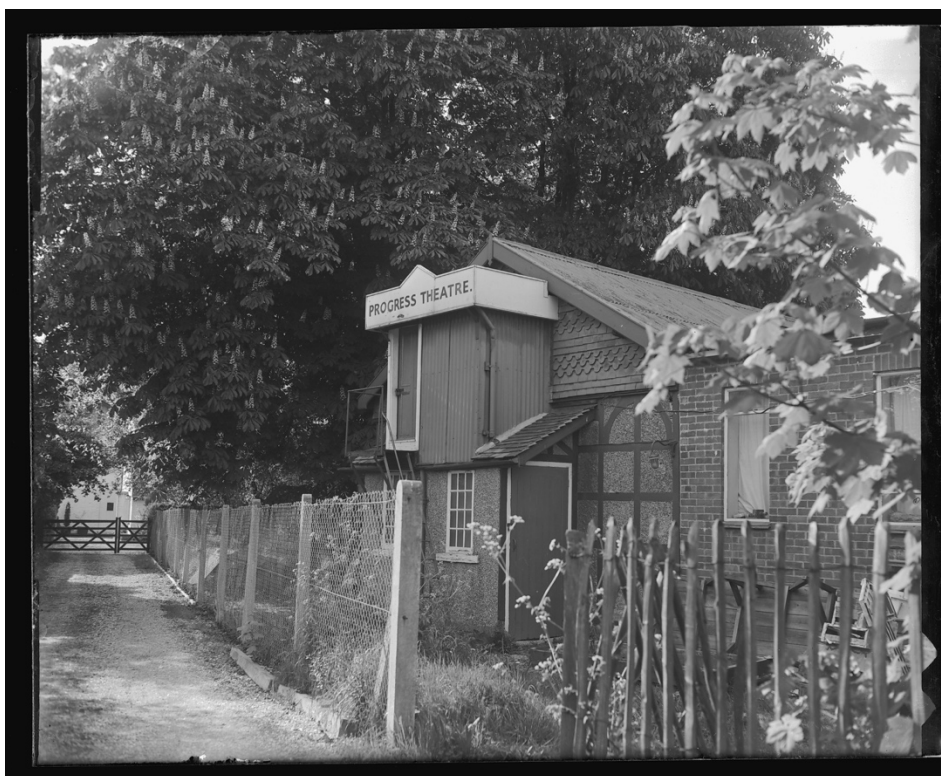
Figure 1: Progress Theatre from the south east in 1964. A cropped version of this image appeared in the Reading Chronicle. Image courtesy of Reading Museum/Reading Chronicle Collection (Reading Borough Council). All rights reserved.

The Progress Theatre is a landmark building in the CA contrasting with the surrounding nineteenth century residential properties. Its modern 1960s architecture pre-dominates, a style which is increasingly being appreciated today. The origins of the building go back to 1881 when the Mildmay Club, founded by Arthur Warwick Sutton two years earlier, moved into a corrugated iron building on the site. It originally had an ornamental 'Swiss front and porch' to the south designed by prolific local architect F W Albury.

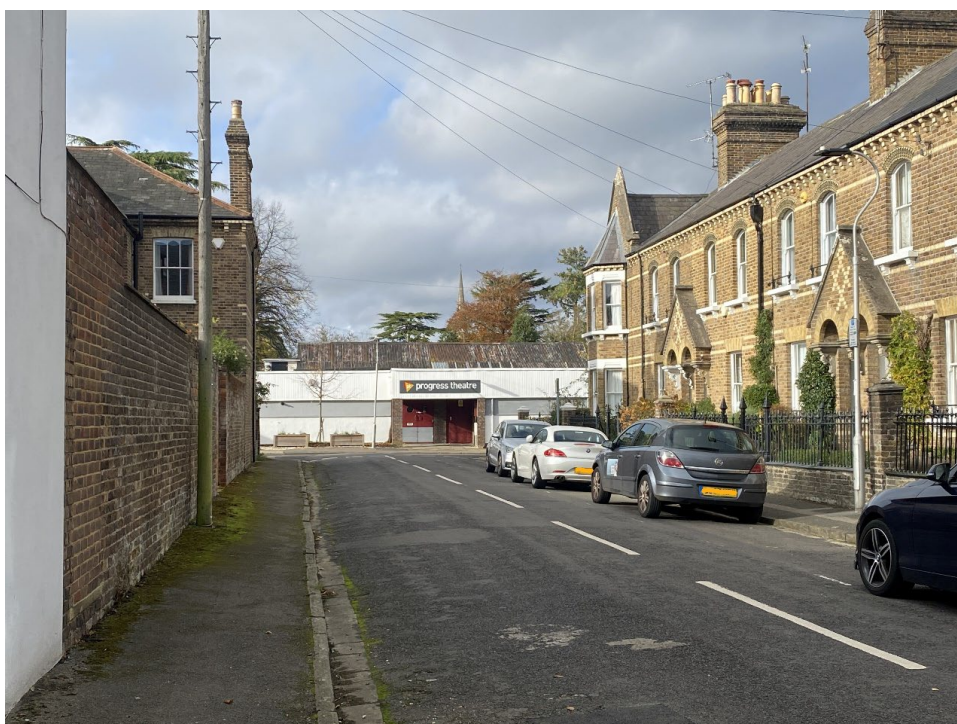
Figure 2: The Progress Theatre November 2025 (Image Claire Truman)

Improvements to the boundary treatment of the site would enhance the appearance of the conservation area.

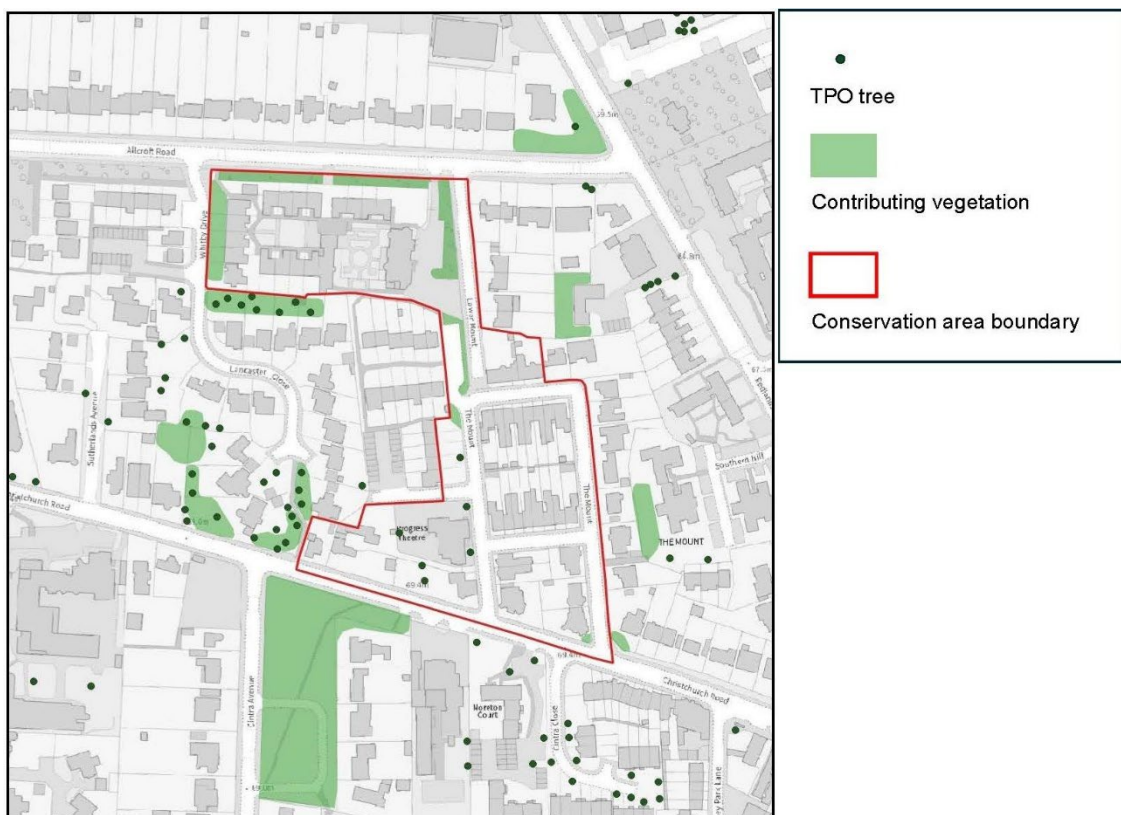
Figure 10: Trees (with TPO trees), other significant trees and green spaces within and adjacent to the CA

There are currently TPOs covering trees at 55 Christchurch Road (type T2) and 79-81 The Mount (type T1) (part of the Sutton Walk development). The Ash tree outside the Progress Theatre (TPO order number 2/03) was approved for felling in June 2020 (felled in the August) and a replacement was planted - Sorbus 'Autumn Spire' - in 2021. The replacement tree retains the same TPO order number (2/03). Planters to Lower Mount were constructed following Community Infrastructure Levy funding received in 2021 and were first fully planted in 2024. These are maintained by a group of local residents of The Mount and Lower Mount.

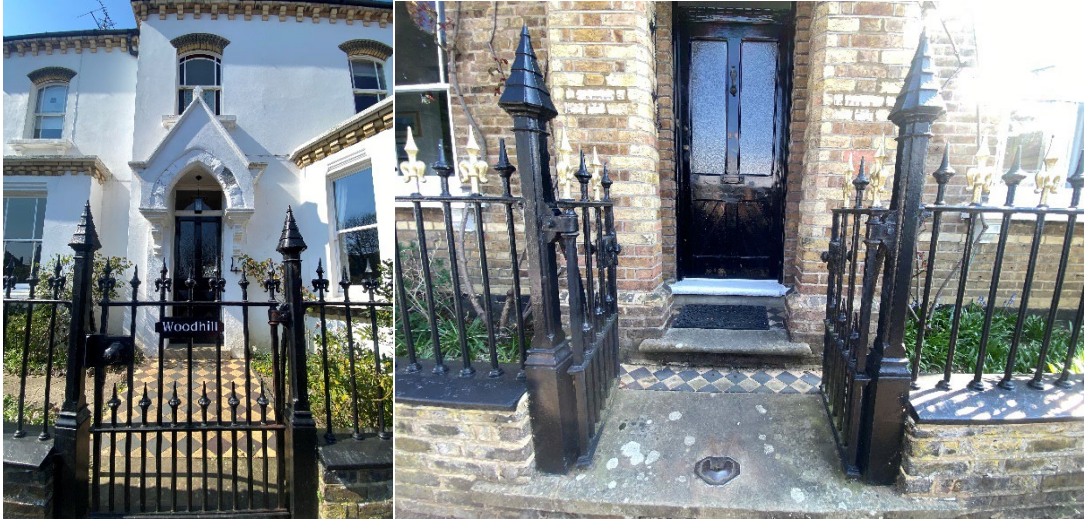
Figure 12: (Left) Single leaf gate at No.4 – also at No.s 10, 12, 14, 16, 18, 20, 23, 25, 38, 40 and side gates to No. 40 and 57 as a reflected pair. (Right) Figure 13 Double leaf gate at No. 24; and opposing detached houses No.s 22 and 8.

Brick walls and railings are to be found throughout the area and are clearly an essential part of the public realm and character of the CA. The cast iron railing design across the CA is consistently of a fleur-de-lys style. No.6 has lost its double leaf gate: it was one of what was 4 pairs. The other three, at No.s 8 and 22 (opposing pairs) and No. 24 (opposing pair to No.6) remain. It is notable that where the railings have been well maintained and repaired these create a positive enhancement to the wholistic character of the CA. The repair and re-painting of railings is encouraged; conversely, there is a conflict between enlarged tree roots that threaten the integrity and retention of historic railings at the corner of No.59 Christchurch Road (refer to Figure 26B).

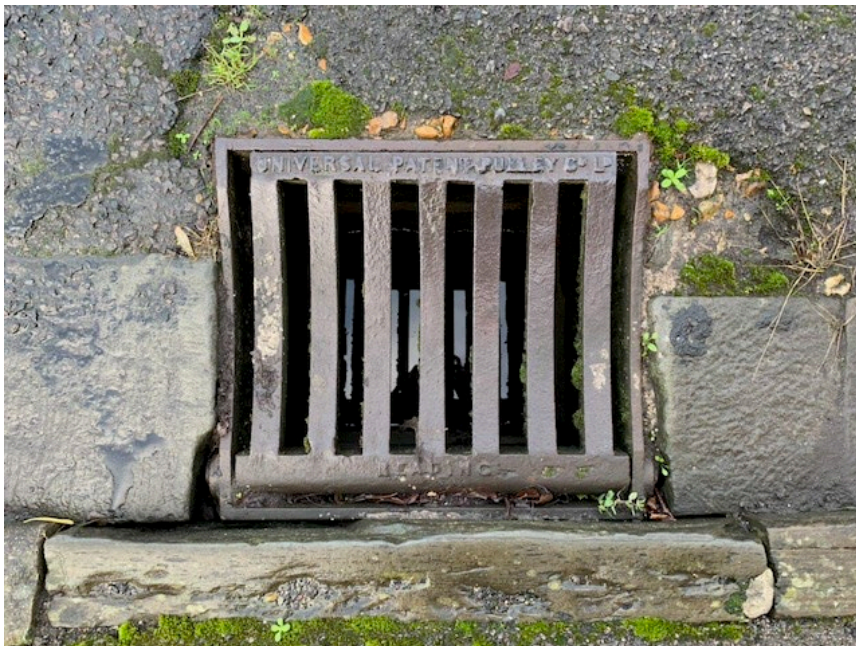
Figure 13: Universal Patent Pulley Co drain set within 'Caithness Flagstone Series' gutter and kerb stones (Image Evelyn Williams)

Road and footway surfaces are a mixture of finishes: the original kerbs and channels are a distinctive local detail of the stone 'Caithness Flagstone Series' of stone – only found elsewhere in Reading in Fatherson Road (adjacent to the Eldon Road Conservation Area); iron drain covers are partially retained and were manufactured in nearby Katesgrove (refer to section 5.4.2 below); the surfaces are tarmac.

Original drain covers can be found in The Mount. Reading Ironworks went into liquidation in 1888 and in the same year The Universal Patent Pulley Co Ltd acquired the patent for the Universal Wrought Iron Split Pulley and manufactured it on part of the former ironworks. They also produced castings using the patterns from Reading Ironworks (Mercury 8 September 1888). The company was wound up in 1894.

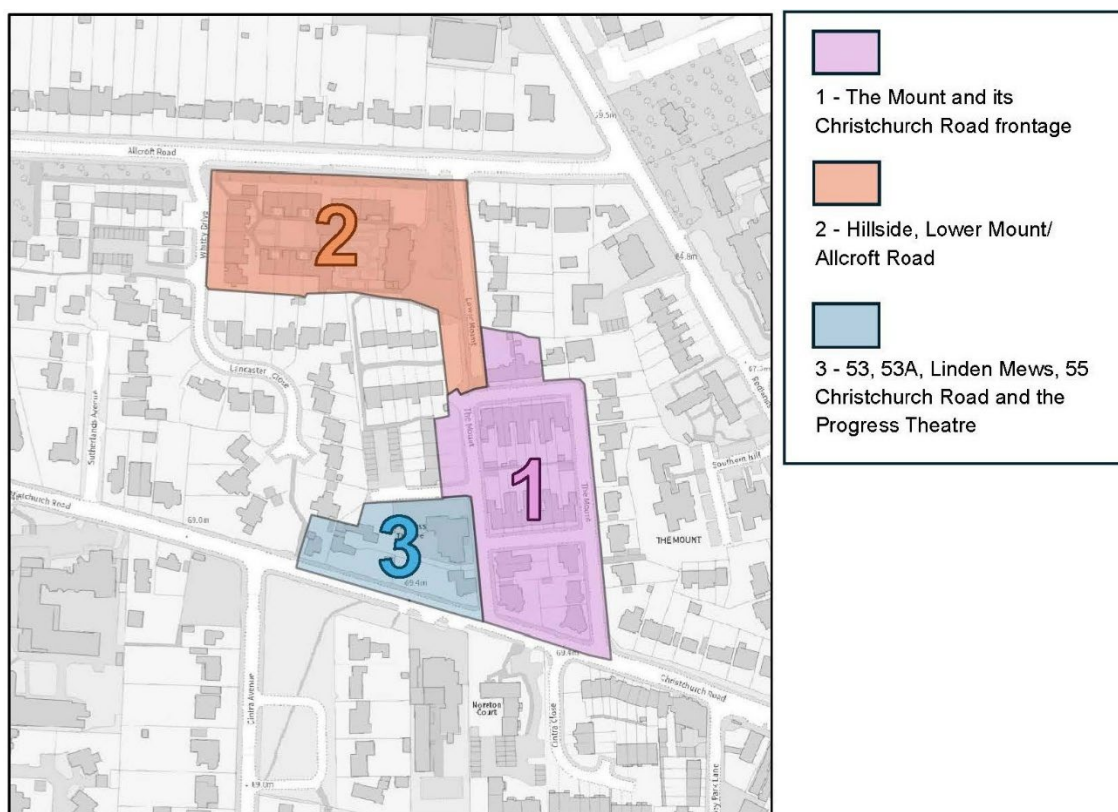
Figure 15: Character Areas 1-3

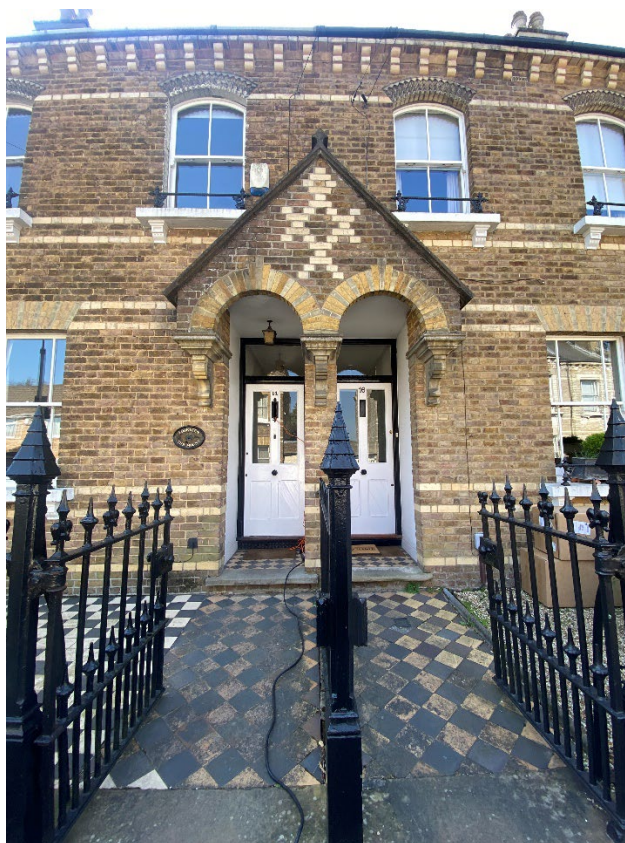
Figure 16: Unifying architectural details (Image Claire Truman)

- 4-panelled door design with upper panels glazed, cast iron central door knob, scrolled knocker and vertical post box;
- chequerboard black and white encaustic tiles to pathway from entrance gate to door – largely retained at The Mount;
- sash windows, some with margin lights expressing a hierarchy of design for the respective occupants (at No.s 4, 6, 8, 22, 24, 25, 38 and 40, and two upper windows at No.2); at the ground floor windows (only) of No.s 10, 12, 14, 16 and 18);
- slate roofs: some with fish scale courses (e.g. at No. 57 and 57A The Mount), some with geometric shaped courses (e.g. at Uplands and 23 The Mount);
- the inclusion of turret designs at key corner locations;
- prominent brick chimneys with dogtooth brick course details;
- fleur-de-lys railing design on a low brick wall.

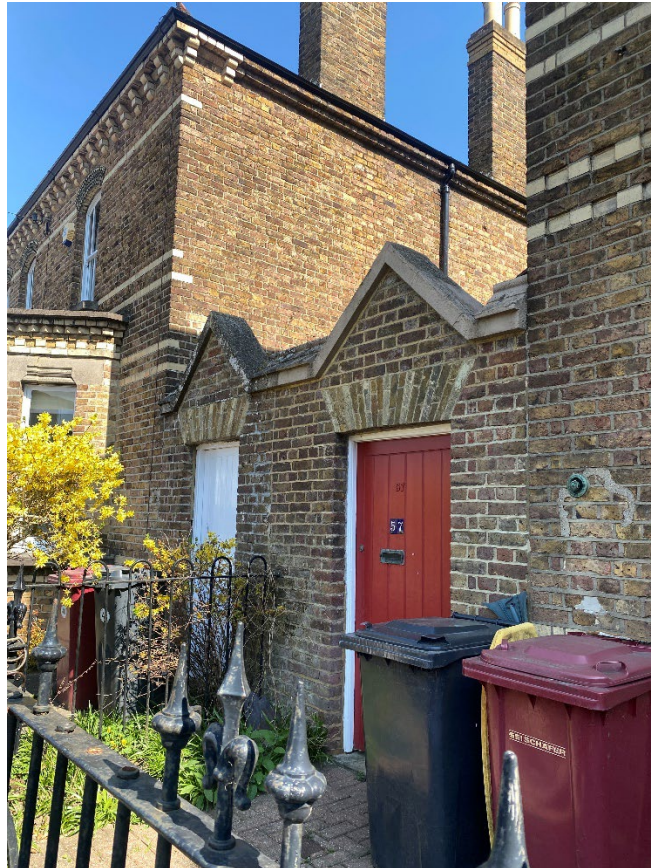
Figure 17: Unifying urban design (Image Claire Truman)

- Unifying walls between properties – such as the enclosing wall with paired garden access between No.s 57 and 40 (refer to Figure 17) illustrate the wholistic urban design.
- The consistent brick band details are located at the same height across the north and south 'blocks' despite the fall in gradient north-south along the road, and internal level changes between rooms and between properties. In particular the band detail carried through between No.6 and No.8 (refer to Figure 18) remains consistent yet the internal floor levels of the two properties differ in their relationship with the banding.
- The unifying architectural details, as listed on the previous page.

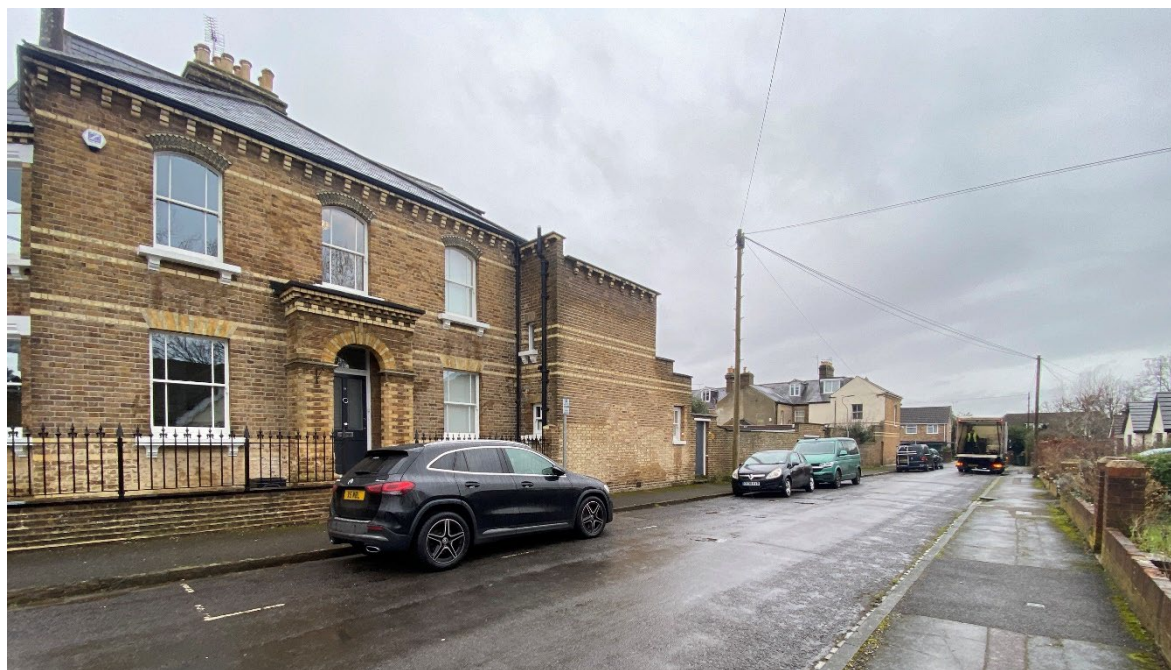
Figure 18: Unifying yellow brick bands between properties in the north-south road directions (Image Claire Truman)

The two groups of terraced houses share these unifying architectural details which subtly obscure differences between them: the north terrace has a third 'attic' floor with original dormer windows whereas the south terrace properties have roof lights that align with the roof, however both terraces appear the same from the street elevation.

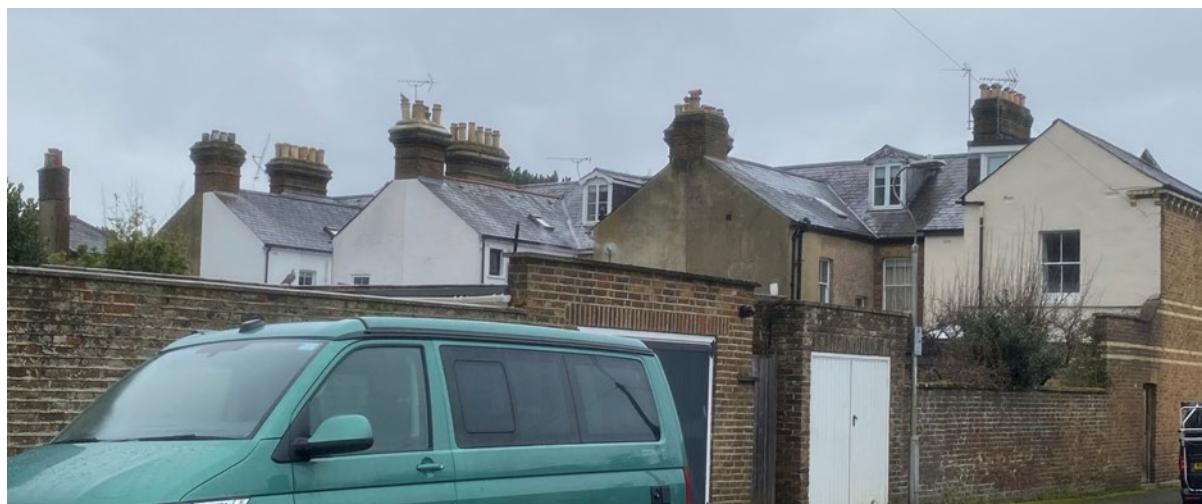
Figure 19: Original dormer windows to the rear of the north terrace of The Mount

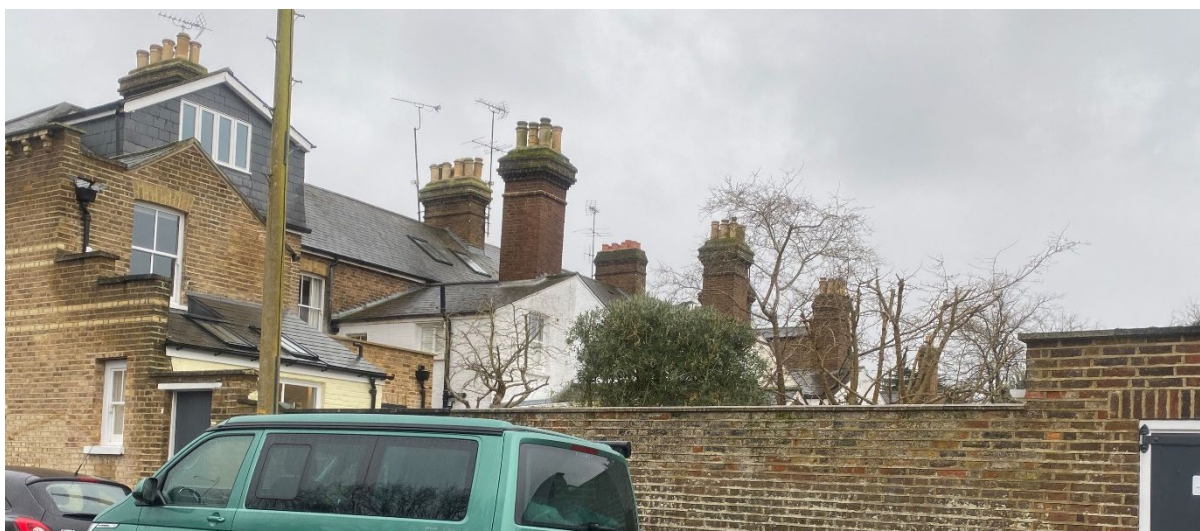
Figure 20: Roof lights to the rear of the south terrace of The Mount

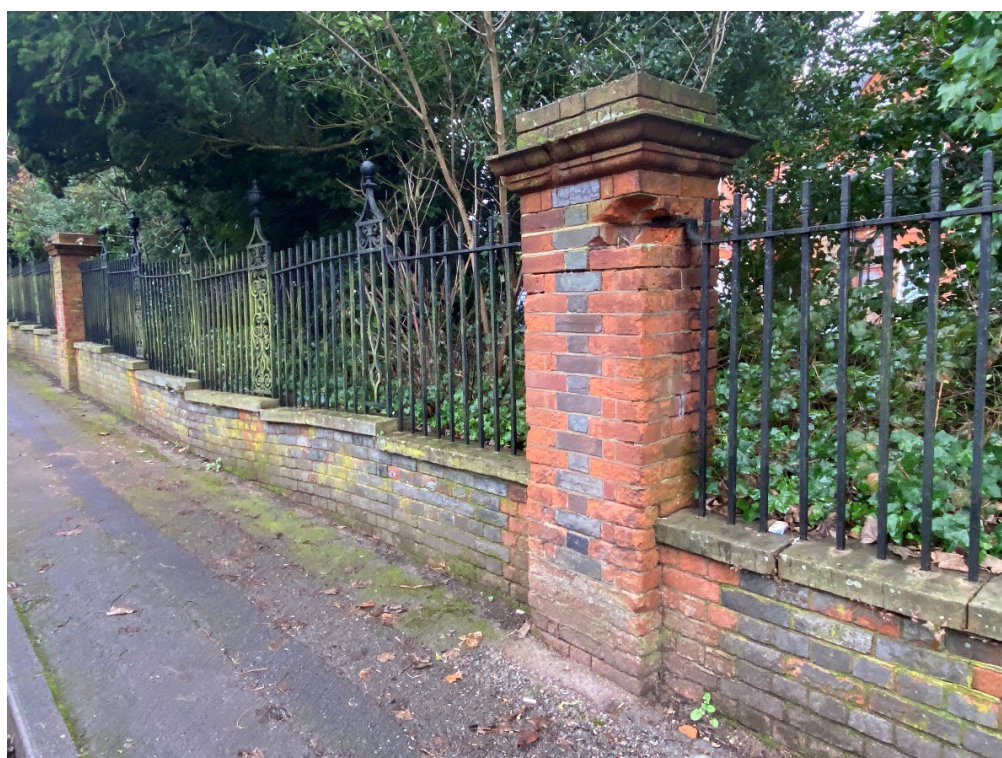
Figure 22: The brick piers and railings to Hillside are falling into disrepair – view along Lower Mount (Image Claire Truman)

The gate piers, walls, gates and railings form two sides of the boundary to Hillside to Allcroft Road and Lower Mount. These date from circa 1880-1900 and are valuable in putting the house in context, and are listed separately (List Entry Number 1392868). A pair of brick piers with an enriched terracotta frieze of rosettes are located either side of the main driveway, inscribed with ‘Hillside’. At the entrance off Lower Mount two less ornate paired brick gatepiers remain: the original timber gates are currently in storage at Hillside awaiting repair

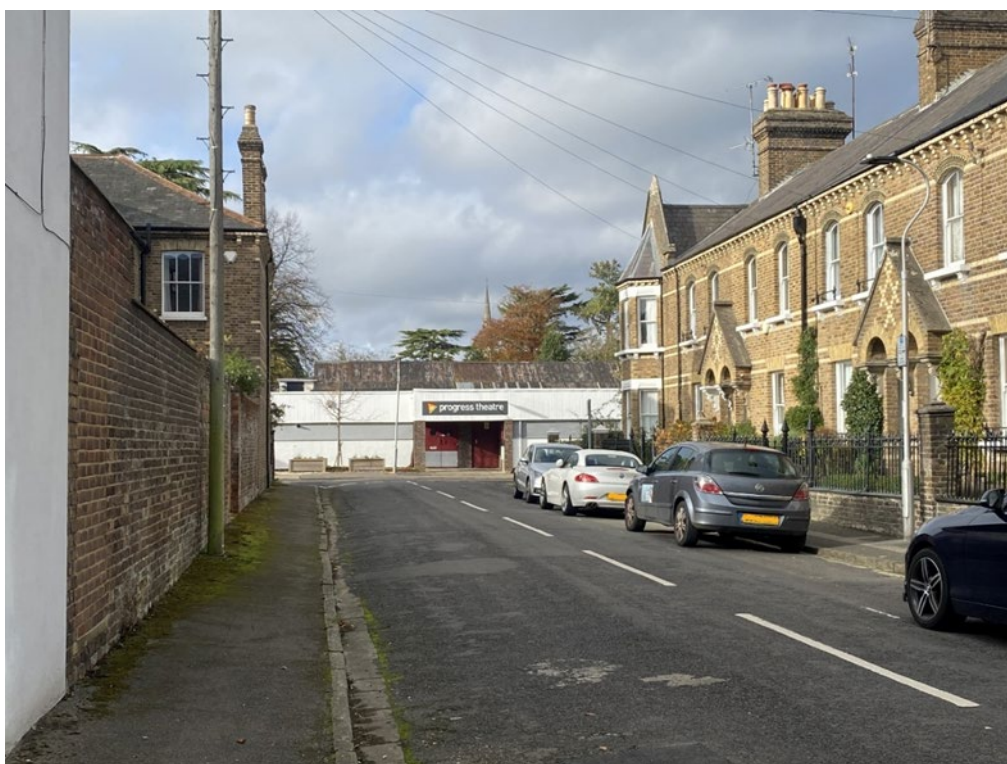
Figure 24: The Progress Theatre November 2025 (Image Claire Truman)

The Progress Theatre, founded in 1946, moved in 1950 from the W I Palmer Memorial Hall in West Street to new premises in The Mount which had formerly been the Mildmay Club, a working men's club founded in 1879 by Arthur Warwick Sutton which moved to the newly built hall in 1881, sufficiently large to hold 200 people. The hall has been enlarged in phases since its initial occupation, particularly after the freehold was secured in 1964. The design of the main entrance façade onto The Mount dates from 1968.

The Progress Theatre has social and cultural importance whose origins are directly associated with the Sutton family. Its avant-garde design contributes substantially to the layers of history within the CA, and specifically to the setting of Character Area 1; every effort should be made to keep the property and the associated external spaces well maintained and managed.

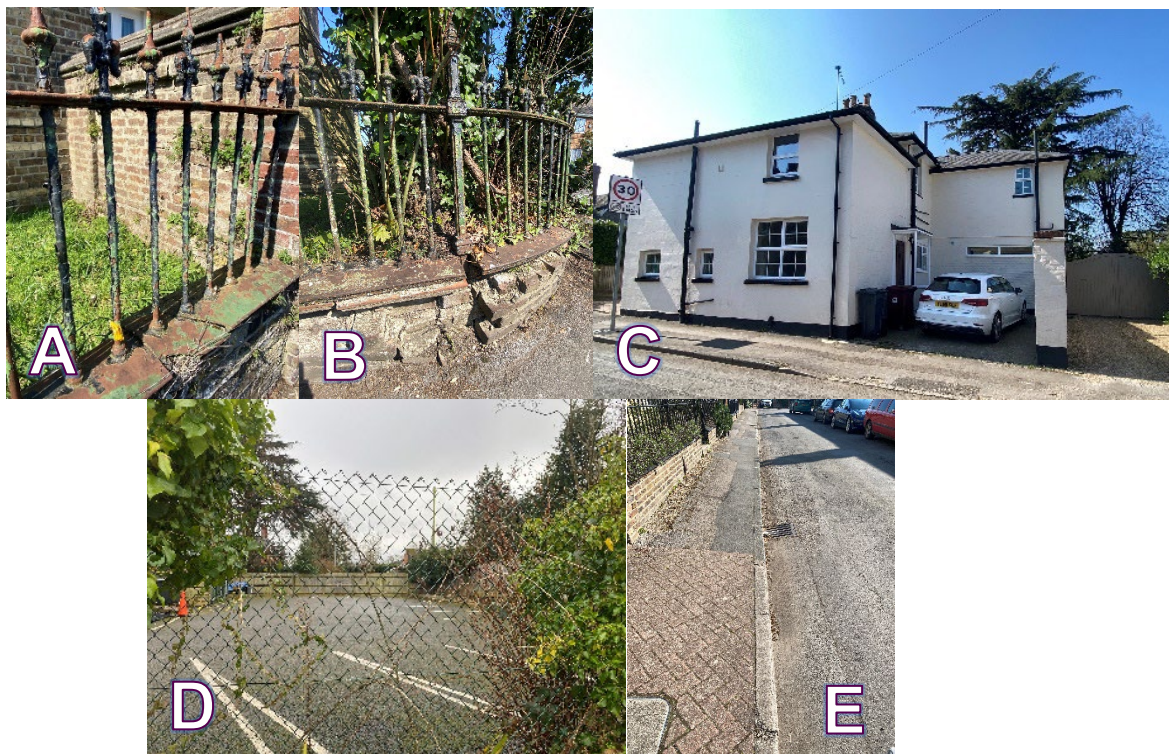
Figure 26: Images of loss or deterioration of details (Images Claire Truman)

A – Deteriorating railings

B – Deteriorating low brick wall and railings

- flat-roofed dormers appear out of keeping with the roofscape character;
- railings and low wall damaged by overgrown tree at number 59 Christchurch Road – this has dramatically changed since the last appraisal;
- deterioration of original railings;
- white painted brickwork at number 25 The Mount;
- some walls in need of repair on the Christchurch Road frontage;

ISSUE	ACTION	WHO
Low wall at 59 Christchurch Road. is breaking up and railings damaged. Cause: tree roots and also vehicular impact (accident).	Awareness: Provide householder information document on the added value and visual importance of boundary walls and railings	RBC and CAAC
Replacement of broken kerbstones especially on corners by concrete. One especially badly placed.	Awareness: Provide street care information document on the added value and visual importance of the treatment of the urban materials upon the conservation area's historic qualities and cohesive character.	RBC
Thames Water did not repair gully/kerb correctly after work in The Mount.	Awareness: Thames Water to be made aware of its duty to pay particular care and attention to repair work.	RBC
The sign instructing 'Park only in marked bays' is causing confusion; additionally dash white lines are faded.	Awareness: Parking wardens to be provided guidance over the use of parking bays where this sign is located.	RBC

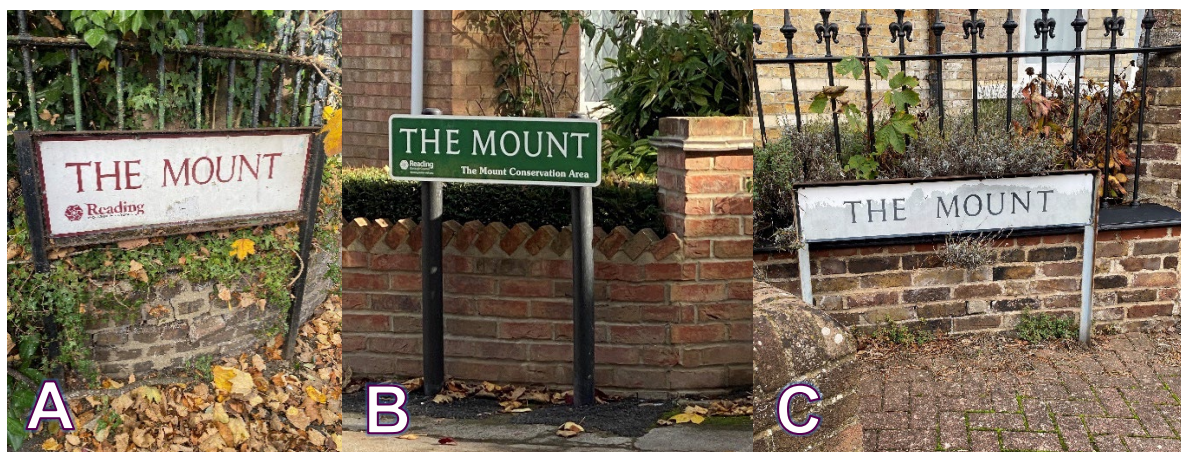
Figure 27: Images of three different conservation area signage styles (Images Claire Truman)

Inconsistent street signage for 'The Mount': three different types are in-situ – refer to Figure 27, below. Figure 27B shows the current design consistent to Reading's conservation areas.

Inconsistent 'conservation area' styled street signage (section 7.2.1).	Awareness: Replace superseded signage design with current design to achieve consistency within The Mount and across Reading's conservation areas.	RBC

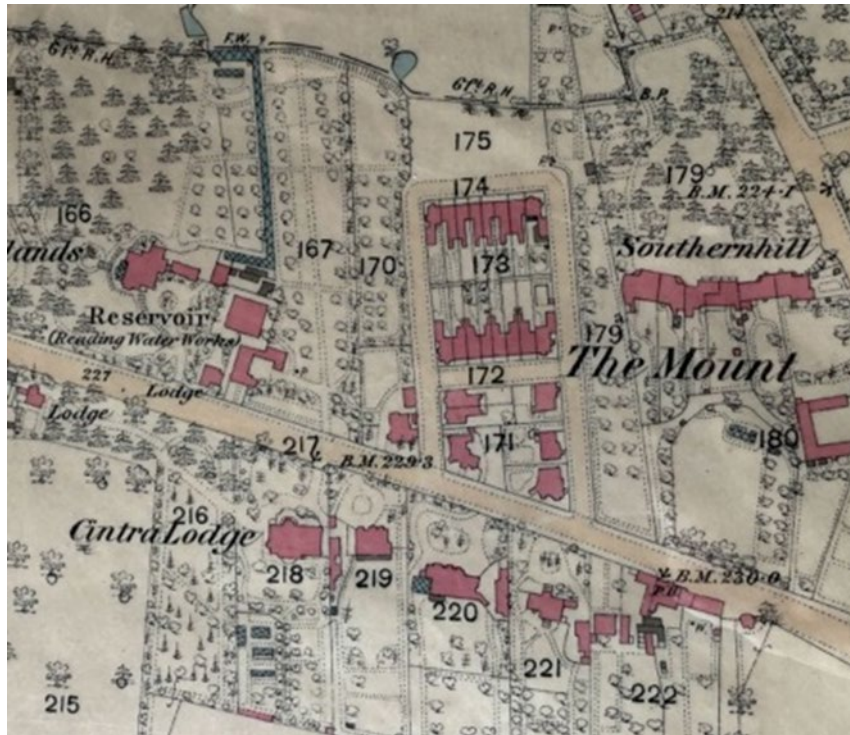
Figure 32: Extract from OS map 1877 showing The Mount which is complete apart from the northernmost two properties. Hillside has not yet been built. Mildmay Cottage had been built. The borough boundary is marked by the long dashed line and BP marks a boundary post. Courtesy Reading Borough Libraries

Listed properties with addresses in The Mount are dated c.1876 by Historic England (HE). Map evidence indicates that nos. 23 and 25, the two most northerly properties, were built slightly later, although both had been built by the time of the 1881 census. The listing for 59 Christchurch Road (Uplands) suggests the moulded brick rosettes are reminiscent of the work of Joseph Morris, but otherwise does not attribute the estate to a named architect.

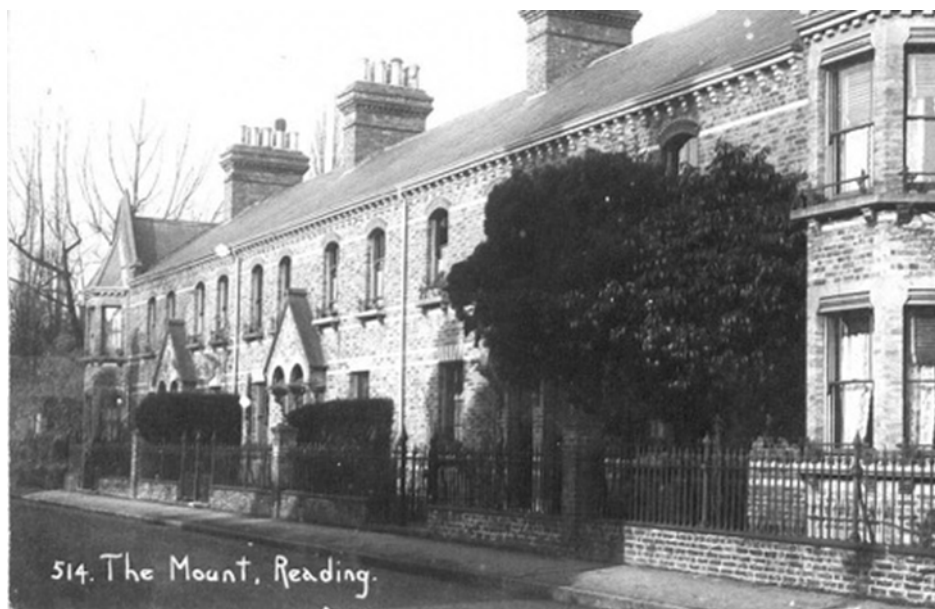
Figure 33: Nos 8-22 The Mount c1910. Postcard by P O Collier. Courtesy Reading Borough Libraries

<p>8-22, The Mount</p>	<p>1113439 https://historicengland.org.uk/listing/the-list/list-entry/1113439</p>	 	 	<p>Grade II (Group Value). Circa 1876. A 2 storey terrace for the clerks at Huntley and Palmers Biscuit Factory with foremen's end terrace houses for foreman. Gault brick with white brick bands and chevron moulded 1st floor brick window arches.</p>
<p>23 (Image 2) and 25 (Image 1), The Mount</p>	<p>1154876 https://historicengland.org.uk/listing/the-list/list-entry/1154876</p>	 	 	<p>Reflected pair circa 1876. Gault brick (No 25 previously painted) with white brick bands at cill and lintel levels, cogging to porch and modillion eaves cornice. Probably for under-managers of the Huntley and Palmers Biscuit Factory.</p>

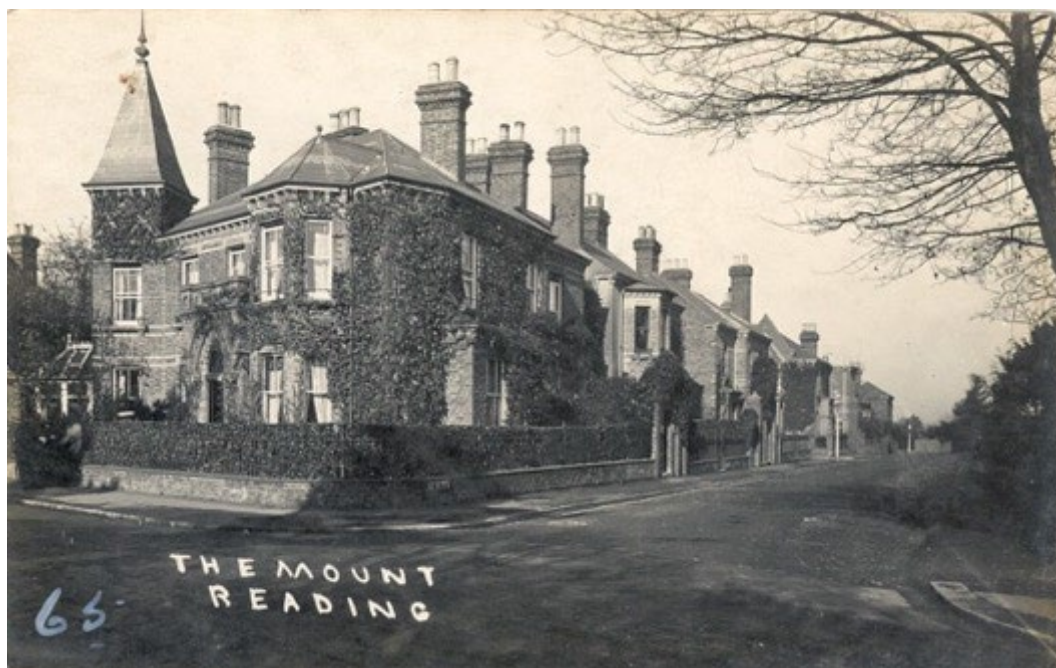
Figure 34: The Mount c1920. Uplands (59 Christchurch Road) in the foreground and Nos 2-8 The Mount, A postcard by H A Giles. Courtesy Reading Borough Libraries

Uplands on corner with Christchurch Road. House for manager at Huntley and Palmers Factory. Decorative features face approach from Christchurch. 1876. 2 storeys gault brick with yellow brick cill and lintel bands and patterning to square corner turret. Elevation to The Mount (east) altered to the detriment of its historic character.

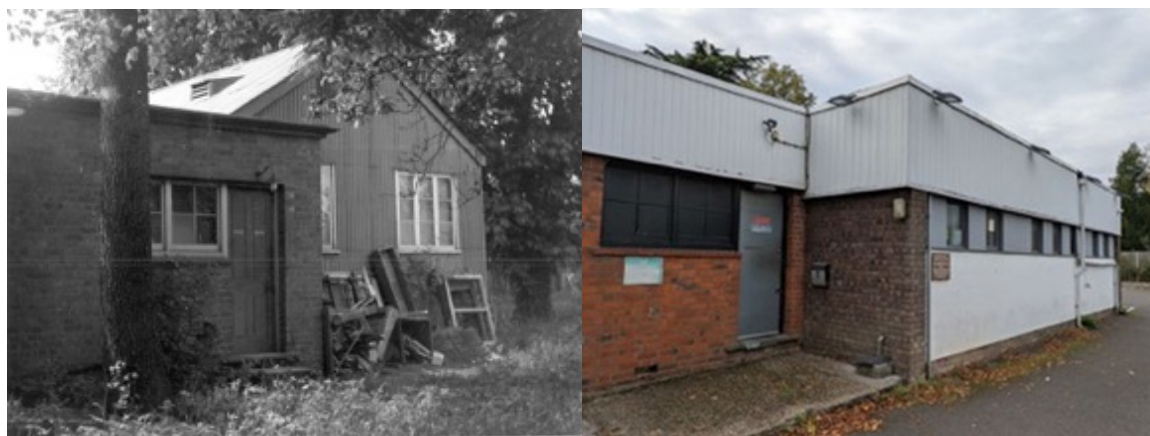
Figure 36: The north side of the Progress Theatre. (Left) stage door c1950 and (right) today when the corrugated iron club hall has been obscured by later extensions. Images courtesy Progress Theatre

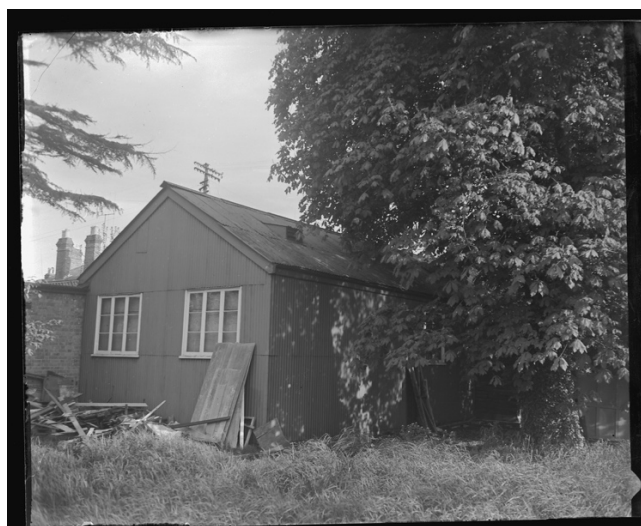
Figure 37: Progress Theatre from the north west in 1964. Image courtesy of Reading Museum/Reading Chronicle Collection (Reading Borough Council). All rights reserved.

A brick wing of two rooms with a bath and kitchen was added during the First World War when the hall was used as an extension to the Sutherlands war hospital.

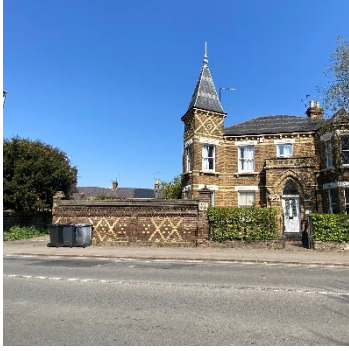
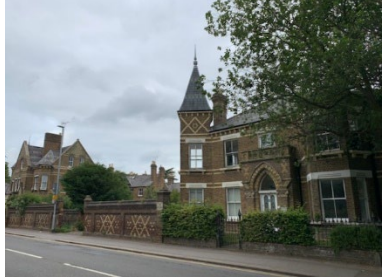
Grade II (Group Value). Circa 1876. In 2 sections. Gates missing and opening widened. About 6 foot 6 inches high. Brick with 3½ and 2½ paler yellow diaper patterns and coggd courses below moulded capping. End piers with moulded capping.
59 Christchurch Road	1321968 https://historicengland.org.uk/listing/the-list/list-entry/1321968

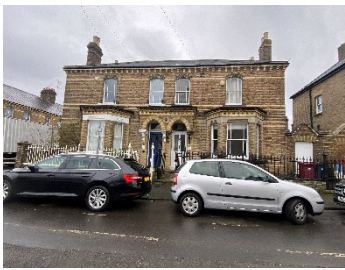
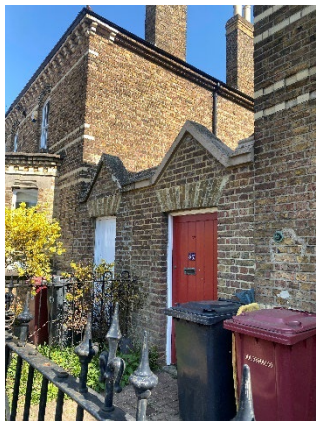
<p>Grade II (Group Value). Circa 1876. 2 storey pair, similar position to Nos 2 and 4. Gault brick with paler bands at cill and lintel levels. Linked to No 57 by garden entrances - a pair of gables breaking short length of wall with moulded cope</p>
<p>6 (Image 1) and 24-36, The Mount</p>	<p>1113438 https://historicengland.org.uk/listing/the-list/list-entry/1113438</p>

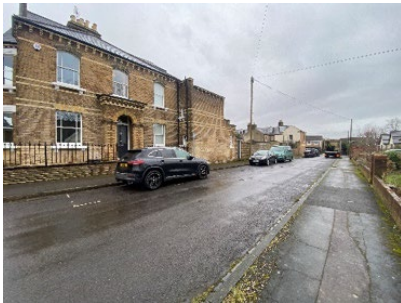
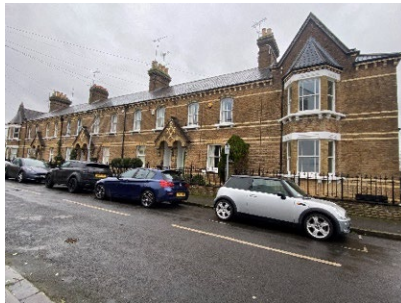
<p>Grade II (Group Value). Circa 1876. A 2 storey terrace for the clerks at Huntley and Palmers Biscuit Factory with foremen's end terrace houses. Gault brick with white brick bands and chevron-moulded 1st floor brick window arches.</p>

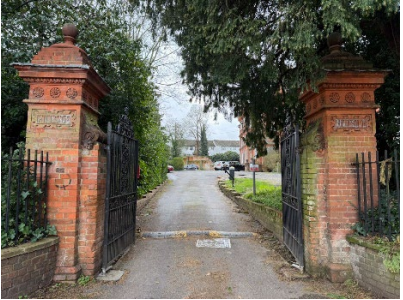
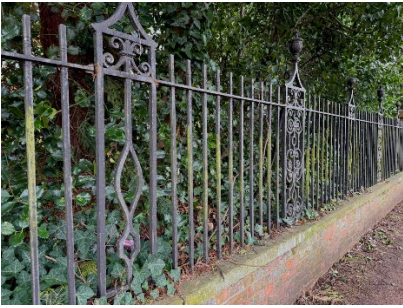
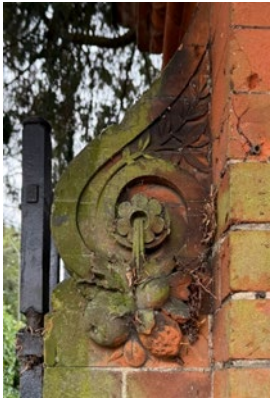
Address of building	HE listing number	Image 1	Image 2	Brief description mainly derived from listing entry
Entrance to Hillside from Allcroft Road	1392868 https://historicengland.org.uk/listing/the-list/list-entry/1392868

Grade II Gatepiers, walls, gates and railings forming two sides of the boundary to Hillside. Circa 1880-1900. Two entrances with gates: from Allcroft Road and Lower Mount. The gateways, gates and railings are valuable in putting the house in context.
As above	As above

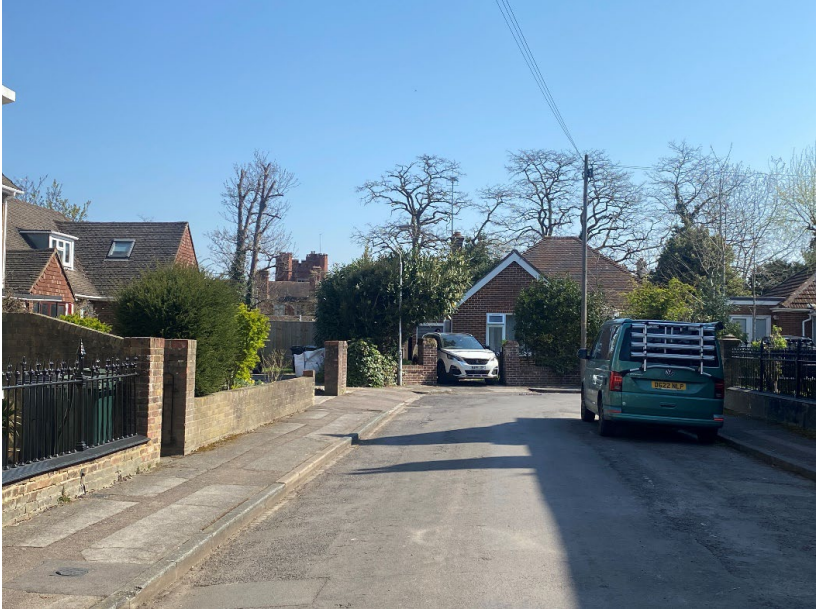
Location of view	Image
<p>View 7: East along The Mount (north) towards Wantage Hall (Image Claire Truman)</p>

A photograph showing a view looking east along The Mount. The road is paved and has a double yellow line on the left. On the left side, there is a brick wall topped with a black metal fence. In the background, there are several houses with brick walls and gabled roofs. A white car is parked on the left side of the road, and a green van is parked on the right side. The sky is clear and blue.
<p>View 8: West along The Mount (north) towards Christ Church (Image Claire Truman)</p>

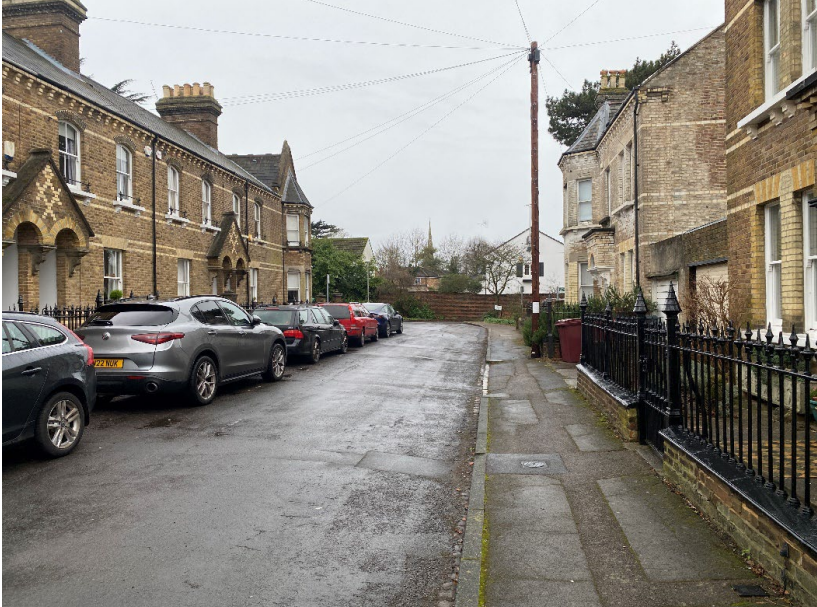
A photograph showing a view looking west along The Mount. The road is paved and has a double yellow line on the left. On the left side, there are several cars parked along the curb. The buildings are made of brick and have multiple windows. On the right side, there is a black metal fence. The sky is overcast and grey.
